Clark County 2020 Survey Summary Reports
Springs Stewardship Institute
Volume 1 of 3

1. Buck Spring, 10/17/20
Survey Summary Report, Site ID 152983
Submitted 2/11/22 by Springs Stewardship Institute

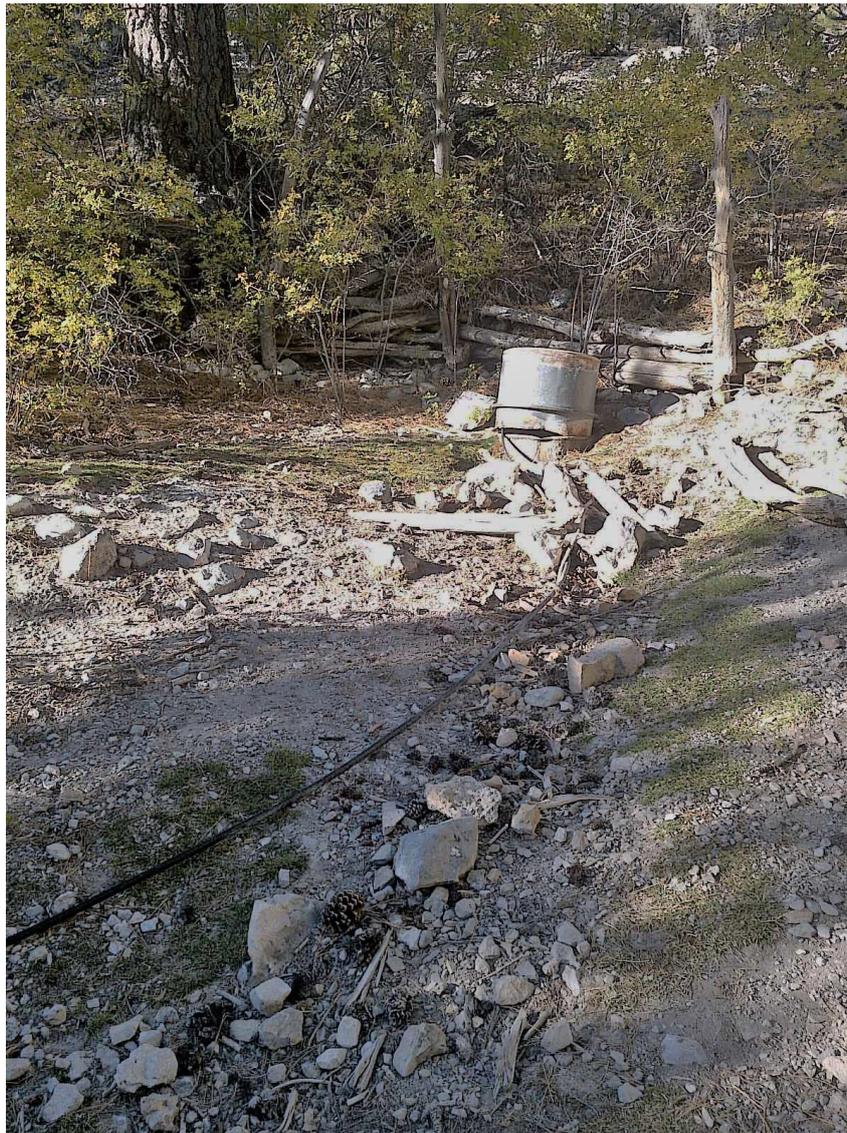
Fig 1.1 Buck Spring: The metal barrel well at the hillslope source, and the dry grazed patch of helocrenic habitat that surrounds it. The thin black pipe leads to a dry trough, 37 m downslope.

Survey Notes: There is no open water other than the water in the barrel. The trough downstream is dry. A surveyor searched 200 meters upstream and 100 meters downstream of the reported GPS coordinate and found no surface water. Inside the metal barrel there is 32 centimeters of standing water. There is woody flood debris in the dry channel/cienega. There is moist soil surrounding the well, supporting grasses which are grazed very close to the ground. The canyon has well-trodden horse trails running parallel to the canyon bottom. The open well poses a wildlife entrapment hazard.

Management Recommendations: The well cover is stuck so that there is a 4 inch gap allowing small animals to get in, but there is also a high risk of becoming entrapped. Land managers should remove the cap completely and provide a ramp for escape, allowing wildlife to access this water safely, or else seal the well cap completely.

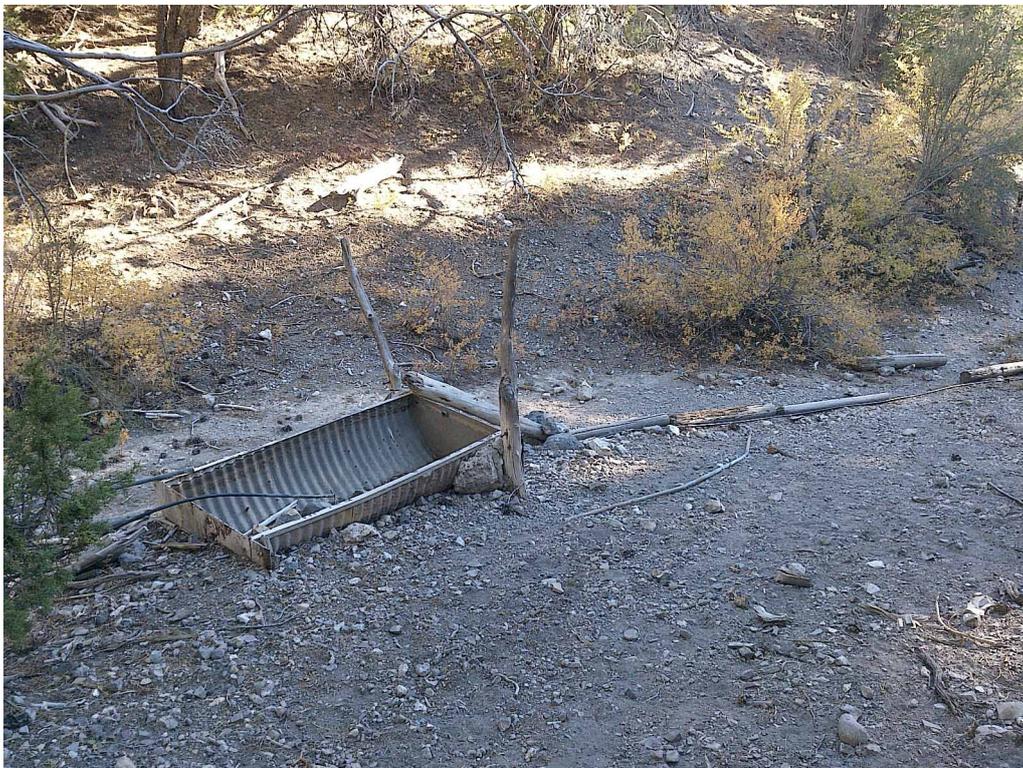
Fig 1.2 Buck Spring: The dry trough 37 m downslope of the metal barrel and hillslope source.

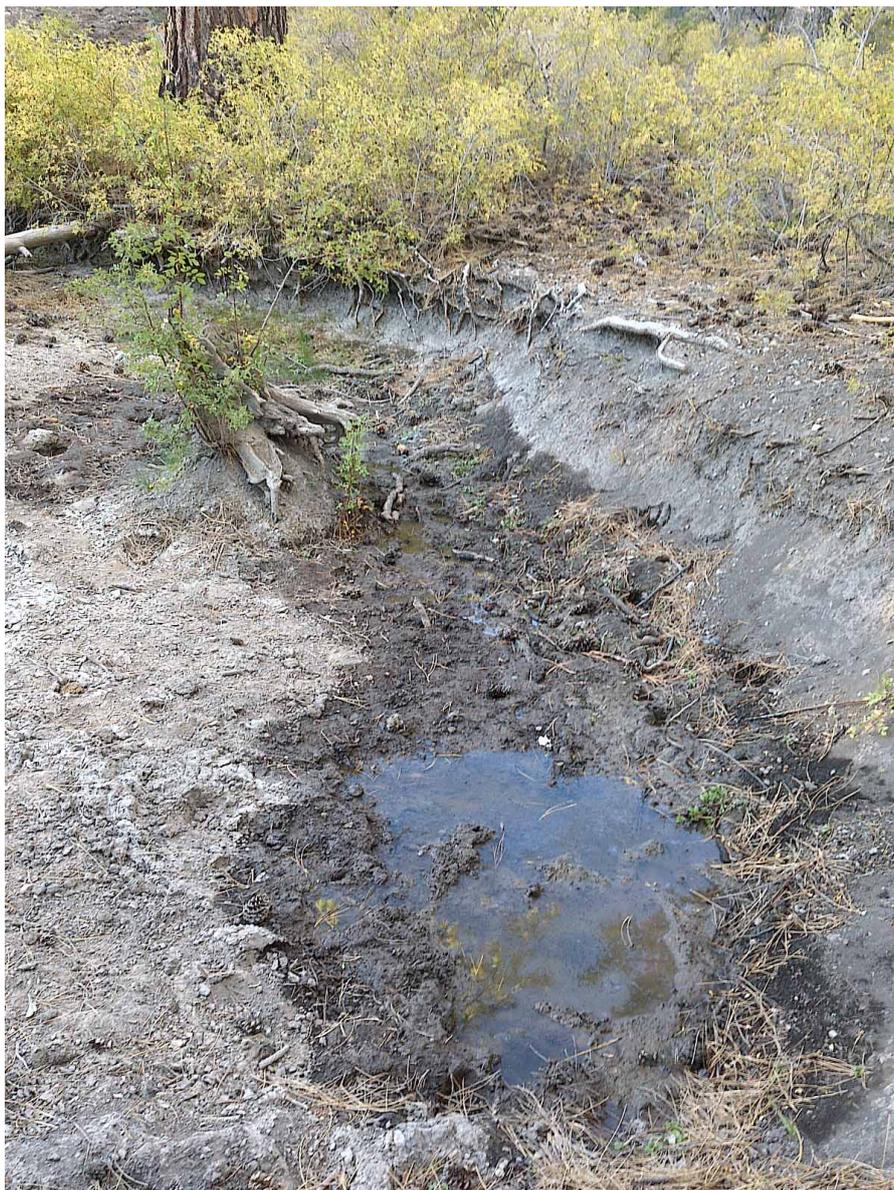
Fig 2.1 Bud Spring: The seeping dirt bank and small pool at the edge of the excavated tank. The photographer is at the southeast end of the saturated area.

Survey Notes: Seepage is emerging from a 2 meter wide by 5 meter long area on the dirt bank at the edge of the tank, and pooling in a smaller arc within the tank. The rest of the excavated tank is dry with evidence of trampling and cracked, dried mud. There is evidence of recent and historic trampling at this site. Several birds were seen drinking from the surface water. The surface water is about 2 inches deep. There is some watercress and grass at the perimeter of the saturated area, otherwise little vegetation. There is some felled wood at the site.

Management Recommendations: This site is used by a diversity of local wildlife. Consider testing the water quality over time to ensure this remains a clean water source for wildlife.

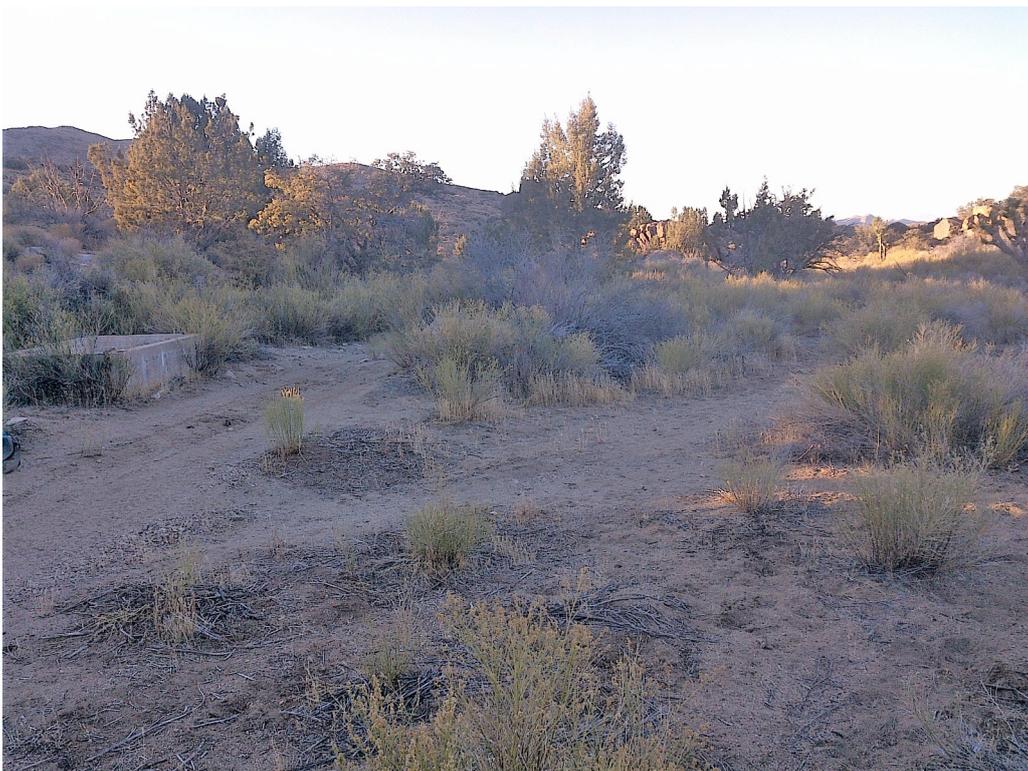
Fig 4.1 Falls Spring: The dry trough (left) adjacent to a 2-track dirt road, and the dry wash to the right. The wash bottom is vegetated with broom baccharis and sporadic junipers.

Survey Notes: The trough is completely dry, as is the wash. The wash bottom is filled with broom baccharis (*Baccharis sarothroides*), suggesting somewhat shallow groundwater. However, there are also sporadic junipers in the wash bottom, indicating encroachment of upland plants.

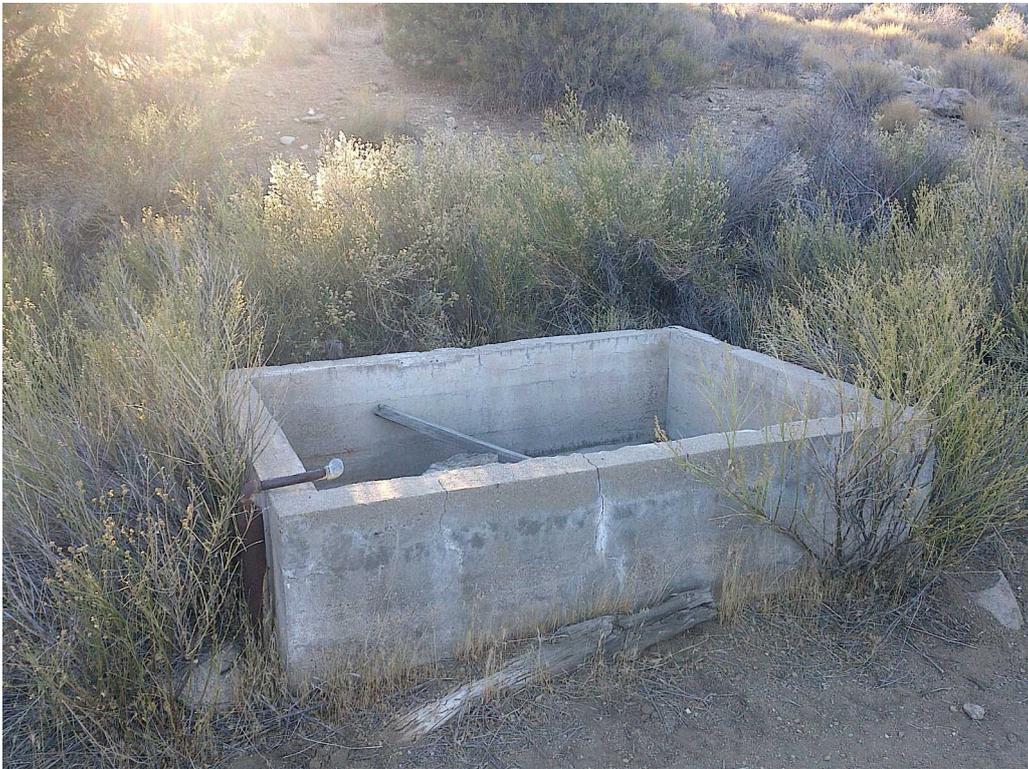
Fig 4.2 Falls Spring: The dry trough. The inflow pipe is still in place (left side) but no longer functional.

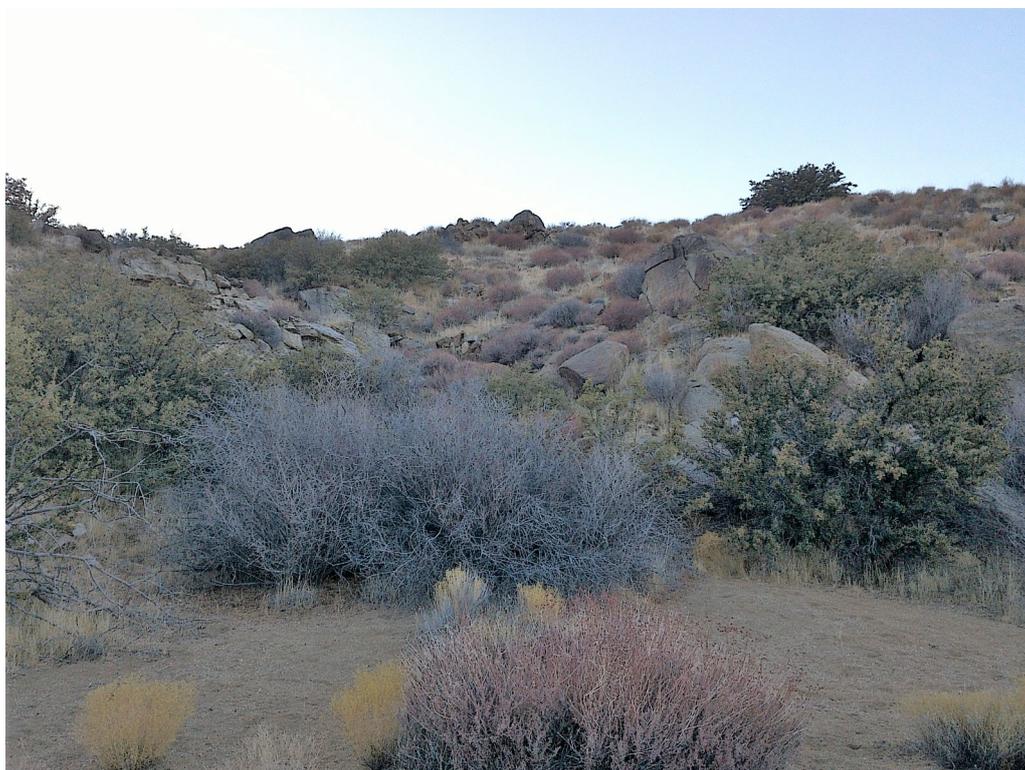
Fig 5.1 Falls Spring: The reported springs location in a dry drainage bottom. The photographer is standing about 10 m downslope of the reported GPS coordinate.

Survey Notes: The surveyor looked 50 meters up the drainage and searched the adjacent landscape and found no evidence of a spring. The brushy drainage was dry.

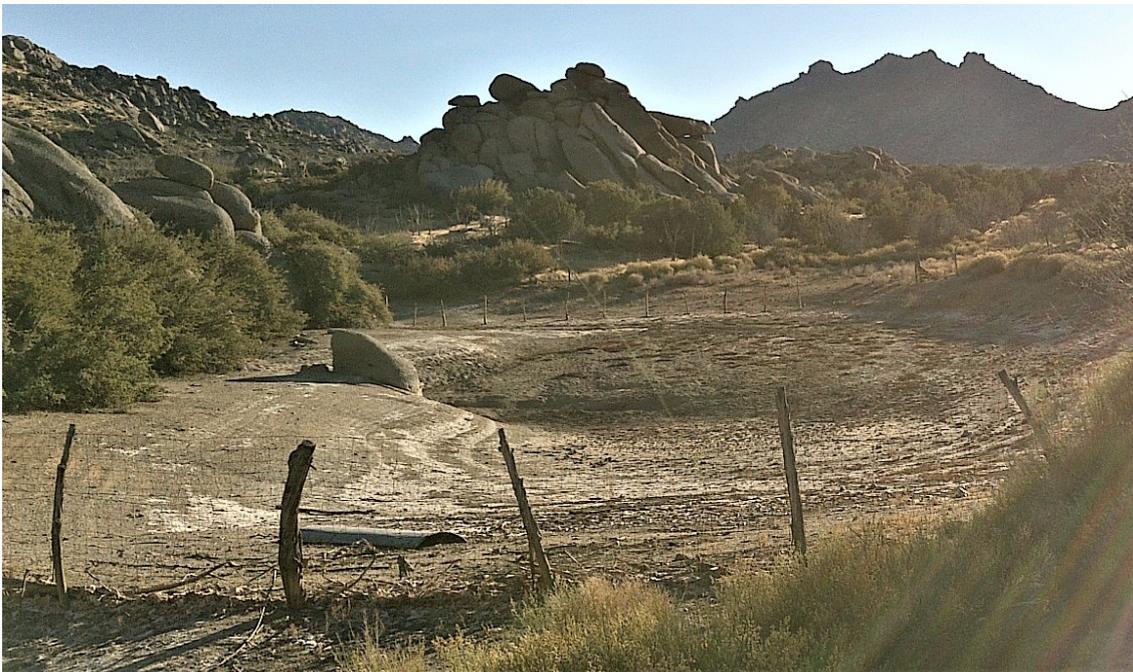
Fig 7.1 Grapevine Spring: The dry excavated pond. Surveyors searched the rock outcrop to the left and found no evidence of a spring, and no grapevines.

Survey Notes: Surveyors searched the granite outcrop east of the pond and found no evidence of a spring. The excavated pond is completely dry, and has a bathtub ring of precipitates. There is evidence of heavy historic cattle use, including hoof prints and old scat. There are no grapevines in evidence.

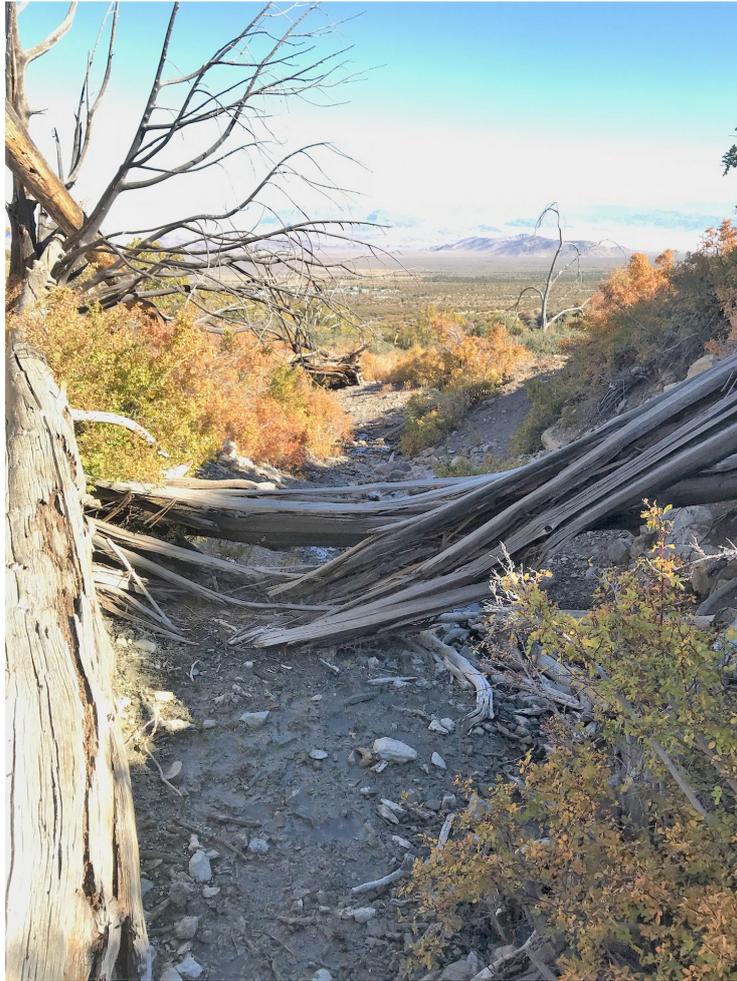
Fig 8.4 Horse Trail Spring: A large downed tree across the outflow channel, about 8 m downstream of the source.

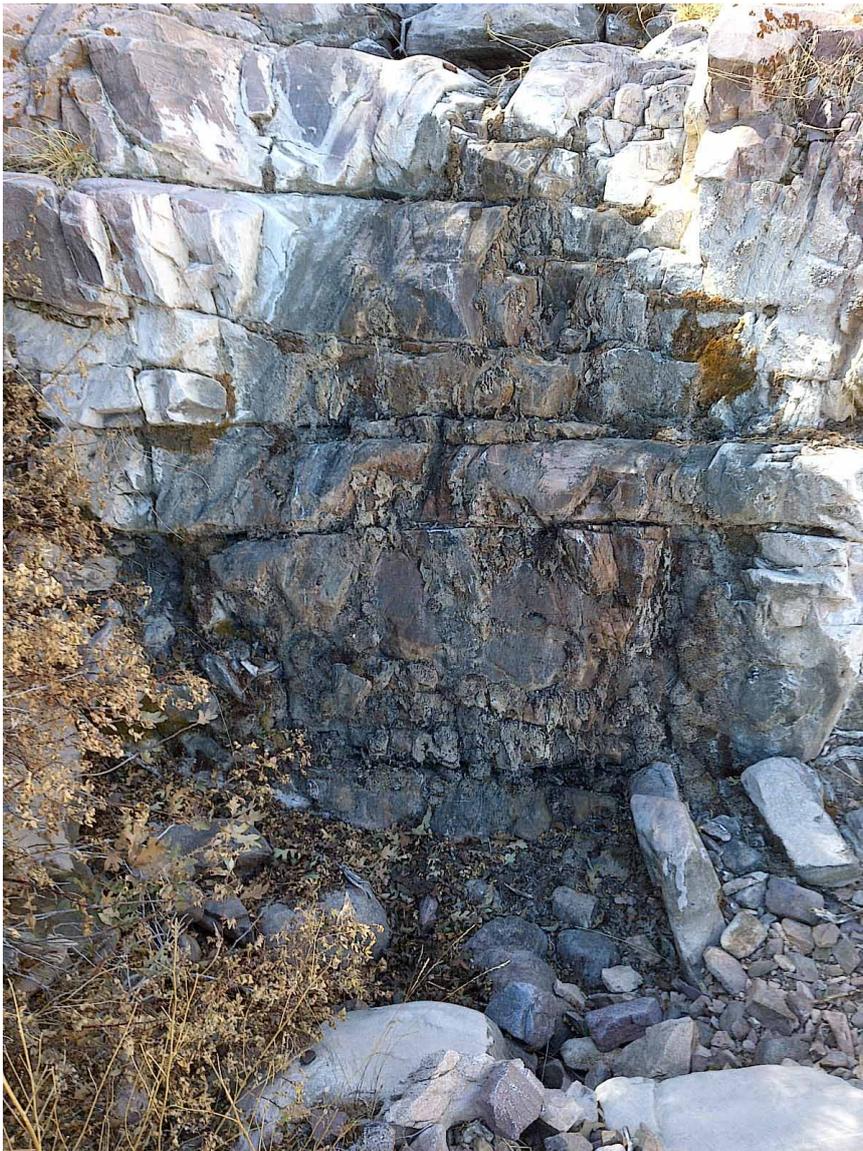
Fig 9.1 Horsetrail Unnamed Spring: A water-stained backwall (the wall is dry) with dead moss peeling off the bedrock. This is the uppermost evidence of a spring in the drainage.

Survey Notes: This spring is dry, but must have been wet somewhat recently, as the rock is quite water stained. There is a dead monkey flower plant about 30 meters downstream from the uppermost water stains, indicating that flow was present for quite a while before the spring dried. Bobcat scat was observed 40 meters upstream of the spring. There are horse trails leading to the spring and plenty of horse, elk, and rabbit scat in the vicinity. Skunk scat was also observed.

Management Recommendations: This spring is dry. Consider if groundwater pumping is influencing the aquifer. The surrounding landscape is in good condition, ecologically, but wildlife that historically relied on this spring may be negatively impacted.

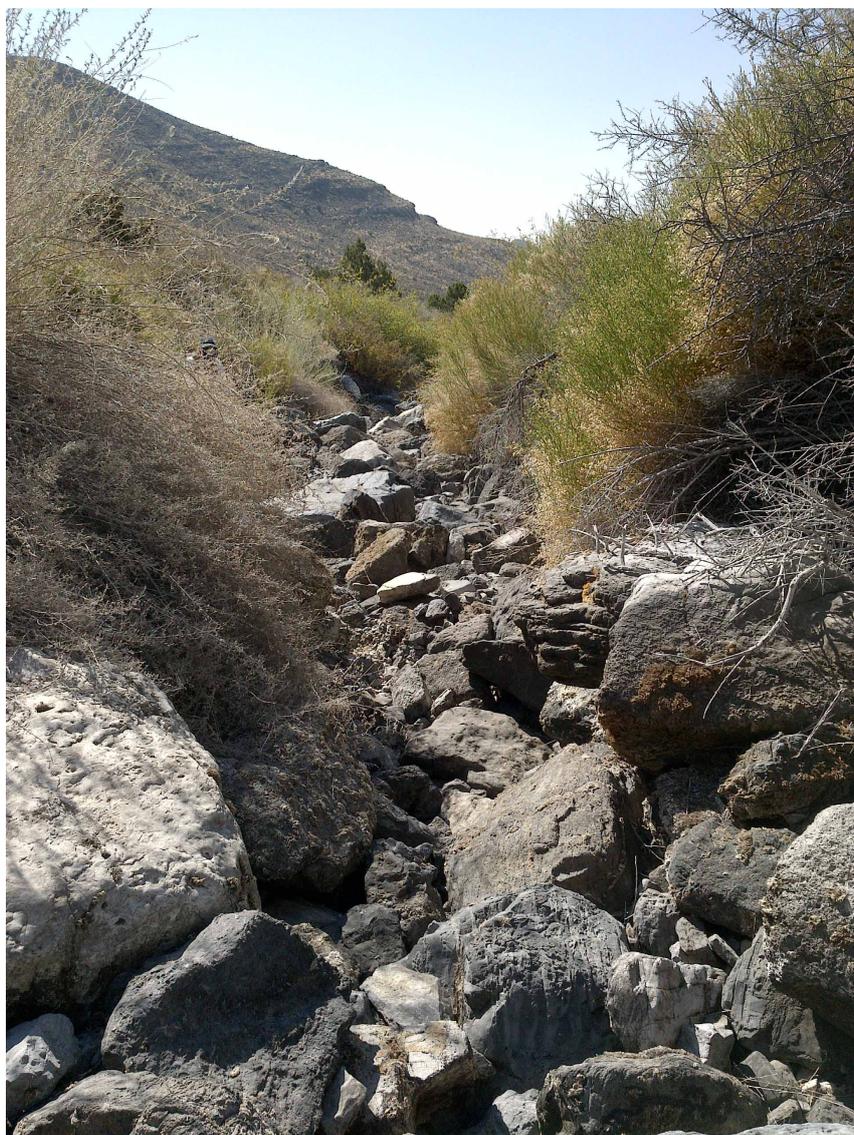
Fig 12.1 Intermittent Spring: The reported spring location in a dry drainage. Photo match 2011, facing downstream.

Survey Notes: The site was dry where it was mapped and for 200 or more meters in the channel upstream and downstream and in the nearby channels. Surveyors found evidence of past seepage 30 meters upstream of the mapped point in the form of magnesium precipitate. Surveyors recommend returning during a wetter season.

Management Recommendations: This naturally ephemeral spring does not warrant management attention, except determining the periodicity and range of discharge.

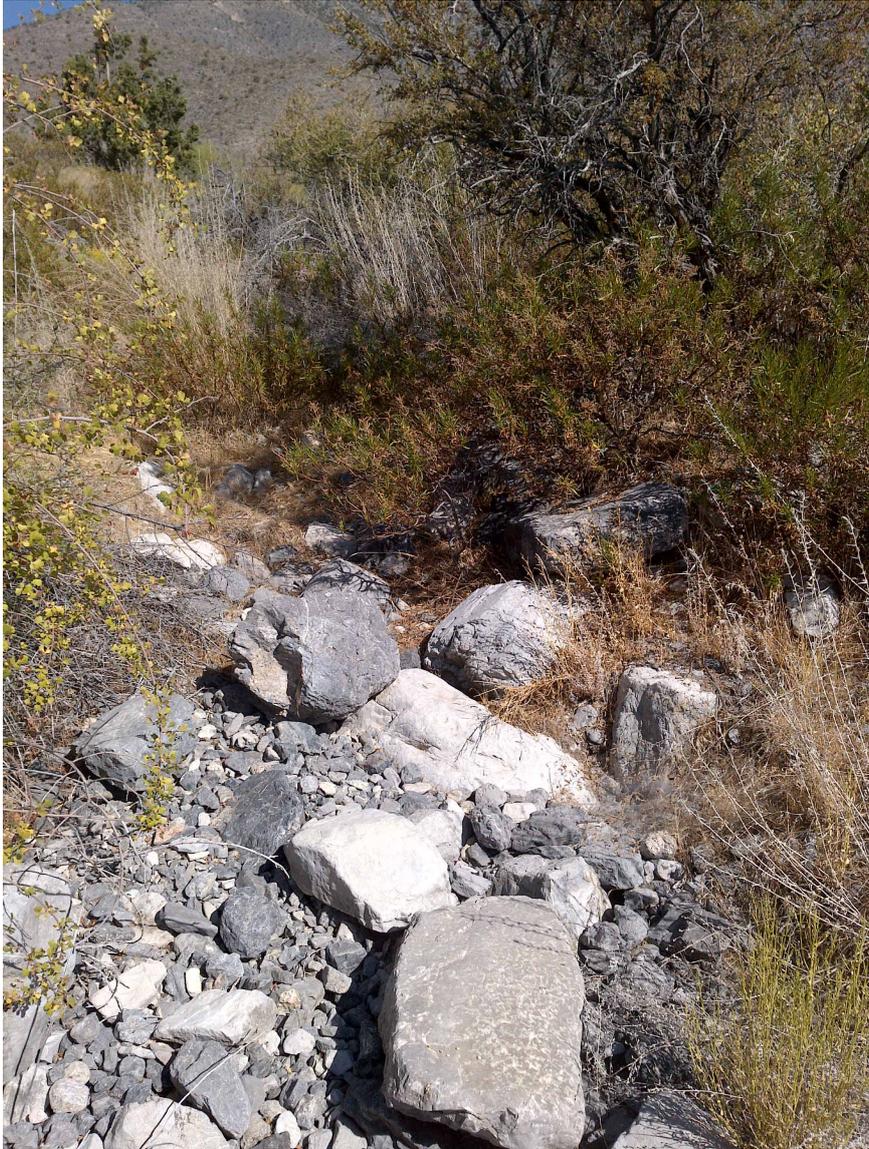
Fig 12.3 Intermittent Spring: The dry channel 30 m upstream of the reported spring location, where there is a small amount of chemical precipitate (not readily visible) indicating past spring flow.

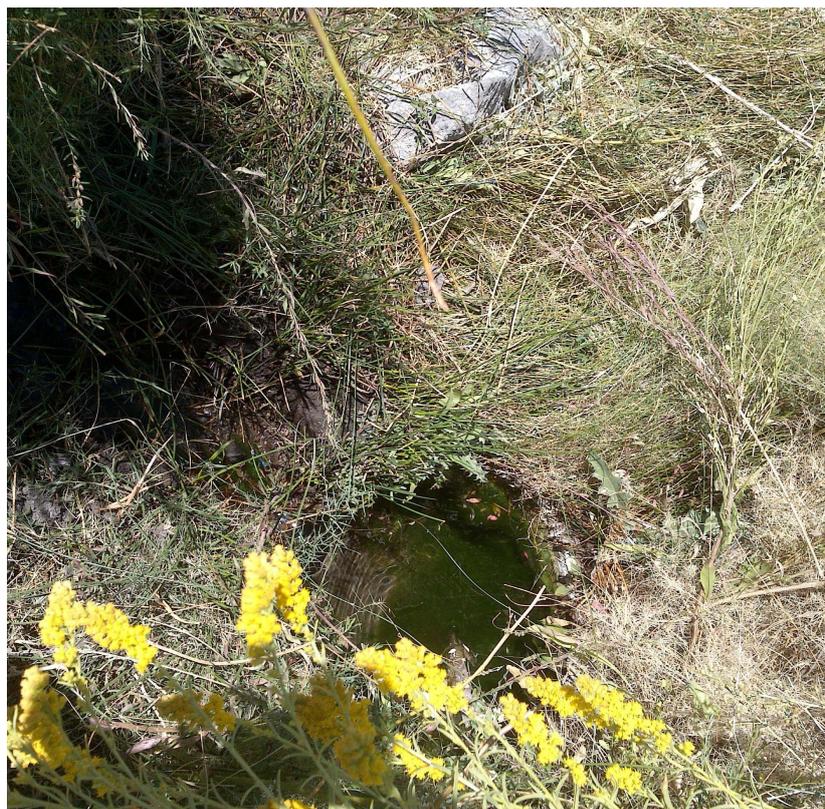
Fig 13.3 Kiup Spring: The vertical section of culvert pipe serving as an open springbox at the source.

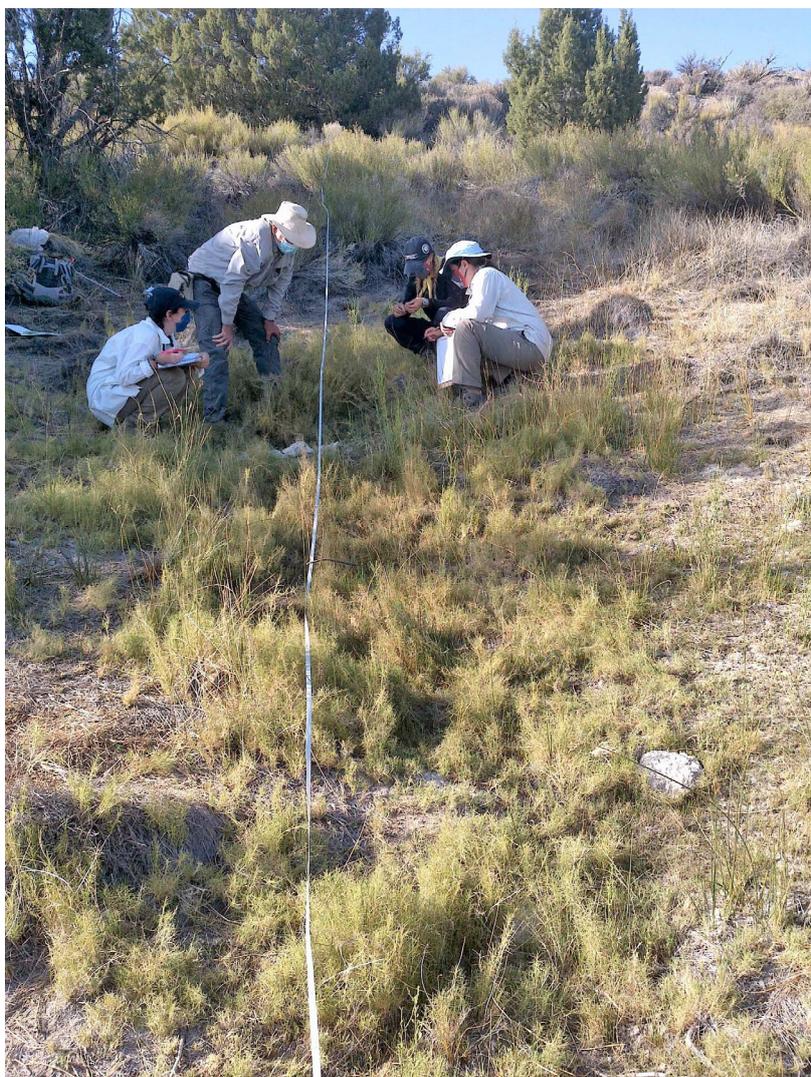
Fig 14.1 Kiup Spring Upper: The field crew gathers around a muddy pozo, or hole dug by an animal to reach water. The pozo, although it lacks exposed water, is the wettest spot in this dry springs ecosystem.

Management Recommendations: Monitor this site to determine the flow timing and extent.

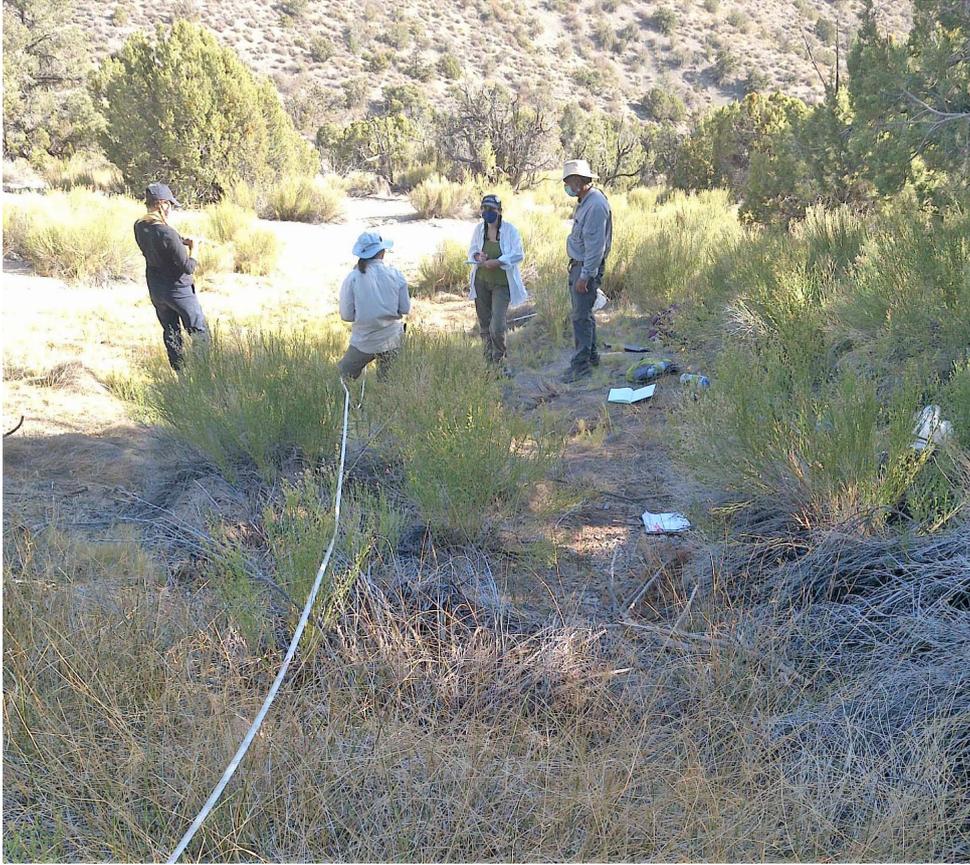
Fig 14.3 Kiup Spring Upper: The dry cienega. The photographer is at the upstream end of the springs ecosystem, facing downslope.

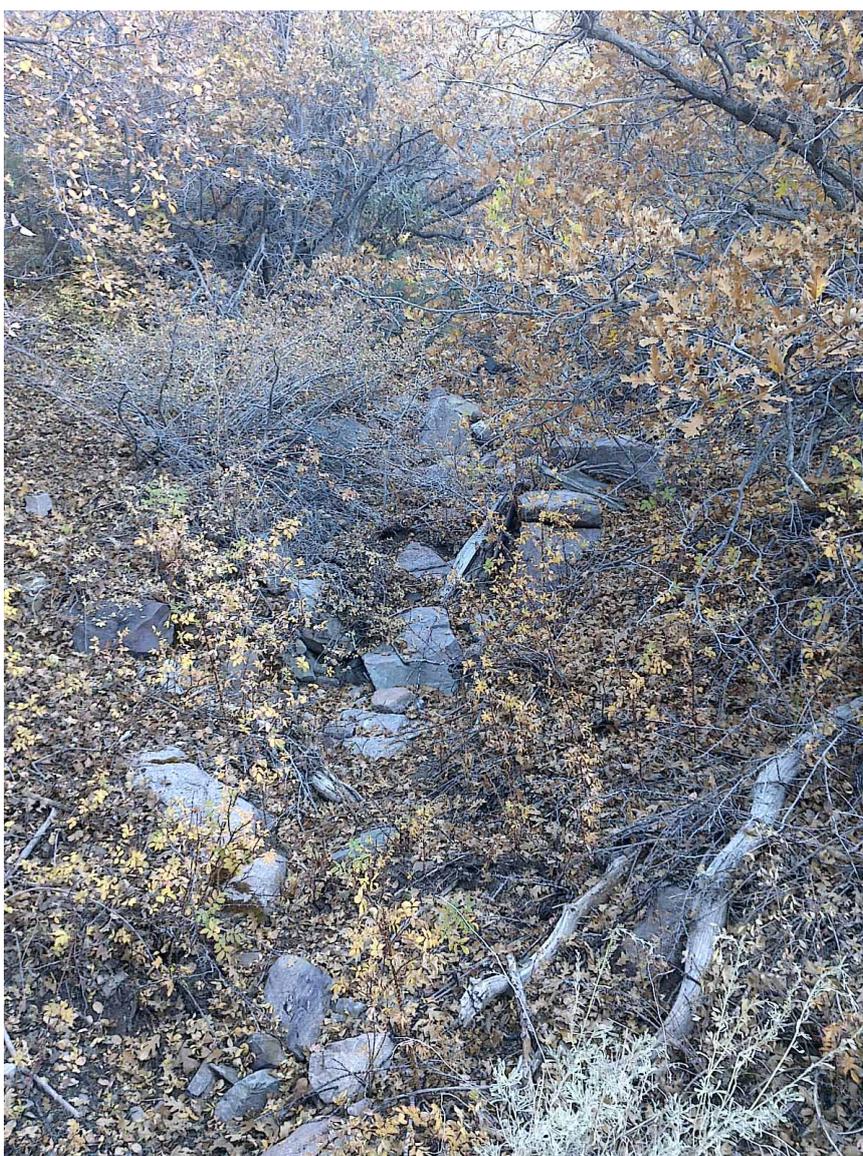
Fig 17.1 Lower Cougar Spring: The reported spring location in the bed of a steep narrow drainage, viewed from 5 meters downslope. This soil is dry and there is no riparian vegetation.

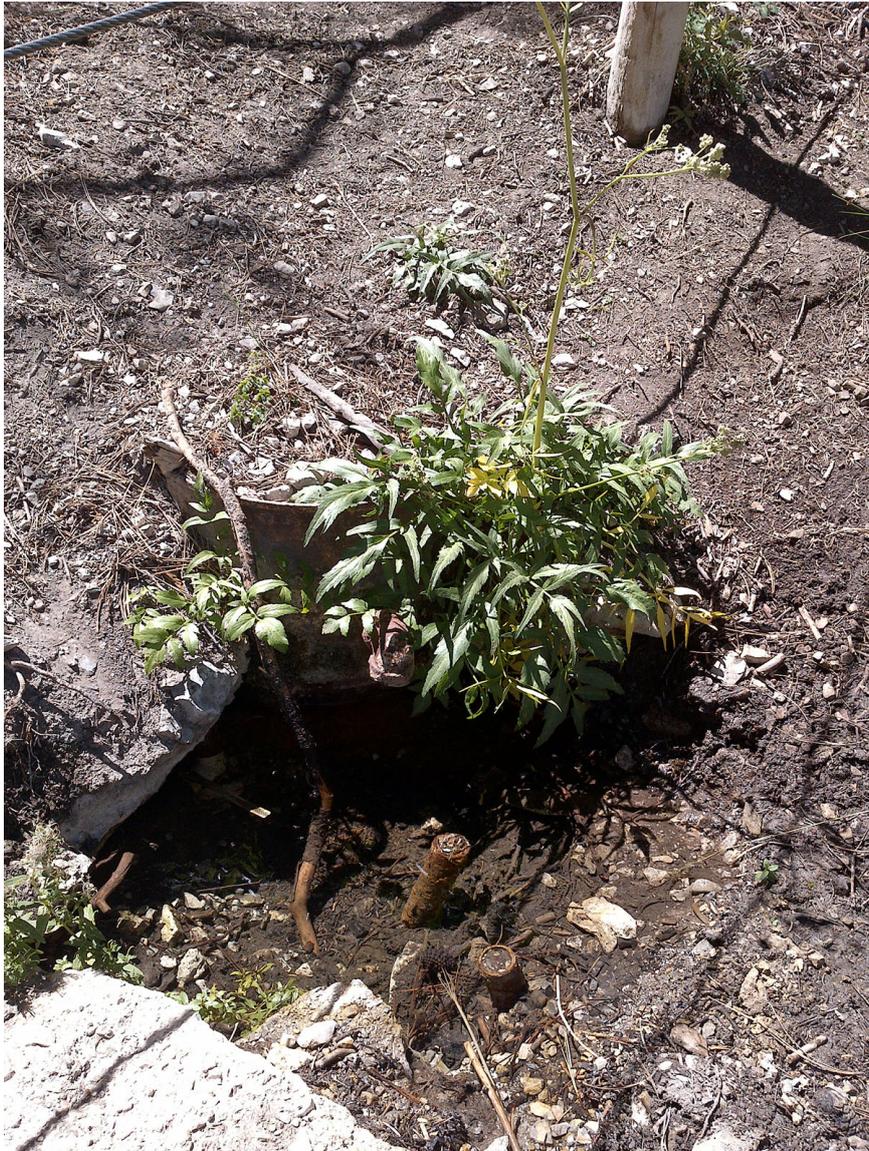
Fig 18.3 Macks Canyon Spring 1: The excavated source with silted-in metal tank and pipes, as viewed from 3 meters downslope. The wood structure at the top of the photo is a fencepost.
