ASSESSMENT AND RESTORATION PLANNING FOR SELECTED STANISLAUS NATIONAL FOREST SPRINGS: 2015 FINAL REPORT

Lawrence E. Stevens, Jeri D. Ledbetter, and Gloria Hardwick
Springs Stewardship Institute
Museum of Northern Arizona
3101 N. Ft. Valley Rd.
Flagstaff, AZ 86001
larry@springstewardship.org

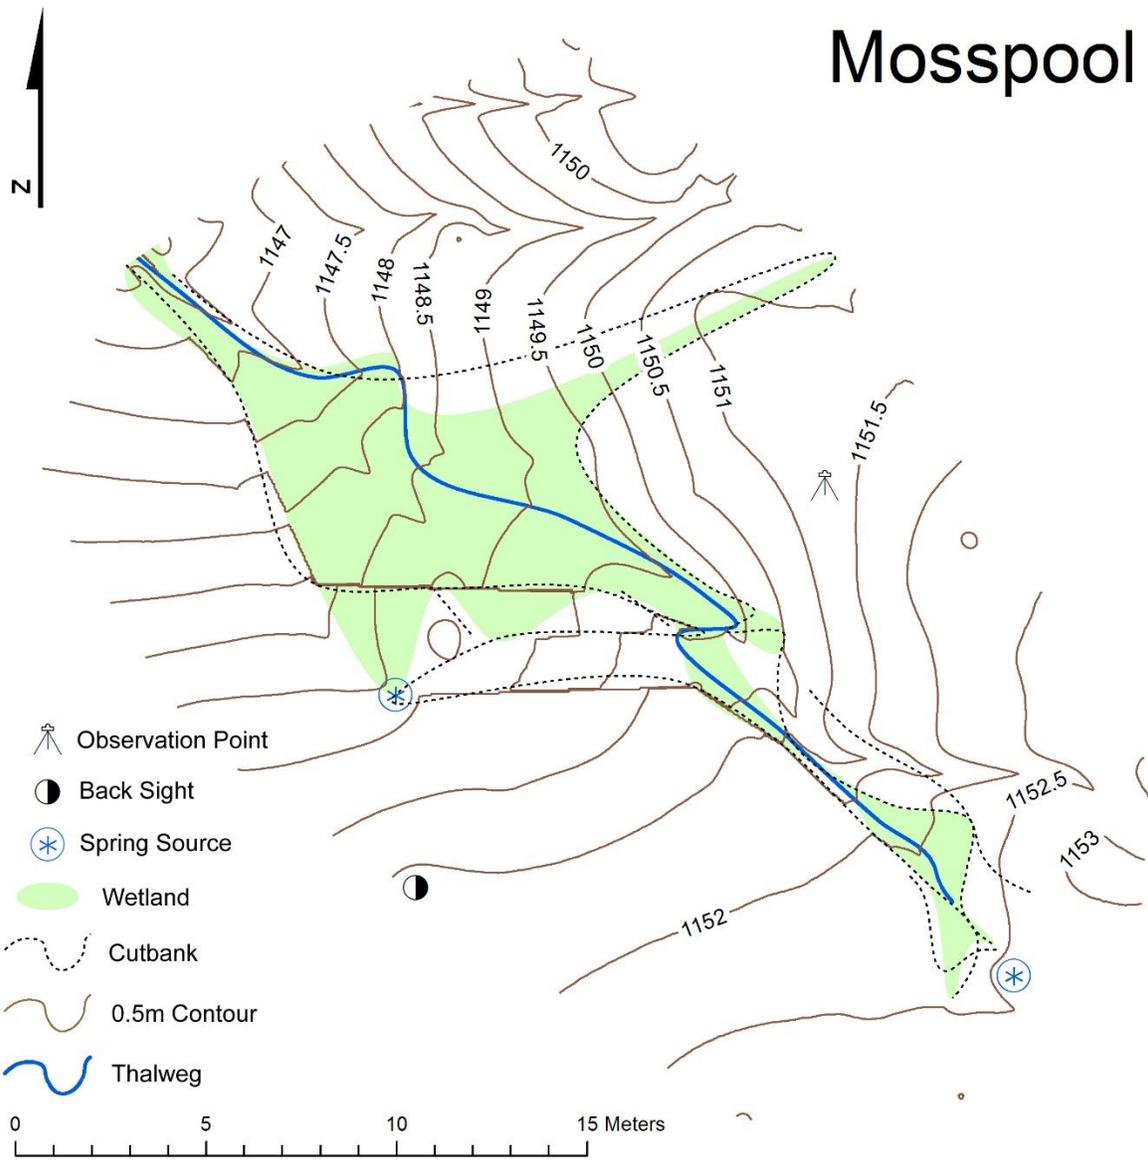
Fig. 2: Mosspool topographic map, September 2015. The Forest Service road (not depicted) lies upslope from the source in the lower right corner of the figure.

The Mosspool Springs area was intensely burned by the Rim Fire in 2013, and all coniferous and several massive California oak trees in the vicinity of the springs were killed in that fire. Many dead conifers stand over the springs, and are soon likely to fall. The presence of these dead trees makes work at the site hazardous.

- 1) Felling of the dead conifer and oak trees around the source and the upper 50 m of flowing channel – the presence of those trees presents a hazard to further work on the site.

Mosspool Springs: The presence of many dead trees at Mosspool Springs makes work at the site hazardous. Wetland vegetation regrowth is vigorous but intensive cattle grazing in 2015 reduced wetland cover greatly and livestock impacts on the site were everywhere conspicuous. In 2014, the Mosspool Springs ecosystem occupied 77 m². In 2015, after the upper source shifted downstream, the total area affected by the springs was approximately the same, but of course lay in a different portion of the channel. Removing weeds and monitoring are recommended. If the site is fenced, the site can be rehabilitated with native plantings.

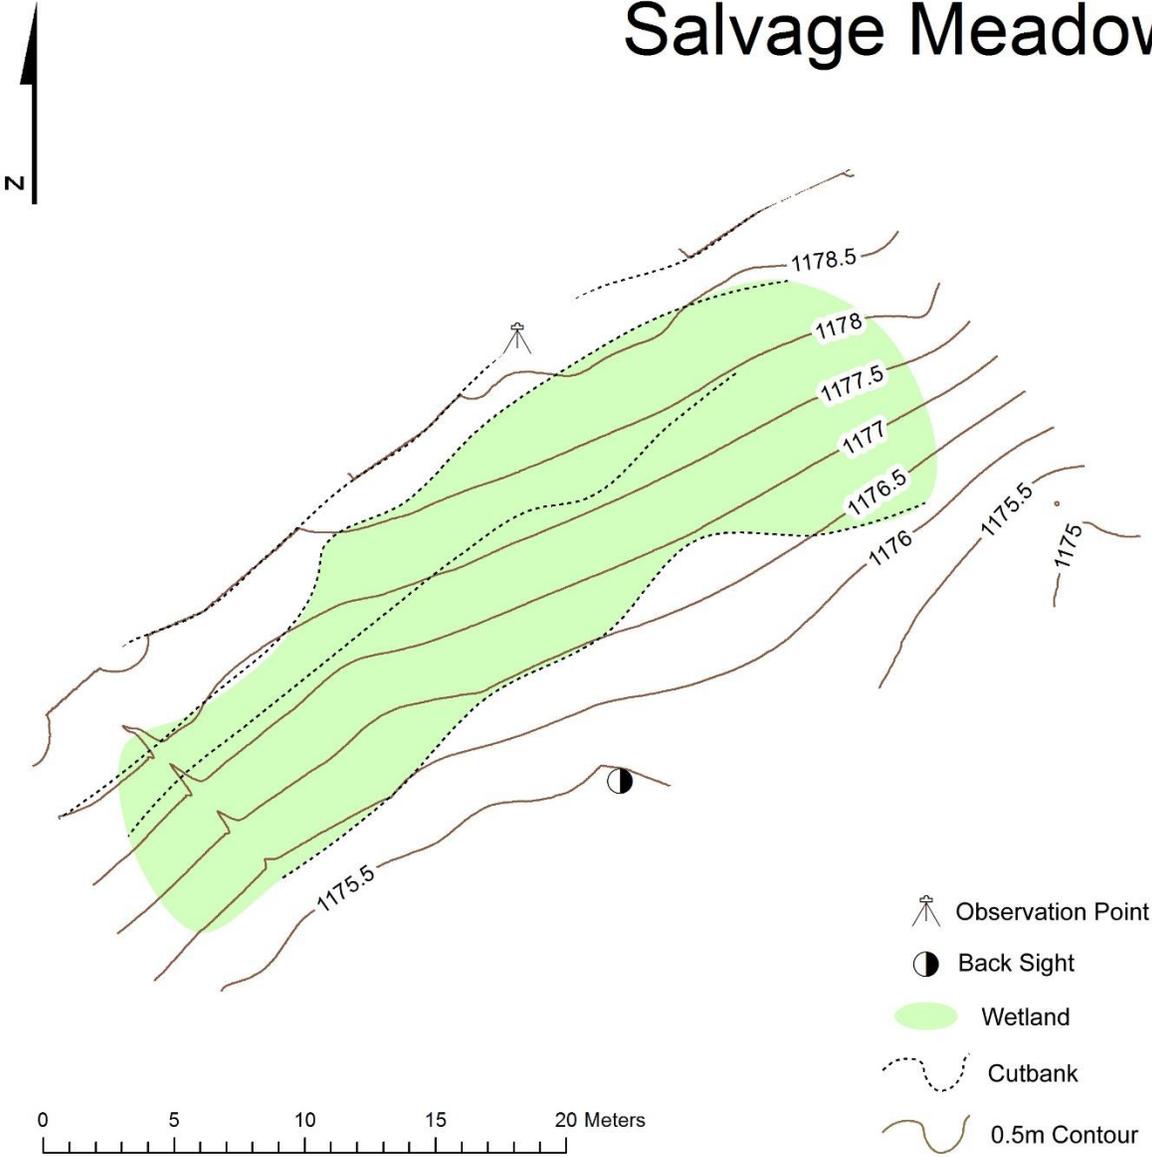
Fig. 3: Salvage Meadow Seep topographic map, September 2015.

30 m. The meadow was drying out by the time of the 2014 inventory, and by mid-September 2015 it had dried entirely. Flow formerly emerged along an upslope seepage line, wetting a meadow for a width of approximately 10 m, and creating a wet meadow approximately 300 m² in area that supported several wetland plant species. Livestock trampling and grazing impacts were everywhere evident. A copse of dead fire-killed conifers on the upslope and eastern side of the site threaten the safety of workers if restoration activities take place at this site.

The SSI SEAP scoring for site restoration potential was more favorable, with a natural resources condition score of 2.9 (of a possible 6) and an anthropogenic risk score of 3.0. Elevated risk was attributed to grazing impacts and the highly degraded condition of the adjacent landscape, which reflect high burn intensity and the impacts of salvage logging on the soils and geomorphology of the surrounding landscape.

The Forest Service Decision Memo (2015) permits consideration of excluding livestock grazing at Salvage Meadow: “...Minimize cattle disturbance by creating a barrier at one site (Salvage Meadow).” Our land survey map of this site shows the approximate location of where livestock enclosure fencing can be placed. Such actions may be important if rains restore flow to this wet meadow; however, if flow does not return, even with fencing the site likely will continue to degrade towards the condition of the surrounding near-dysclimax rangelands. If flow does recover, and the enclosure is maintained, planting with wetland species plugs may be warranted to maintain the meadow functionality of this helocrene. We do not recommend planting phreatophytic shrubs or trees here, so as to preserve its meadow characteristics.

- 1) Felling of the dead conifer trees at the upslope end – the presence of those trees presents a hazard to further work on the site.
- 2) Occasional monitoring (e.g., semiannual) to determine the extent of source shifting intra- and inter-annually

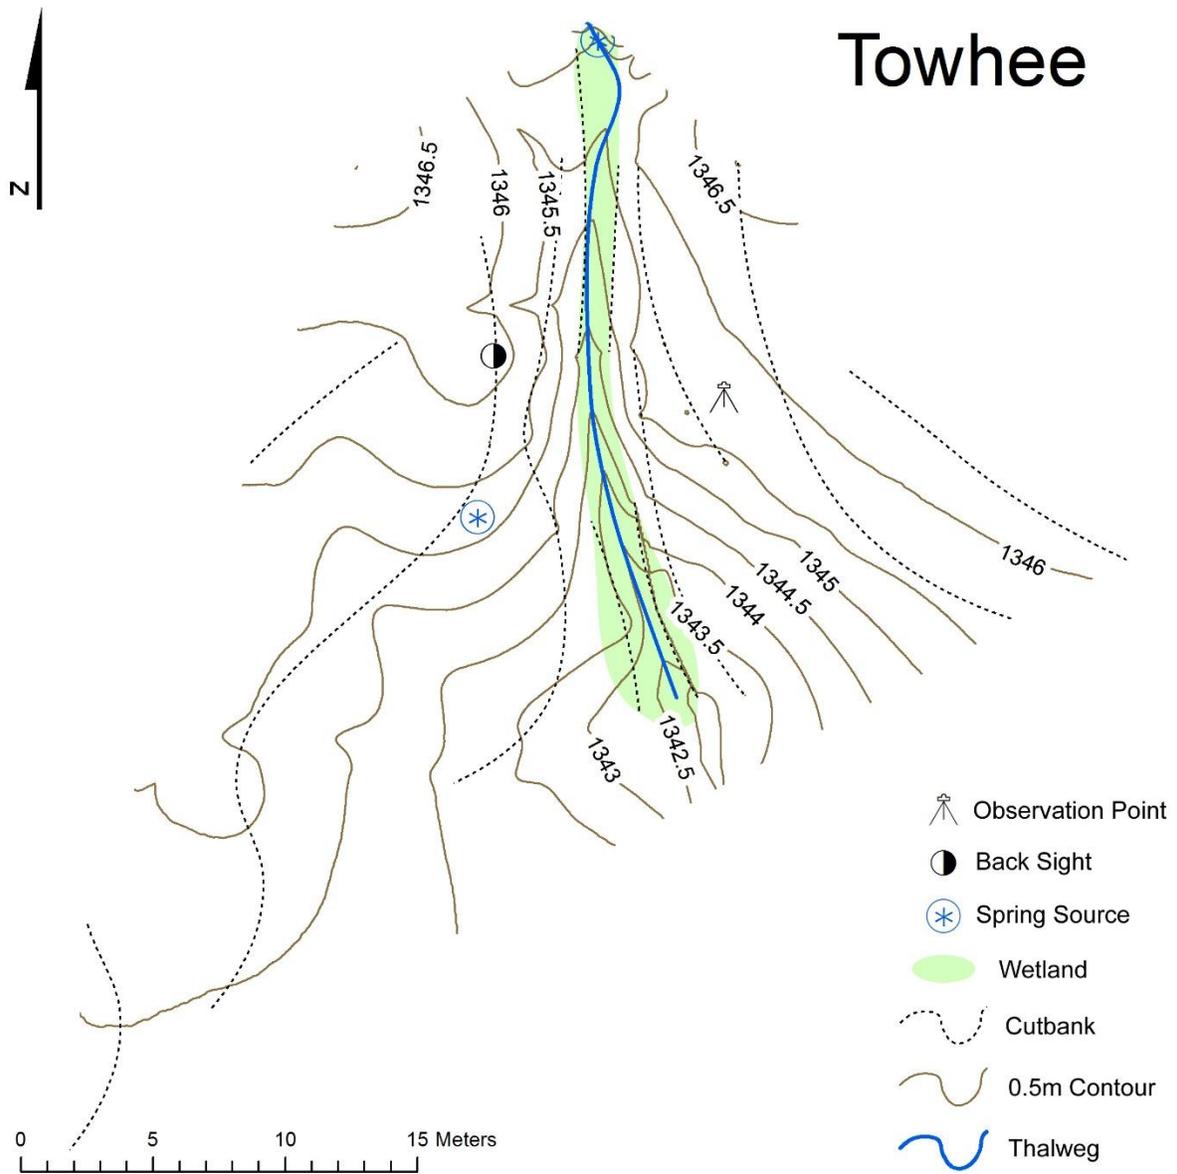
Fig. 4: Towhee Springs topographic map, September 2015.

Towhee Springs: Towhee Springs ecosystem is a small rheocrene springs ecosystem that emerges from beneath semi-consolidated granitic alluvium in the channel of a moderately steep, minor tributary of Cherry Creek at N 37.95635°, W -119.91800°, and at 1,364 m elevation (Fig. 4). The springs generate a small flow (0.1 L/sec) that flowed 22.5 m from the source before losing into channel alluvium in 2015. The channel becomes increasingly flat and open for the first 5 m, then drops into a deeply incised, *Actaea*-dominated channel. The springs area was a relatively open, sloping meadow and did not appear to have been burned by the Rim Fire, but a previous fire had occurred on the site. Channel and terrace vegetation regrowth was vigorous in both 2014 and 2015. No livestock grazing impacts were detected, but piping, earth movement, broken glass, and a parking lot and primitive roadway that crosses the creek attest to a long history of water extraction and recreational use. Towhee Springs supported 6 m² of wet channel habitat, 75 m² of terrace habitat, and 270 m² of adjacent terrace/anthropogenic habitat in 2015. The site did not change appreciably between 2014 and 2015.

The FSMI score for Towhee Springs was 24 of 66 (36.4%), one of the higher values of the 10 springs, but not a score that indicated that substantial investment in restoration will result in project success. The geomorphology and soils partial score was 36.7%, largely attributable to the extent of anthropogenic influences on and around the springs, as well as the impacts of roads and recreation there. The SSI SEAP scoring for site restoration potential was more favorable, with a natural resources condition score of 2.3 (of a possible 6) and an anthropogenic risk score of 2.9. Elevated risk from 2014 to 2015 was attributed to use of the formerly abandoned road and the highly degraded condition of the adjacent landscape. Thus, FSMI and SEAP scoring corroborate high levels of anthropogenic impacts at Towhee Springs.

We first recommend ensuring the source area is protected from flow abstraction, and if abstraction is no longer needed, or is only needed seasonally, that flow is recovered into the drainage. The spring runout stream extends just 22 m downstream from the source, with more than 75% of that channel in a deeply incised streambed and largely unavailable to wildlife. If flow restoration is accomplished, our land survey map of this site shows the approximate location of where a gabion composed of hand-moved large erosion barrier (LEB; woody debris) could be installed to rebuild the stream base level, and create a broader wetland area (Fig. 4).
