Clark County 2020-2021 USFWS Refuge Survey Summary Reports  
Springs Stewardship Institute  
Volume 1 of 2

## 1. Big Spring, 12/06/21

### Survey Summary Report, Site ID 111676

Submitted 2/03/22 by Springs Stewardship Institute

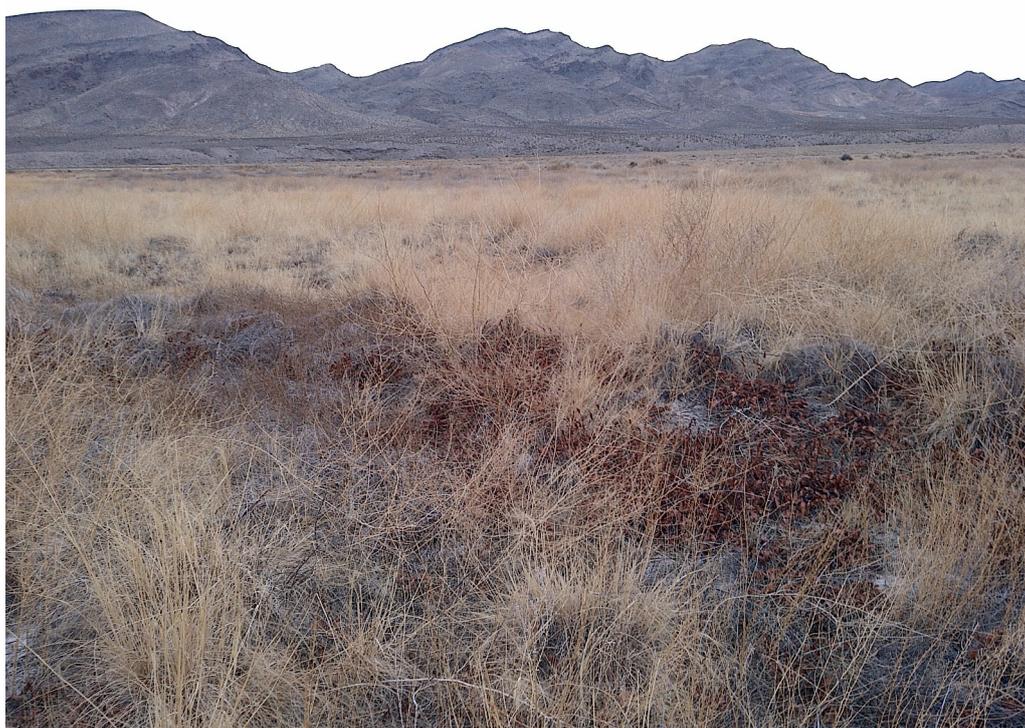
**Fig 1.1 Big Spring:** The reported spring location with dry soil and winter-dormant vegetation. The photographer is facing south.

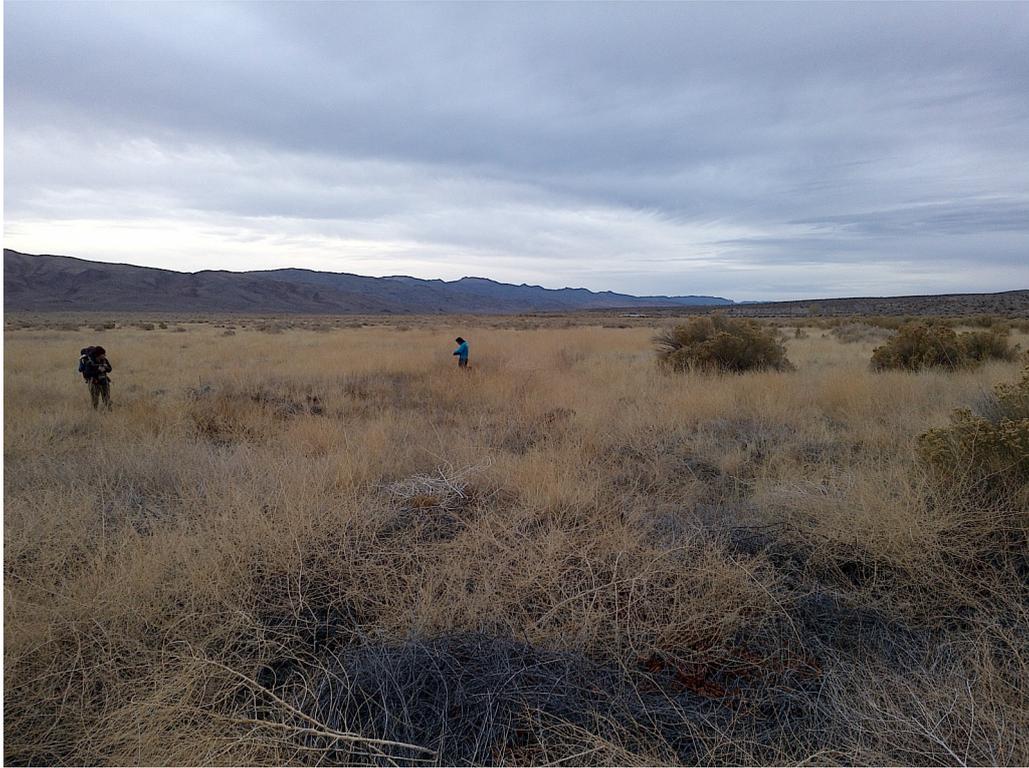
**Survey Notes:** No water was found at the time of survey. The dominant vegetation is *Kochia*, *Juncus*, and *Anemopsis californica*, with scattered *Ericameria nauseosa*. One lone *Tamarix* was observed. Vegetation was winter-dormant at the time of the survey.

**Fig 1.2 Big Spring:** The valley bottom, as viewed from the old roadbed south of the reported springs location. The GPS point is about 50 meters beyond the surveyors.

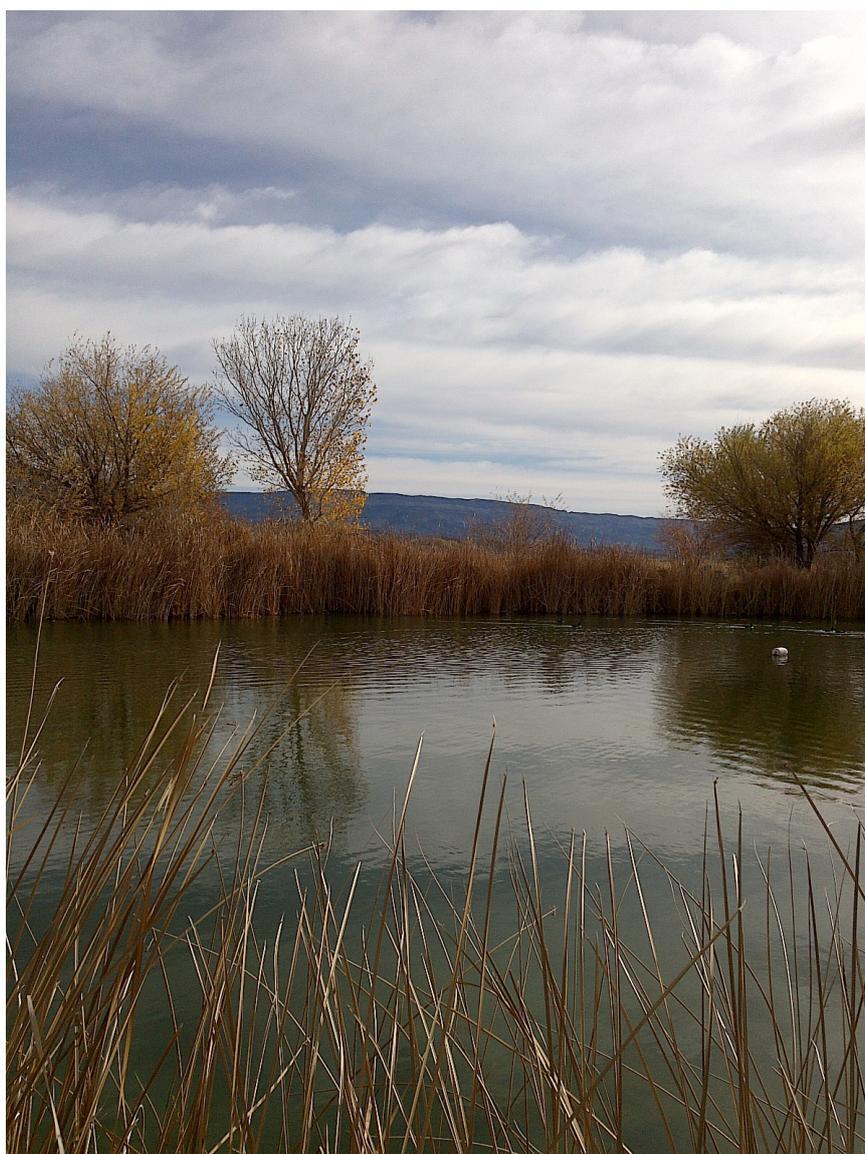
**Fig 2.1 Cottonwood Spring:** The excavated pool, lined with cattails and sedges.

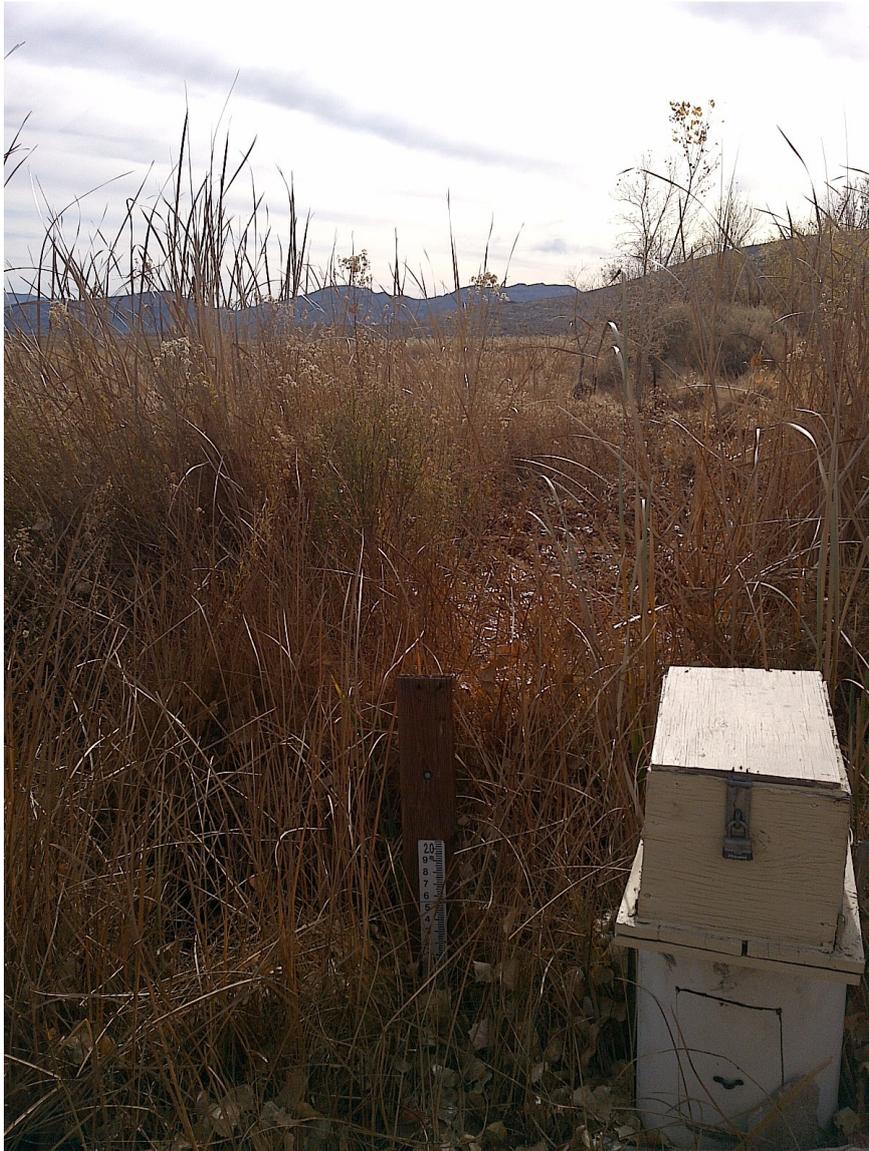
**Fig 2.3 Cottonwood Spring:** The gauge station, which is likely non-functional, located in the pond outflow channel. A permanent weir is installed less than a meter downstream of the gauge station. The photographer is facing south. The pond is out of view, right of the photo frame.

**Management Recommendations:** Remove old and non-functional piping. Monitor for bullfrogs during their active season; they were not observed during this survey but they have been recorded at this spring in the past.

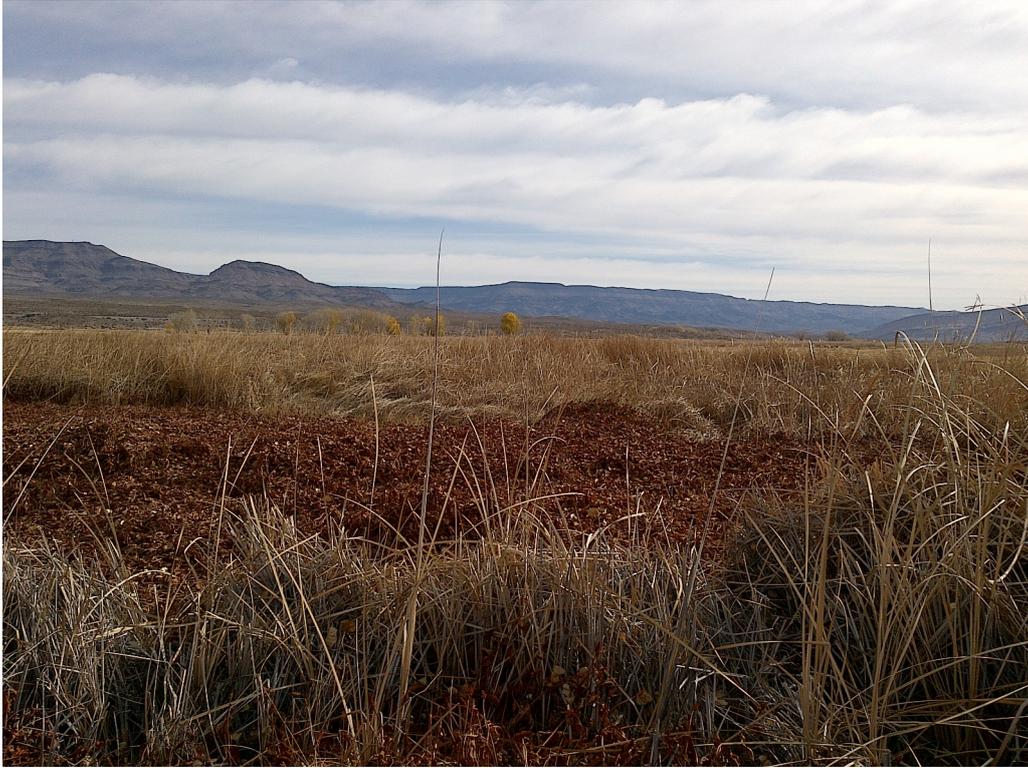
**Fig 2.4 Cottonwood Spring:** The outflow channel and low gradient cienega, both densely covered with winter-dormant vegetation and dried litter. The photographer is facing southeast.

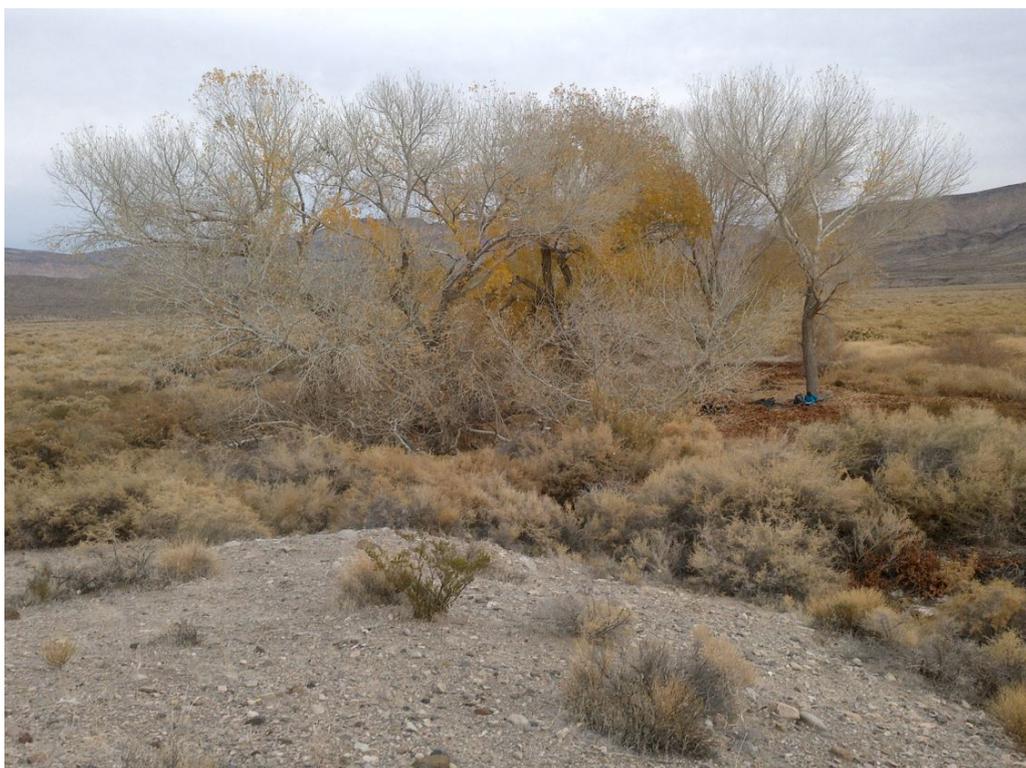
**Fig 3.1 Lone Tree Spring:** Seepage emerges within a wet patch of cienega with shallow standing water, located within the grove of cottonwood trees. The photographer is on the low hill to the west of the spring, facing east.

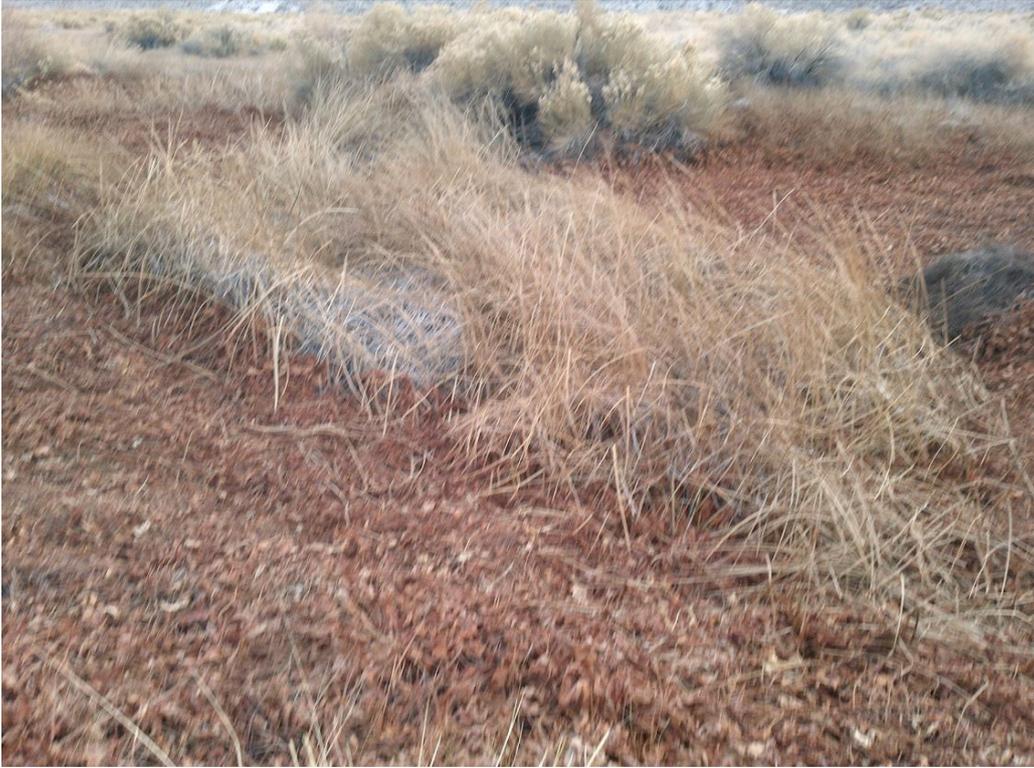
**Fig 3.3 Lone Tree Spring:** Bullrushes and dense mats of yerba mansa fill the relatively dry cienega that surrounds the pools and channel.

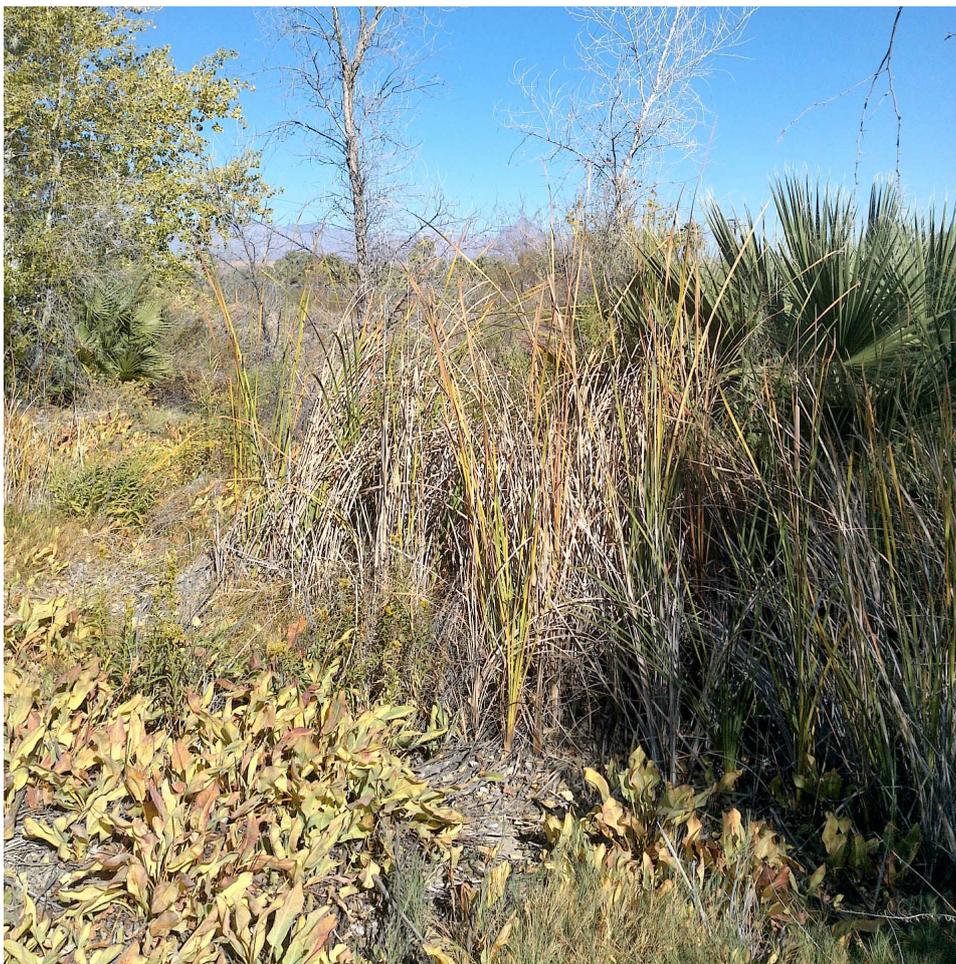
**Fig 5.1 Moapa NWR, Apcar Springs A:** The springs source, which is dominated by herbaceous wetland vegetation. The photographer is facing northwest.

**Physical Description:** Moapa NWR, Apcar Springs A is a helocrene spring. This spring and the 2008 survey were imported in February 2016 from a compilation of Don Sada's research. The Land Manager ID number is from this dataset. The coordinates reported in 2017 by Dr. Sada for this site were significantly different from those previously

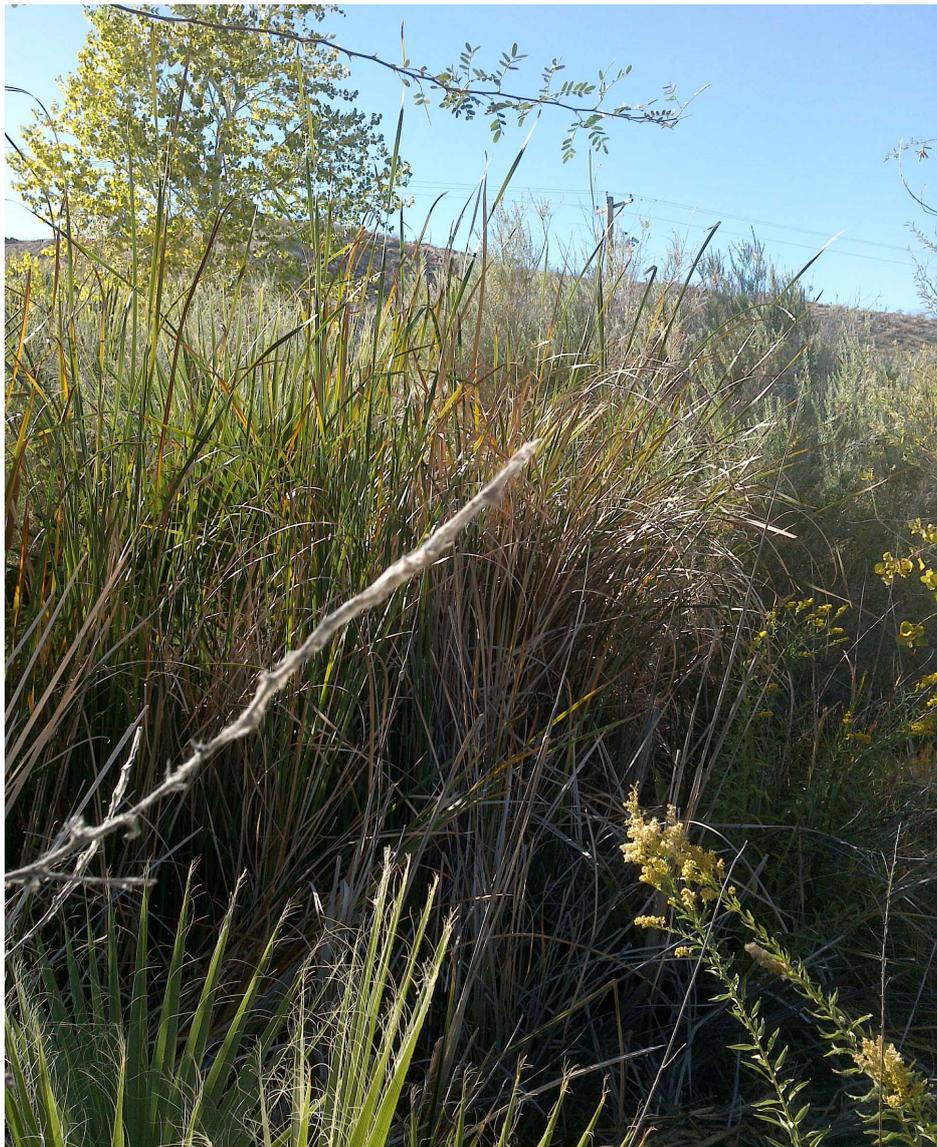
**Fig 6.1 Moapa NWR, Apcar Springs B:** The dense thicket of riparian vegetation at the source. The photographer is facing south.

**Physical Description:** Moapa NWR, Apcar Springs B is a hillslope spring. This spring's record and its 2008 survey were imported in February 2016 from a compilation of Don Sada's research. The Land Manager ID number is from this dataset. Additional data were imported from the Sada 2017 data import. In 2020, surveyors described this spring as a minor hillslope source within the Apcar Springs Complex. Flow emerges within a dense stand of vegetation and flows down a narrow, 20 centimeter-wide channel through a dense riparian thicket. Notes from the 2017 data import state that there are six springs in this province. All of these springs flowed into a common springbrook that leaves MVNWR and flows onto SNWA property. This was the third piece of property purchased by the U.S. Fish and Wildlife Service for the MVNWR to conserve the endangered Moapa dace. These springs have also been altered for recreation, but it was never used as a resort. It now includes a pumping facility for the Moapa Valley Water District, which captures discharge from the largest spring in the province and delivers a portion of it to downstream agriculture. These springs were restored in 2007 and 2008, and the riparian community along all springbrooks remains in an early seral stage of recovery. The condition of all springs and springbrooks in the province was similar, with exception of Spring-F, which was large, relatively steep and swift, and contains large substrates. Substrate composition in all other springs was dominated by fine sand and gravel. Riparian vegetation was dominated by shrub willow (*Salix* sp.) and arrowweed (*Pluchea* sp.), which was often dense. Dense vegetation prevented access to two spring sources, but the springbrook below their confluence was surveyed. Native mesquite (*Prosopis* spp.) and ash trees (*Fraxinus* sp.) were scarce. Albrecht et al. (2008) did not find *Pyrgulopsis* in these springs during 2008, which may be attributed to their sampling during the winter (when springsnails abundance is at its annual lows) and/or the immediate stress cause by construction during restoration. Mosquitofish and *M. tuberculata* were common in these springs during 2016 surveys.

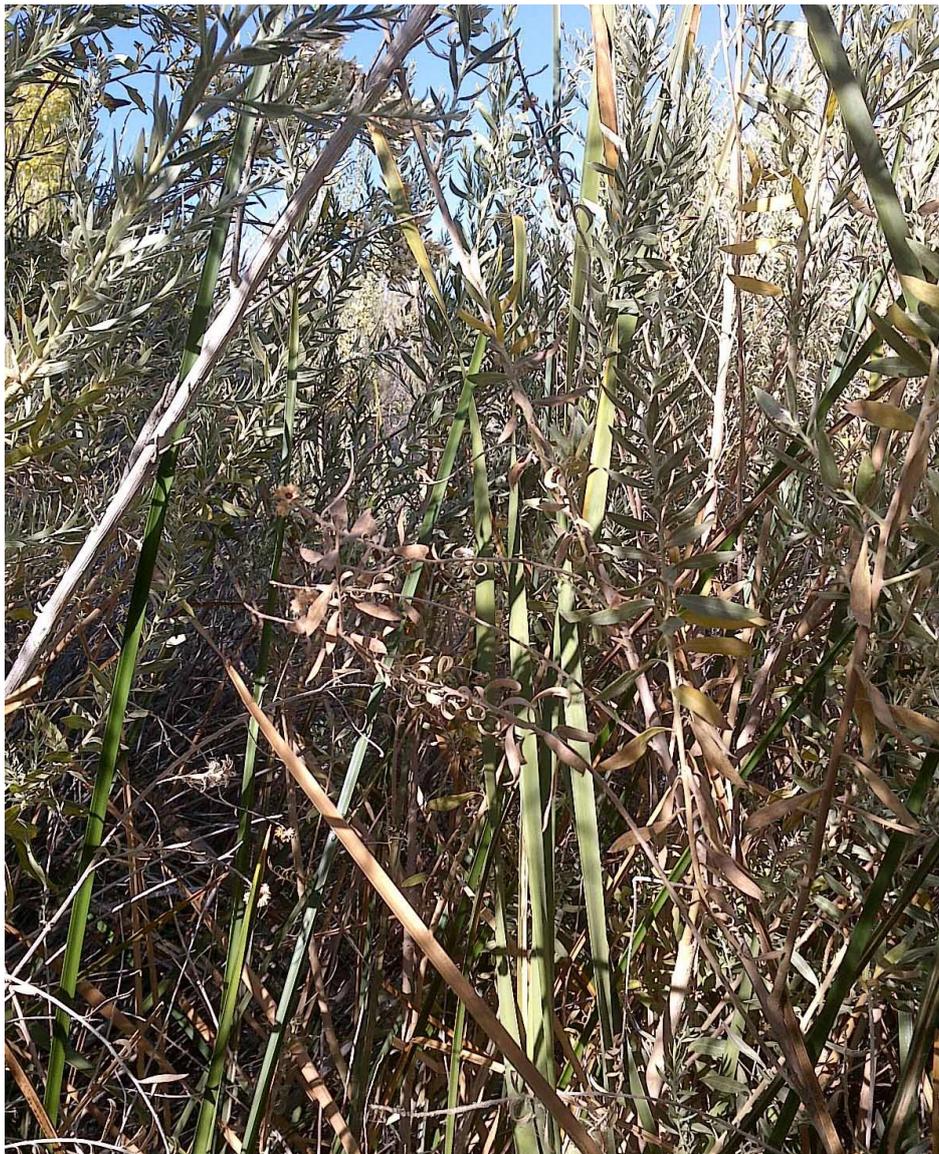
**Fig 7.1 Moapa NWR, Apcar Springs C:** The dense thicket of arrowweed and cattail at the source.

**Physical Description:** Moapa NWR, Apcar Springs C is a hillslope spring. Flow emerges in the middle of a seepwillow, arrowweed, and cattail thicket. This source is part of the Apcar Springs Complex. This source was mapped and named in 2020 based on its location relative to the 2016 Sada record for Apcar D and for Apcar C and D confluence.

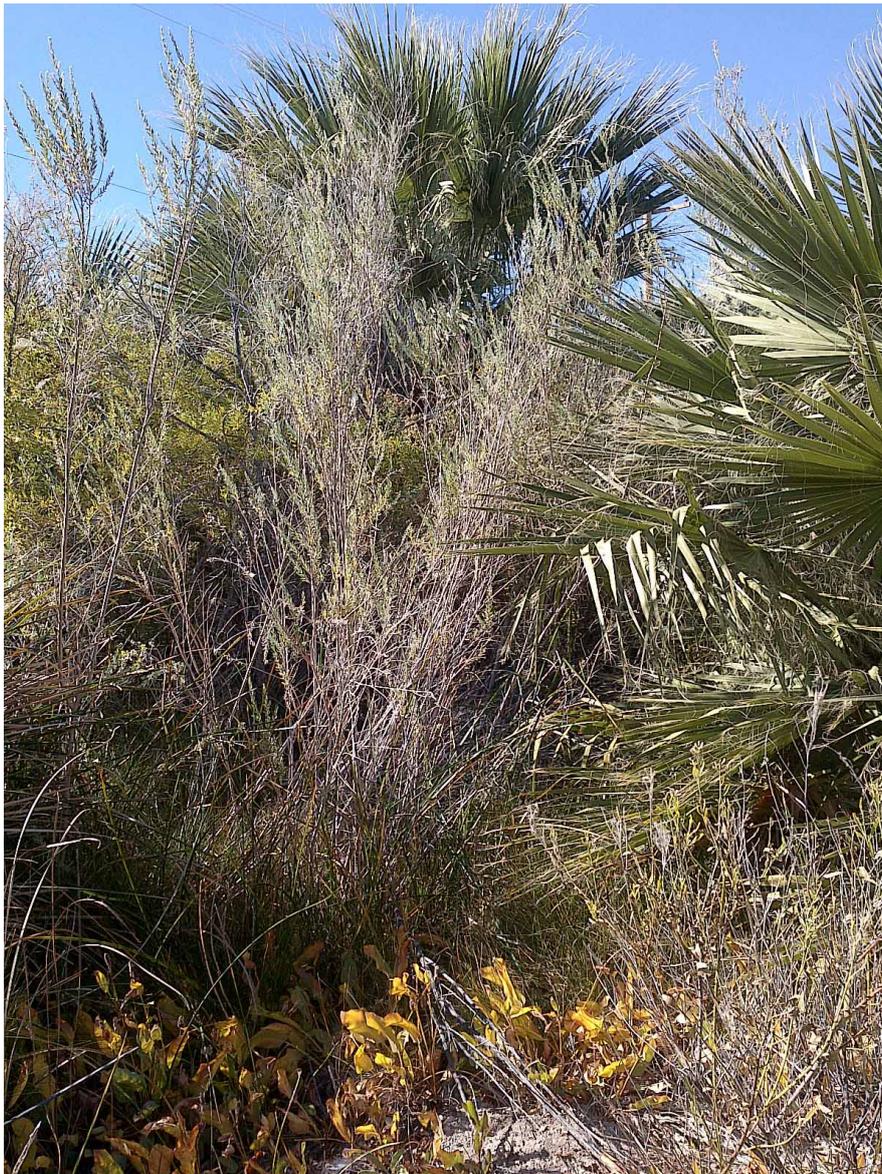
**Fig 8.1 Moapa NWR, Apcar Springs D:** The open, moist, precipitate-coated area that appears to serve as an outflow channel for this source when flows are higher.

**Physical Description:** Moapa NWR, Apcar Springs D is a hillslope spring. This springs record and its 2016 survey were imported in December 2017 from a compilation of Don Sada's 2016 research. The Land Manager ID number is from this dataset. Surveyors in 2020 described this site as a flowing hillslope source within the Apcar Springs Complex. It is located about 10 meters northeast of the most prominent source in this complex, the Apcar E Pipe Outlet. Flow from this source continues southeast and joins the outflow from the Apcar E Pipe Outlet within a short distance, about 10 meters. While flowing water is visible from this source, it is not possible to physically access the source through the dense seepwillow. There is another smaller source visible a few meters to the northeast that lacks outflow but shows evidence of an outflow channel leading east toward the coordinates for Apcar C and D Confluence. The area that appears to be the outflow channel for this small source is less vegetated than the surrounding thicket, and has moist soil coated with precipitates. Notes from the Sada 2017 dataset state that here are six springs in this province. All of these springs flowed into a common springbrook that leaves MVNWR and flows onto SNWA property. This was the third piece of property purchased by the U.S. Fish and Wildlife Service for the MVNWR to conserve the endangered Moapa dace. These springs have also been altered for recreation, but it was never used as a resort. It now includes a pumping facility for the Moapa Valley Water District, which captures discharge from the largest spring in the province and delivers a portion of it to downstream agriculture. These springs were restored in 2007 and 2008, and the riparian community along all springbrooks remains in an early seral stage of recovery. The condition of all springs and springbrooks in the province was similar, with exception of Spring-F, which was large, relatively steep and swift, and contains large substrates. Substrate composition in all other springs was dominated by fines, sand, and gravel. Riparian vegetation was dominated by shrub willow (*Salix* sp.) and arrowweed (*Pluchea* sp.), which was often dense. Dense vegetation prevented access to two spring sources, but the springbrook below their confluence was surveyed. Native mesquite (*Prosopis* spp.) and ash trees (*Fraxinus* sp.) were scarce. Albrecht et al. (2008) did not find *Pyrgulopsis* in these springs during 2008, which may be attributed to their sampling during the winter (when springsnails abundance is at its annual lows) and/or the immediate stress cause by construction during restoration. Mosquitofish and *M. tuberculata* were common in these springs during 2016 surveys.

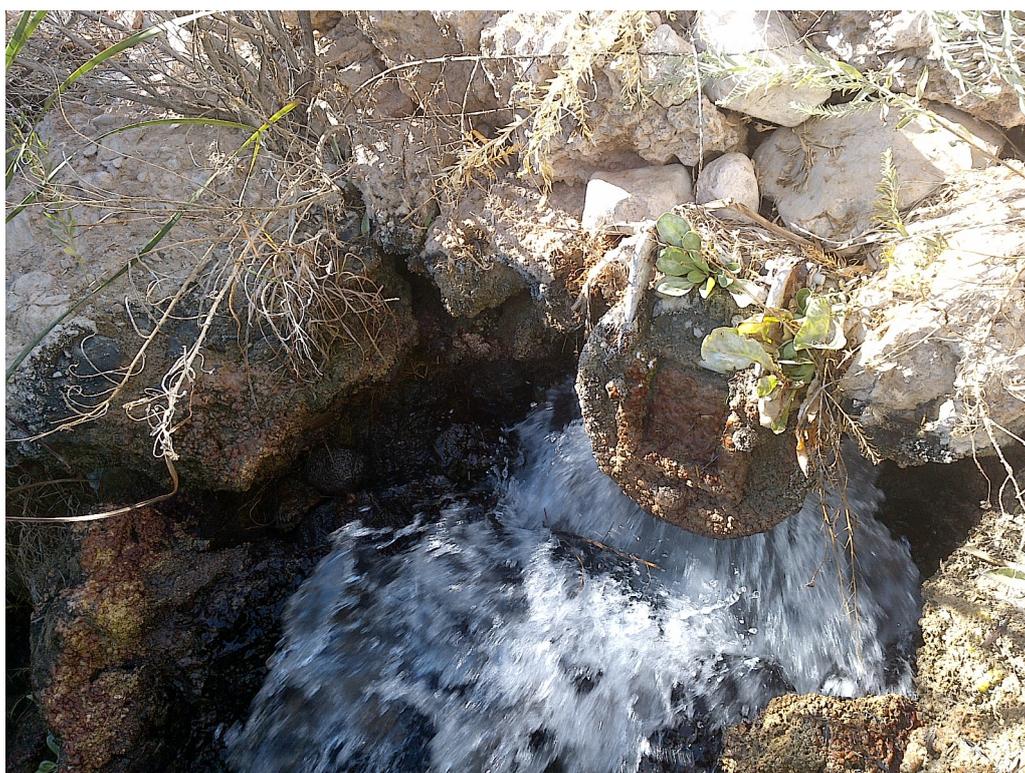
**Fig 9.1 Moapa NWR, Apcar Springs E Pipe Outlet:** The outflow pipe, which releases a constant 1 cfs of the groundwater pumped by the adjacent well. Note that the pipe cover and the rocks within the spray zone are coated with precipitates.

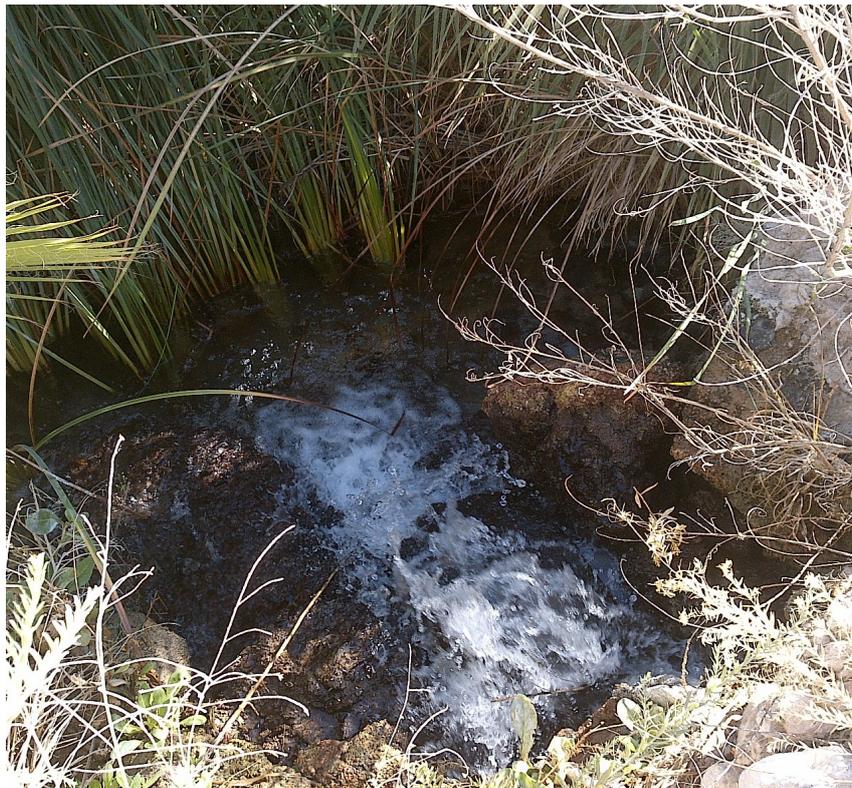
**Fig 9.2 Moapa NWR, Apcar Springs E Pipe Outlet:** The cobble and boulder-bed outflow channel, which is filled with cattails (*Typha*). The piped source is at the lower right-hand corner of the photo.

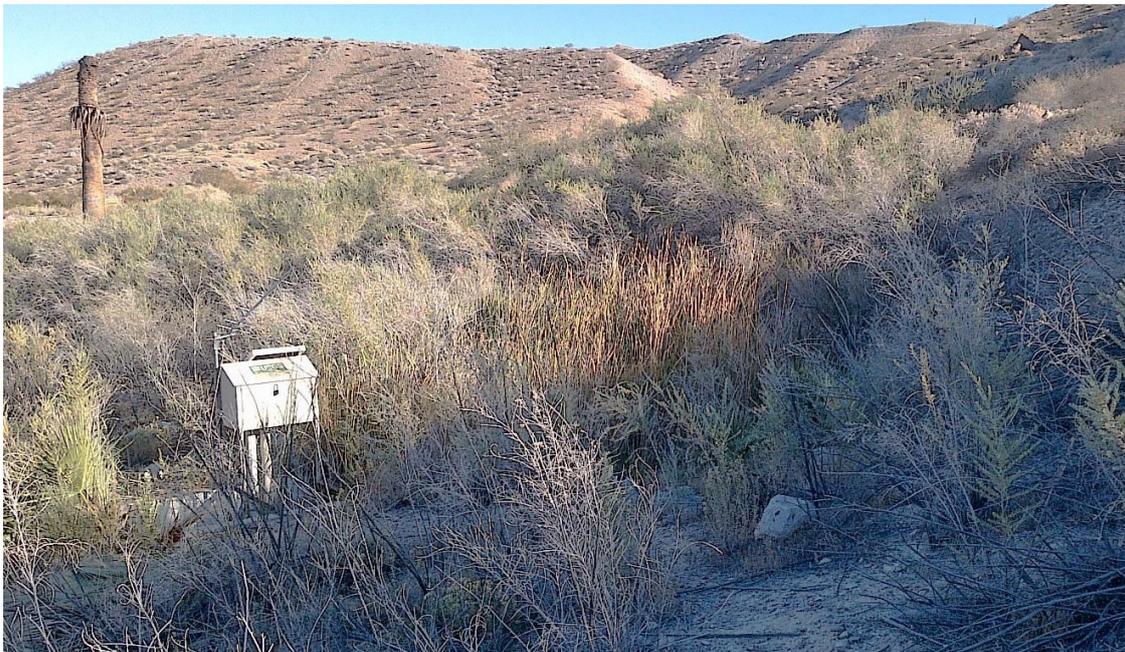
**Fig 10.1 Moapa NWR, Pederson Springs A:** The small hillslope source, visible as a patch of cattails at the center of the photo, and the USGS gauge a few meters downslope of the source. The surrounding dense shrubby vegetation is mostly arrowweed associated with the springs complex. Note the juvenile palm just downslope of the gauge, and the burned mature palm tree in the background.

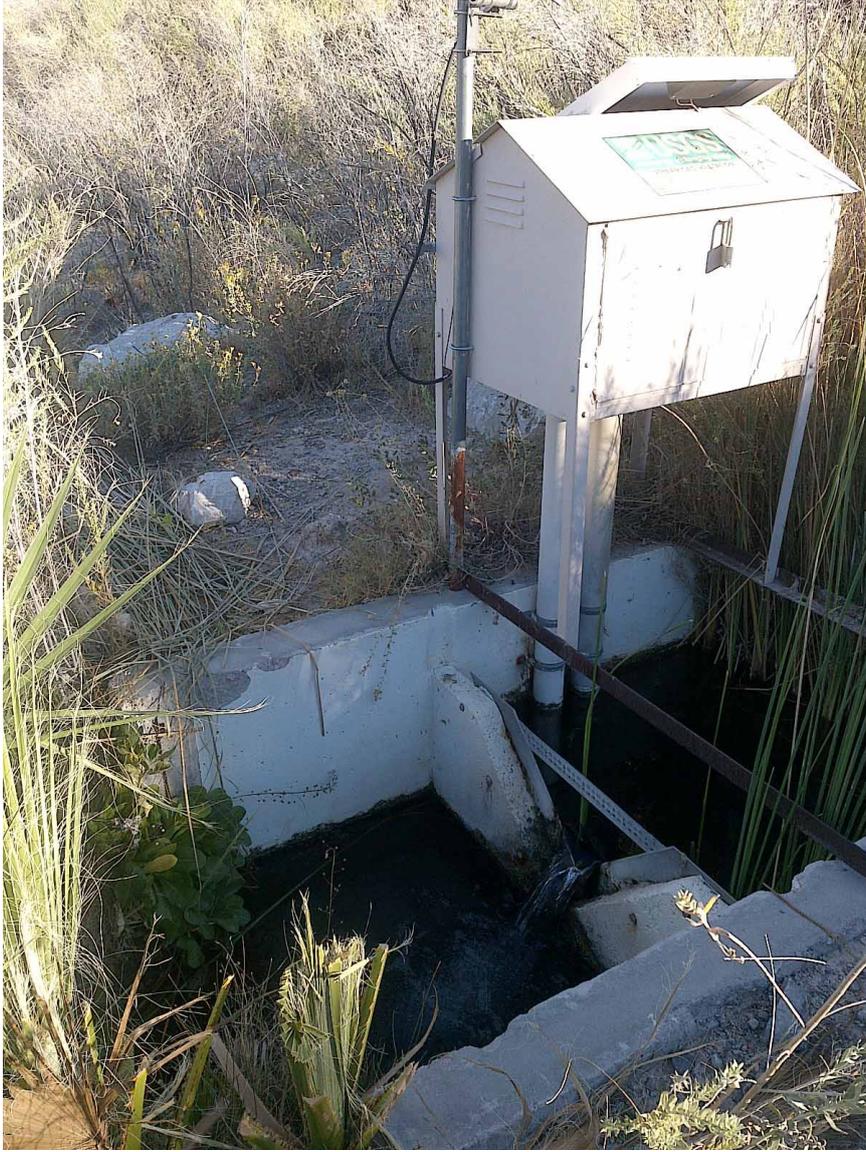
**Fig 10.2 Moapa NWR, Pederson Springs A: The USGS weir gauge, located a few meters downslope from the source.**

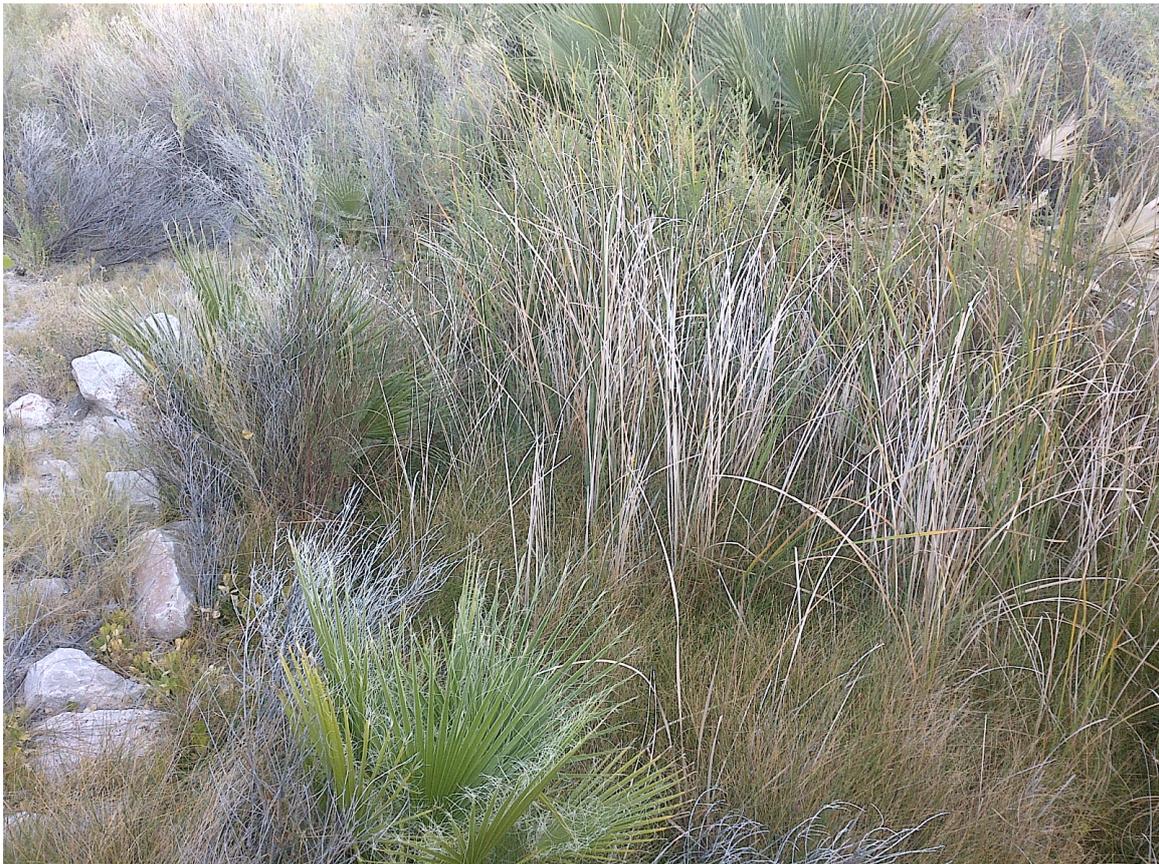
**Fig 11.1 Moapa NWR, Pederson Springs B:** Herbaceous wetland vegetation on the left bank of the springbrook. The flowing springbrook is just outside the photo frame, to the right.

**Physical Description:** Moapa NWR, Pederson Springs B is a hillslope/rheocrene spring. This springs record and the data from the 2008 survey were imported in February 2016 from a compilation of Don Sada's research. In 2020, this spring was barely distinguishable as such; just downstream of the confluence of the springbrooks associated with Pederson A and Pederson I, the left bank of the springbrook was seeping. The location of the seeping bank corresponded with the GPS coordinate for this springs record.

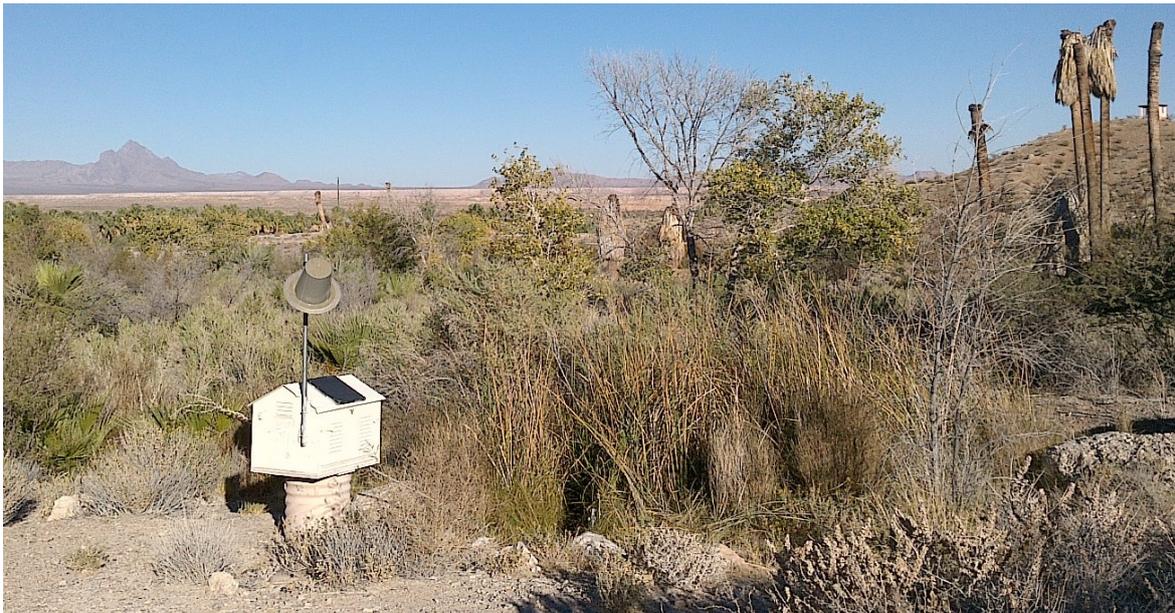
**Fig 12.1 Moapa NWR, Pederson Springs C:** The spring source, which is visible as a patch of cattails just to the right of the USGS gauge. The outflow channel for this springs complex is visible as a line of riparian vegetation crossing the desert in the photo-left mid-ground.

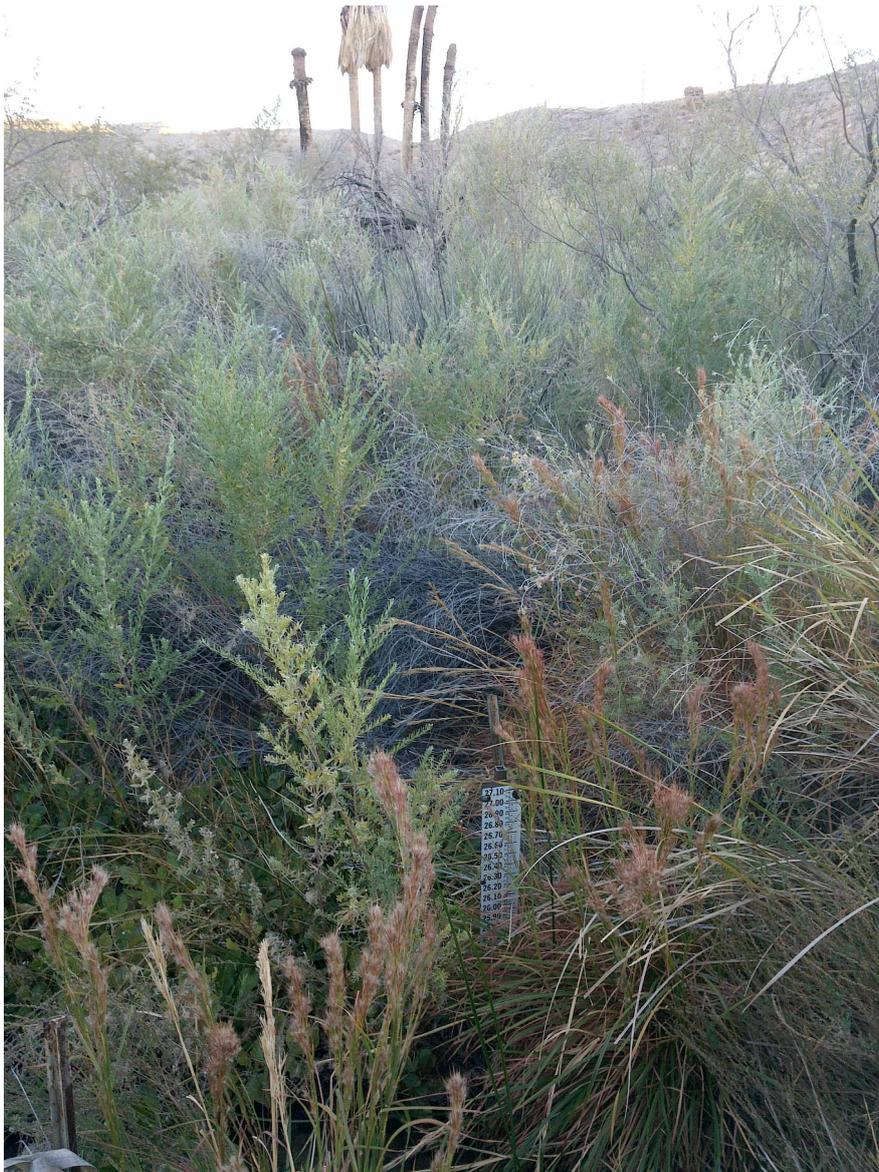
**Fig 15.1 Moapa NWR, Pederson Springs F:** The old staff gauge at this hillslope source. The photographer is facing south across much of this densely vegetated springs complex.

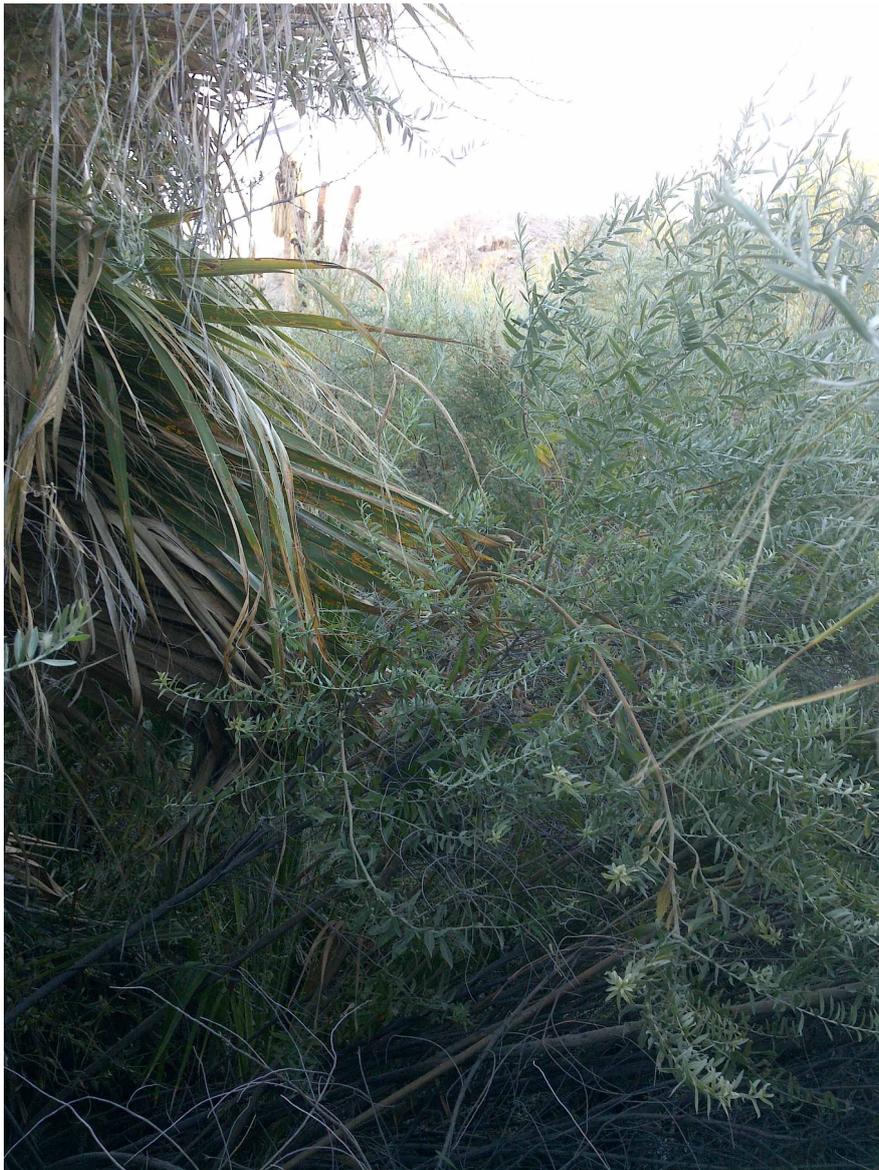
**Fig 16.1 Moapa NWR, Pederson Springs H:** The arrowweed thicket surrounding the springs source. The photographer is facing south.

**Physical Description:** Moapa NWR, Pederson Springs H is a hillslope spring. This springs record was imported in February 2016 from a compilation of Don Sada's research. The Land Manager ID number is from this dataset. Vegetation is extremely dense at this spring source and all along its 35 meter- long springbrook, and sampling was not possible without removing vegetation. The proximity to other Pedersen springs and its connection with the Spring A springbrook suggests that it also supports a *Pyrgulopsis* population that is similar in abundance to other springs in the province. Habitat metrics and *Pyrgulopsis* abundance were not evaluated in this spring. There are eight springs in this province. All of them flow into a common springbrook that leaves the MVNWR and flows onto SNWA property. This was the first property purchased by the U.S. Fish and Wildlife Service in 1979 to create the MVNWR and conserve the endangered Moapa dace (*Moapa coriacea*). Prior to this purchase, it was managed as a warm springs resort that included an olympic-sized swimming pool and bathhouses. Some springs were impounded within concrete walls and springbrooks were lined with pea-size gravel. Palm trees were the only riparian vegetation, aquatic vegetation was dominated by an invasive plant (*Vallenseria* sp.), and the gastropod assemblage was dominated by *M. tuberculata*. Native fish were scarce and the springs exhibited little resemblance to natural conditions. A Moapa dace restoration program was initiated, *Vallenseria* was eradicated, artificial pools were removed, and native fish (Moapa dace and Moapa White River springfish [*Crenichthys baileyi moapa*]) (e.g., Scopettone et al. 1992, Scopettone 1993), and a native benthic macroinvertebrate community returned (e.g., Sada and Herbst 1999). The riparian community at these springs remains in early seral stage of recovery following restoration. During 2016, it was dominated by shrub willow (*Salix* sp.) and arrowweed (*Pluchea* sp.), which were often dense, and it restricted access to some portions of springbrook and to all of one spring and its springbrook. Native mesquite (*Prosopis* spp.) and ash trees (*Fraxinus* sp.) were scarce.

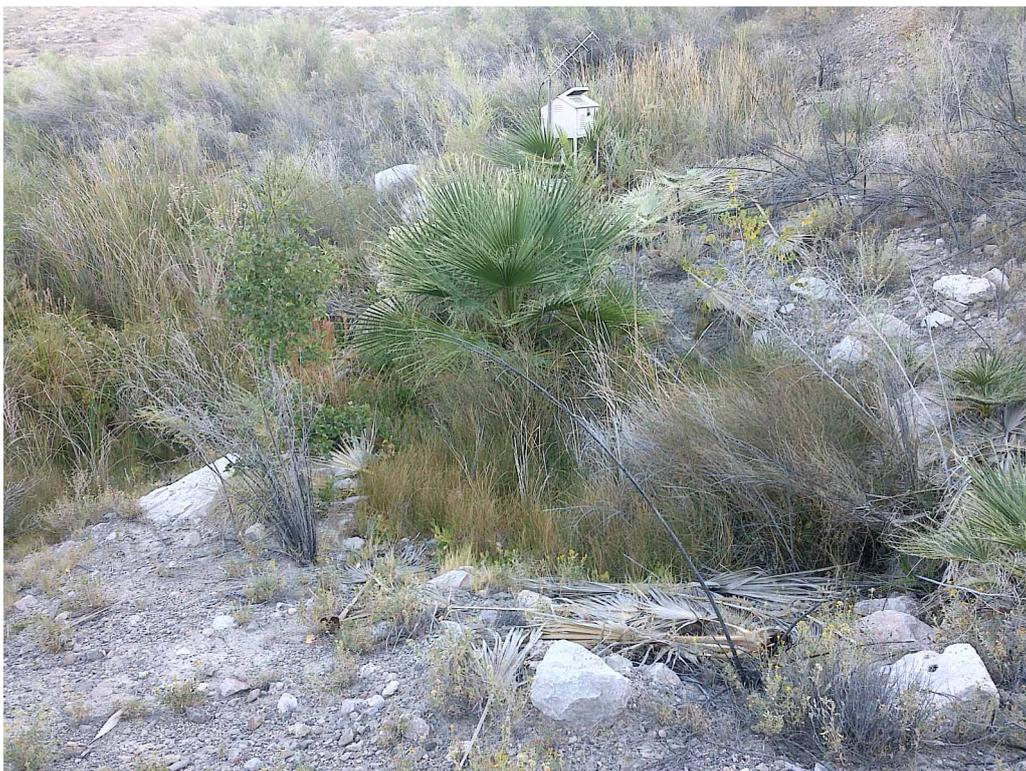
**Fig 17.1 Moapa NWR, Pederson Springs I:** The springs source, with a juvenile palm in the middle. The Pederson A source and its USGS gauge are visible in the background. Outflow channels from these two sources merge at the left edge of the photo.

**Physical Description:** Moapa NWR, Pederson Springs I is a hillslope spring. This small source is part of the Pederson Springs Complex and located about 10 meters northwest of Pederson A, which is instrumented with a USGS gauge. Flow from this source joins the outflow from Pederson A on creek left about 8 meters downstream from the gauge. The record for this spring was imported in December 2017 from a compilation of Don Sada's 2016 research. The Land Manager ID number is from this dataset. According to the 2016 dataset, this small spring flows into its east side of the Spring-A springbrook, and approximately 10 meters downstream from the Spring-A source. Its springbrook is

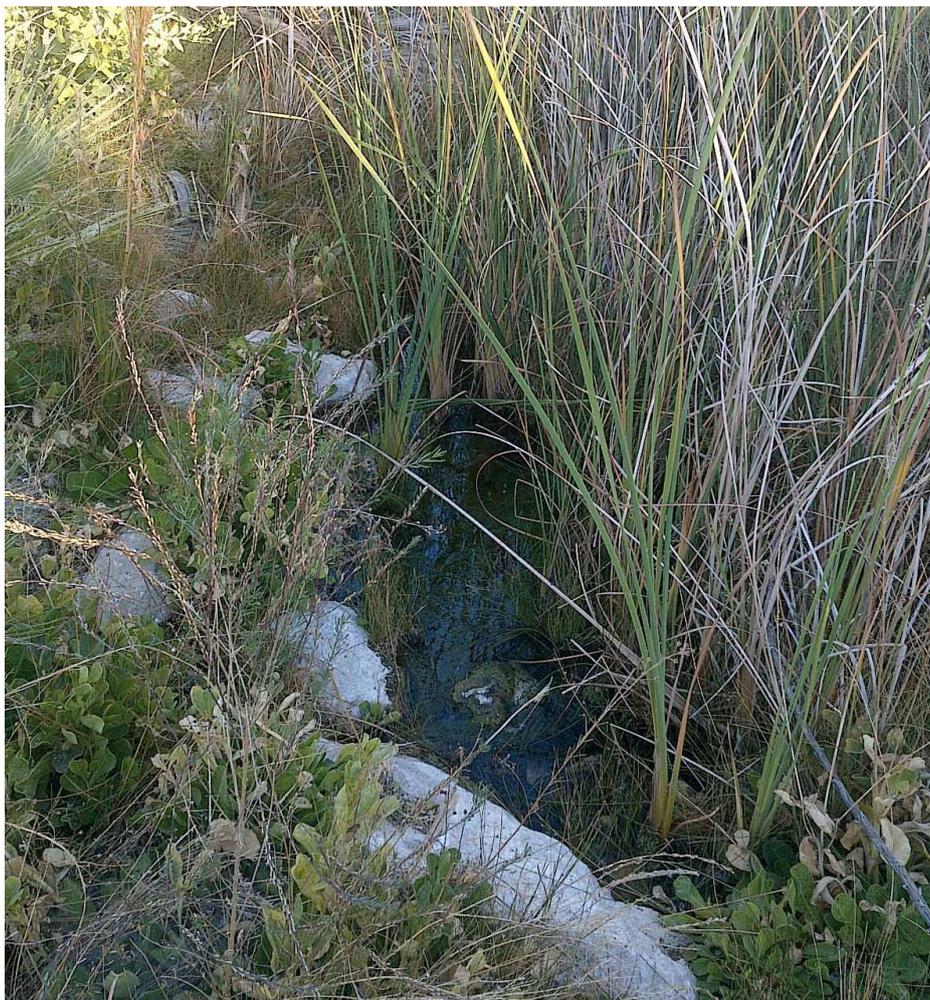
**Fig 18.1 Moapa NWR, Pederson Springs J:** The spring source, filled with cattails and spikerush; photographer is facing upstream (south).

**Physical Description:** Moapa NWR, Pederson Springs J is a hillslope spring. This small source is part of the Pederson Springs Complex. Flow emerges from a hillslope source and travels less than 10 meters down a marshy channel before merging with the
