Clark County 2020-2021 USFWS Refuge Survey Summary Reports  
Springs Stewardship Institute  
Volume 1 of 2

## 1. Big Spring, 12/06/21

### Survey Summary Report, Site ID 111676

Submitted 2/03/22 by Springs Stewardship Institute

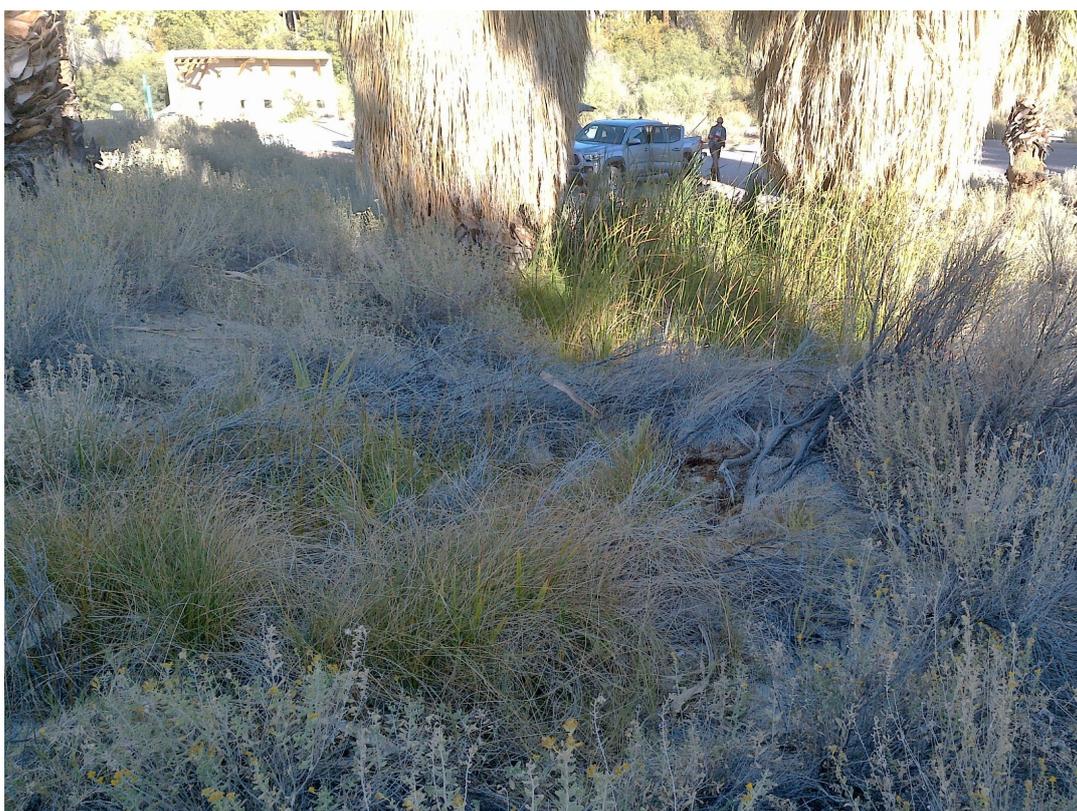
**Fig 19.1 Plummer Pond:** Dense wetland vegetation obscures the pool formed by this spring's hillslope source. The visitor parking lot and a building are visible in the background. The photographer is facing north (downslope).

**Physical Description:** Plummer Pond is a hillslope/limnocrone spring. Seepage emerges from a hillslope source and collects in a small (4 meters by 10 meters) pool which is filled with wetland vegetation, primarily cattails (*Typha*). The spring is about 10 meters upslope (south) of the Moapa National Wildlife Refuge visitor parking lot and brick walking path. It is about 10 meters east of the building housing the pit toilets.

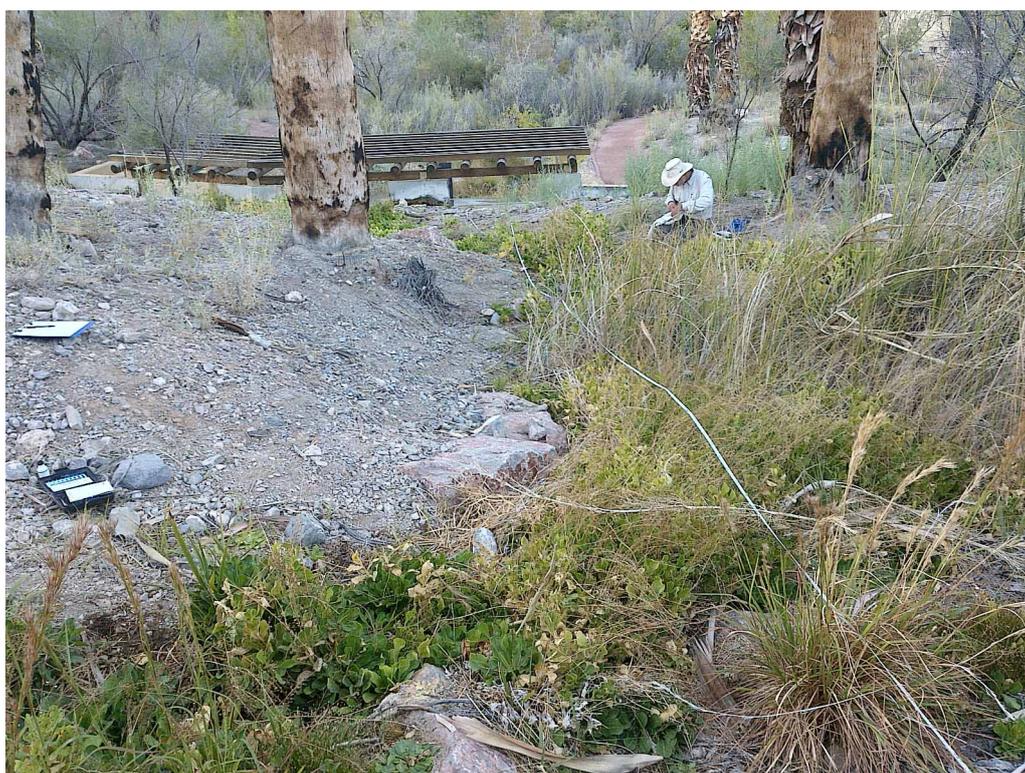
**Fig 20.1 Plummer Springs A:** The confluence of outflow channels from the two sources. Biologist Larry Stevens sorts invertebrates on the right bank of the combined outflow channel. The interpretive fish display is in the background.

**Physical Description:** Plummer Springs A is a hillslope spring. This spring and its 2008 survey were imported in February 2016 from a compilation of research from Don Sada. The Land Manager ID number is from this dataset. According to a 2020 SSI survey crew, flow emerges from two distinct sources about 25 meters apart on a gravelly slope. At each source, seepage forms a small (less than 20 square meters) patch of marshy cienega habitat before picking up flow and becoming channelized. The channels associated with the two sources flow together, forming a Y shape and continue north for

**Survey Notes:** Despite the long history of human use and adjacent construction, this spring is in excellent condition. The sources and springbrooks appear geomorphically unaltered and the vegetation is mostly native. There is a variety of invertebrate life, including springsnails. The interpretive display does not seem to be negatively impacting the ecosystem and trails are designed to prevent visitors from stepping in the streams.

**Management Recommendations:** The aquifer is at risk from groundwater abstraction from the nearby housing development. The refuge appears to be well-managed with limited visitation from the public, with well-designed visitor trails and outreach. Surveyors recommend researching springsnail-algae relationships and clarifying the referencing of sources. Continued efforts to remove non-native fish are warranted.

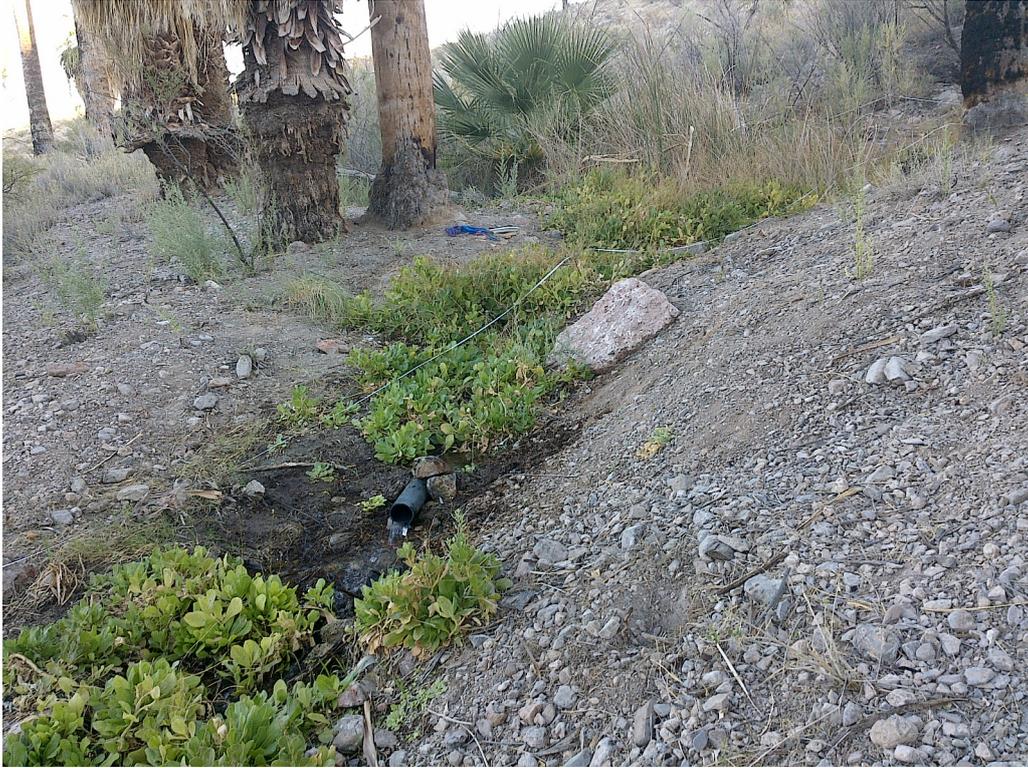
**Fig 20.3 Plummer Springs A:** The flow measurement location (black pipe at center), 5.5 m downstream of the confluence of flow from the two sources.

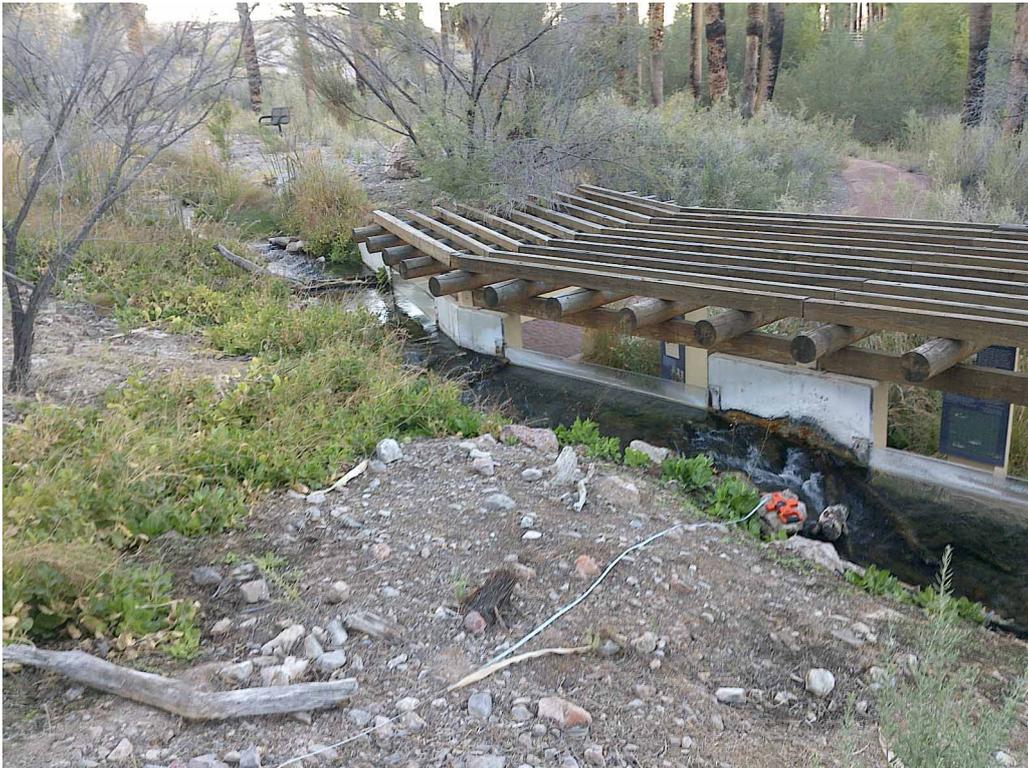
**Fig 20.4 Plummer Springs A:** Outflow (entering from lower left) joins Plummer Creek at the interpretive display.
