Clark County 2020 Survey Summary Reports
Springs Stewardship Institute
Volume 1 of 3

1. Buck Spring, 10/17/20
Survey Summary Report, Site ID 152983
Submitted 2/11/22 by Springs Stewardship Institute

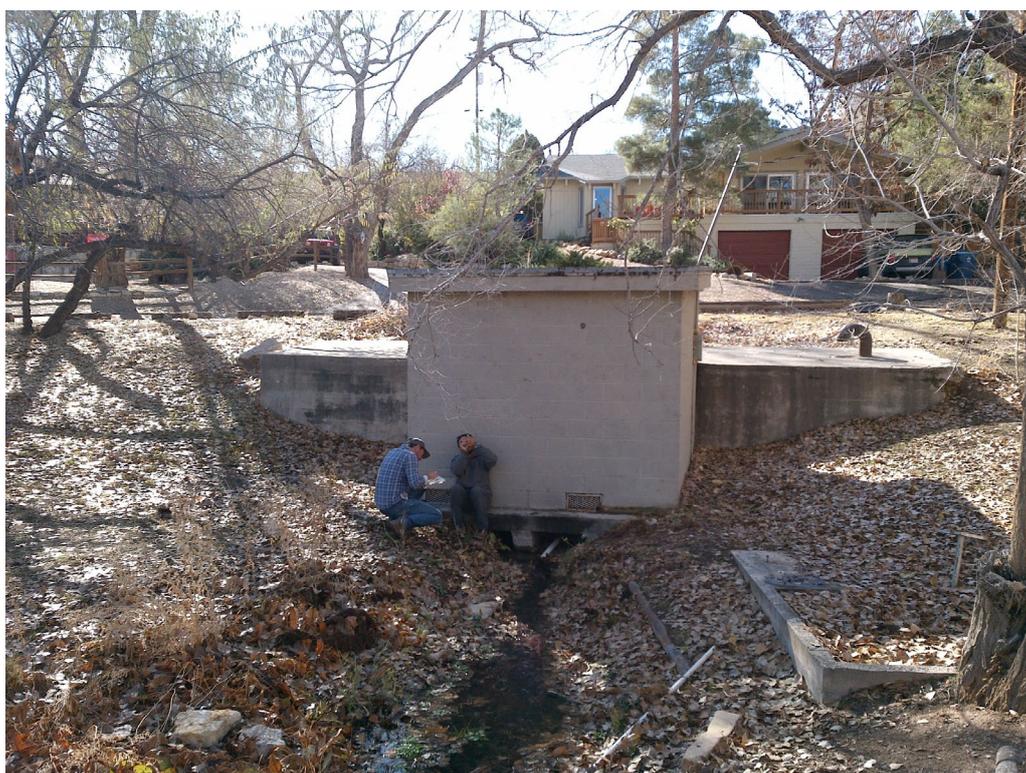
Fig 3.1 Cottonwood Spring: View from the bridge looking towards the springhouse/source.

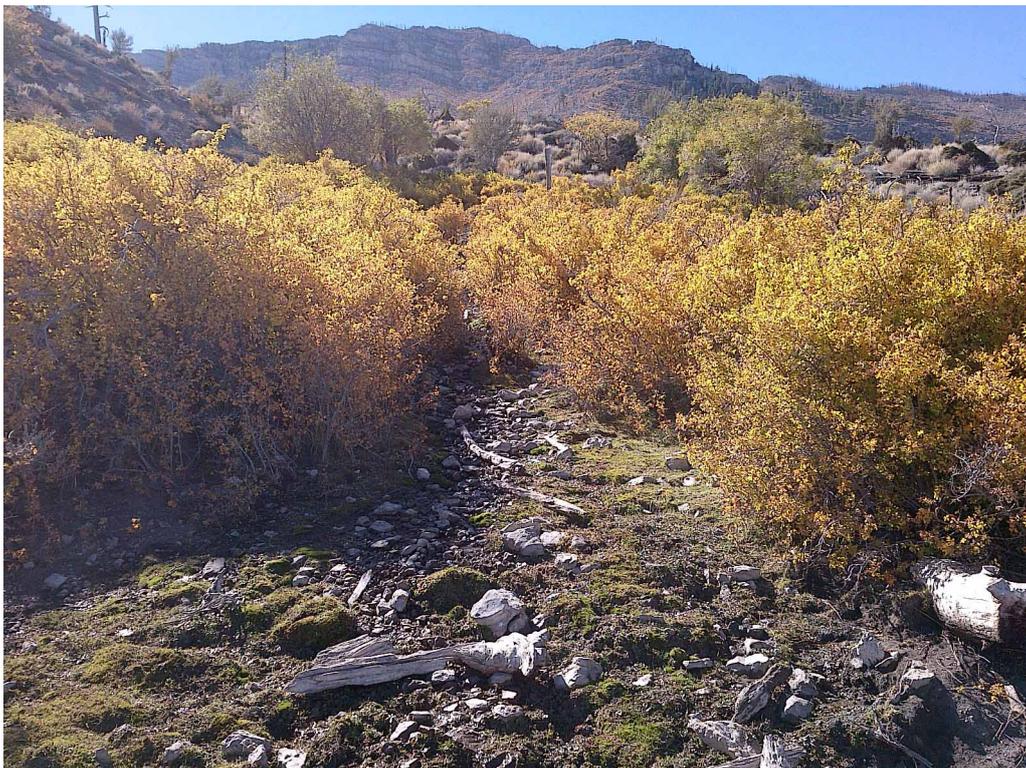
Fig 6.1 Fence Spring: Looking upstream at the outflow channel and rose thicket from the downstream fenceline. The source is out of view, beyond the rose thicket.

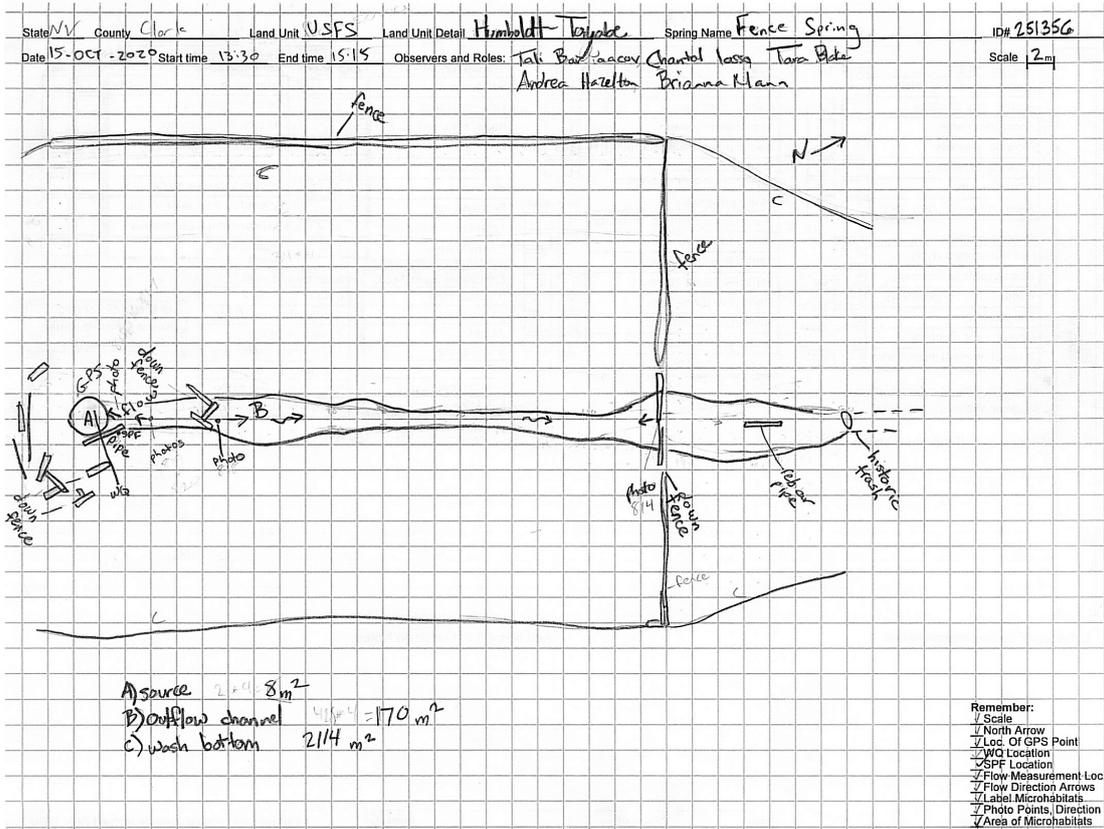
Fig 6.2 Fence Spring Sketchmap.

Fencing Effects: Protection fencing and enclosures are appropriate and functional.	False	fence needs repair
Herbivore Effects: Herbivory is not adversely affecting	False	plants closely grazed; hummocks/pedestals

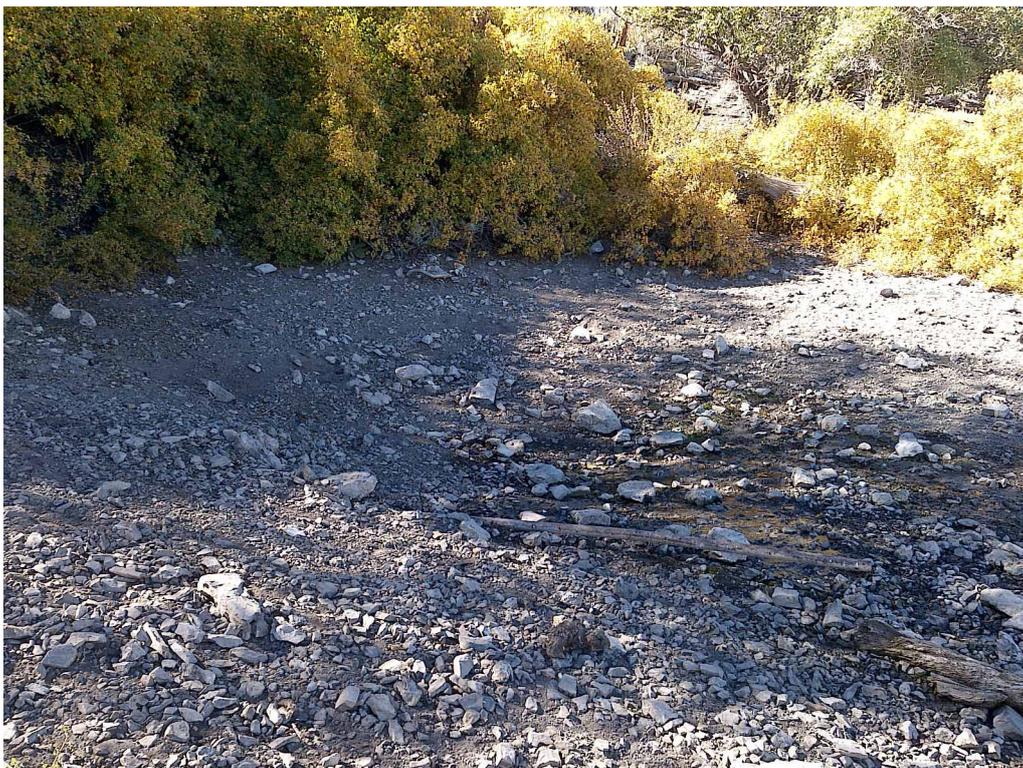
Fig 6.3 Fence Spring: The hillslope source.

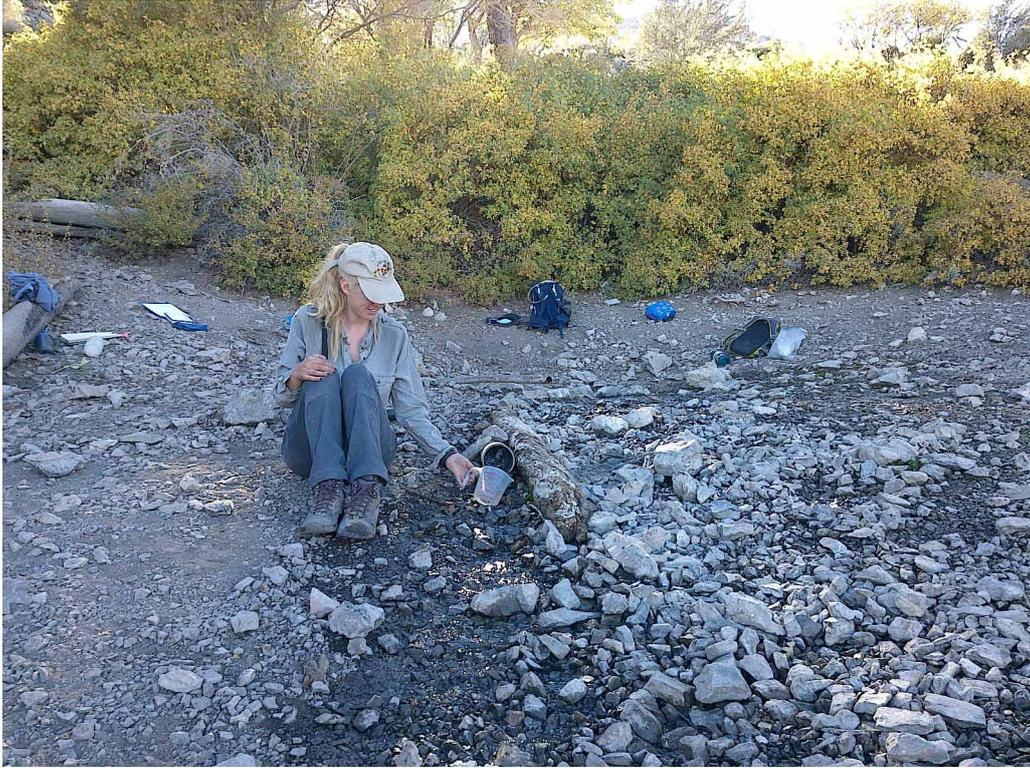
Fig 6.4 Fence Spring: The flow measurement location 4 m downstream of the source.

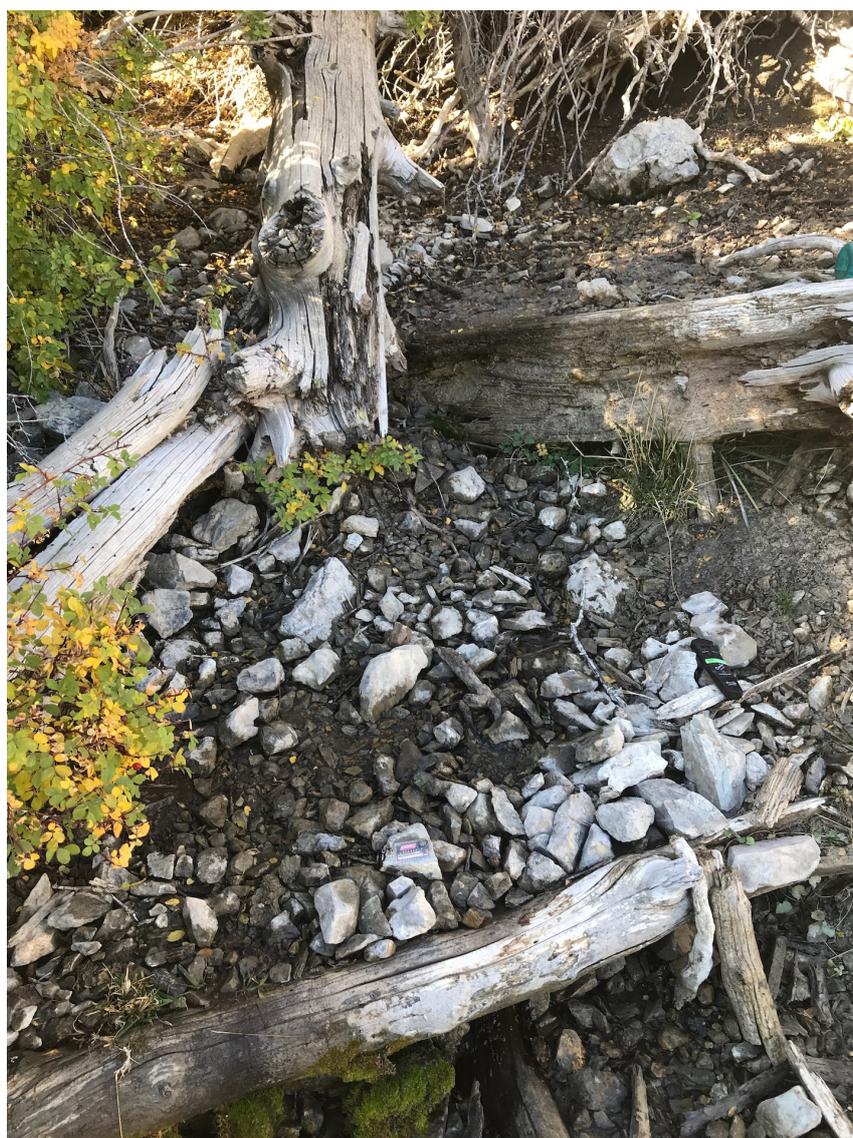
Fig 8.1 Horse Trail Spring: The main rheocrenic source where surveyors measured water quality.

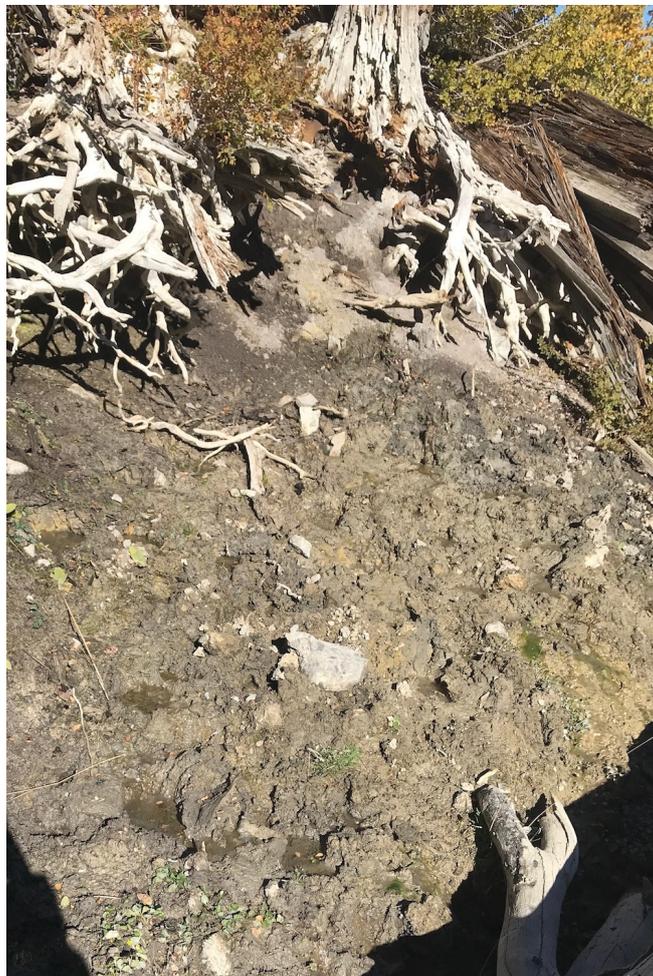
Fig 8.3 Horse Trail Spring: The muddy, diffuse seeping source on the left bank of the stream, just west of the main flowing source.

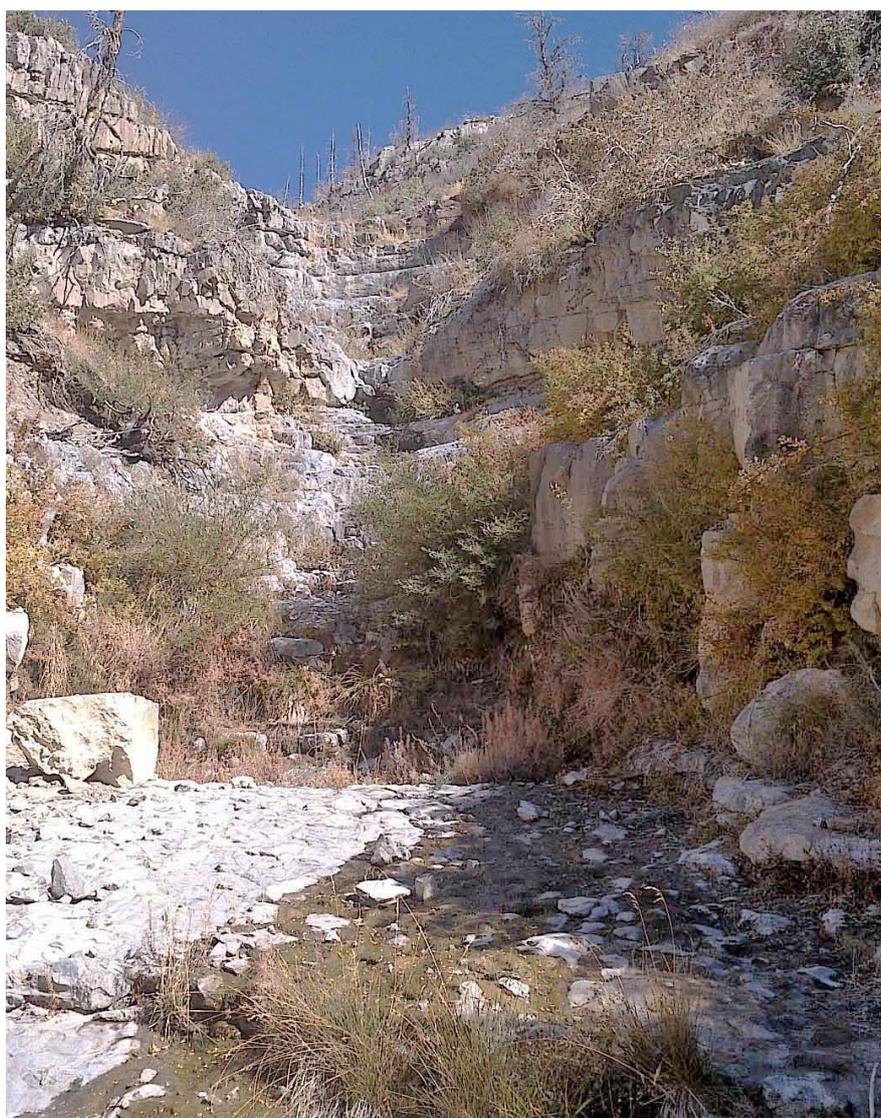
Fig 10.1 Ice Falls Spring Left: Seepage emerges from the ledges on the left canyon wall (right side of the photo) and collects in the canyon bottom, flowing down to merge with outflow from Ice Falls Spring Right, about 150 meters downstream (out of view, behind the photographer).

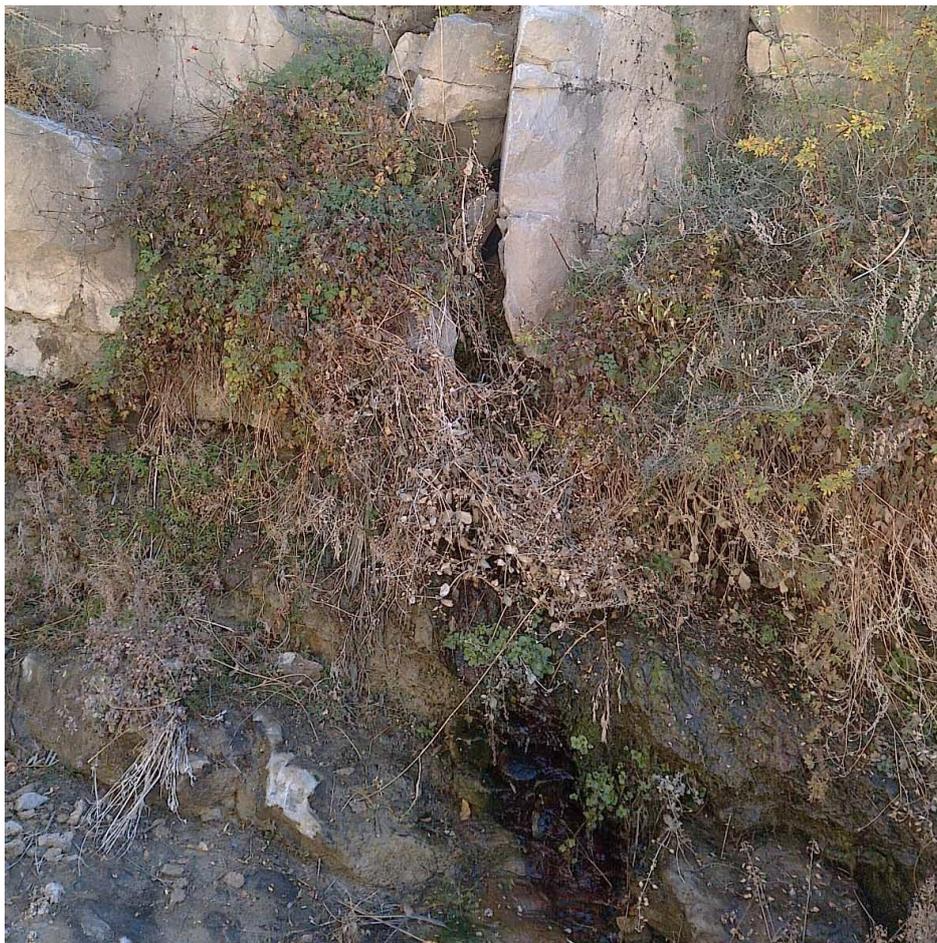
Fig 10.2 Ice Falls Spring Left: The vegetated seep line on the left canyon wall.

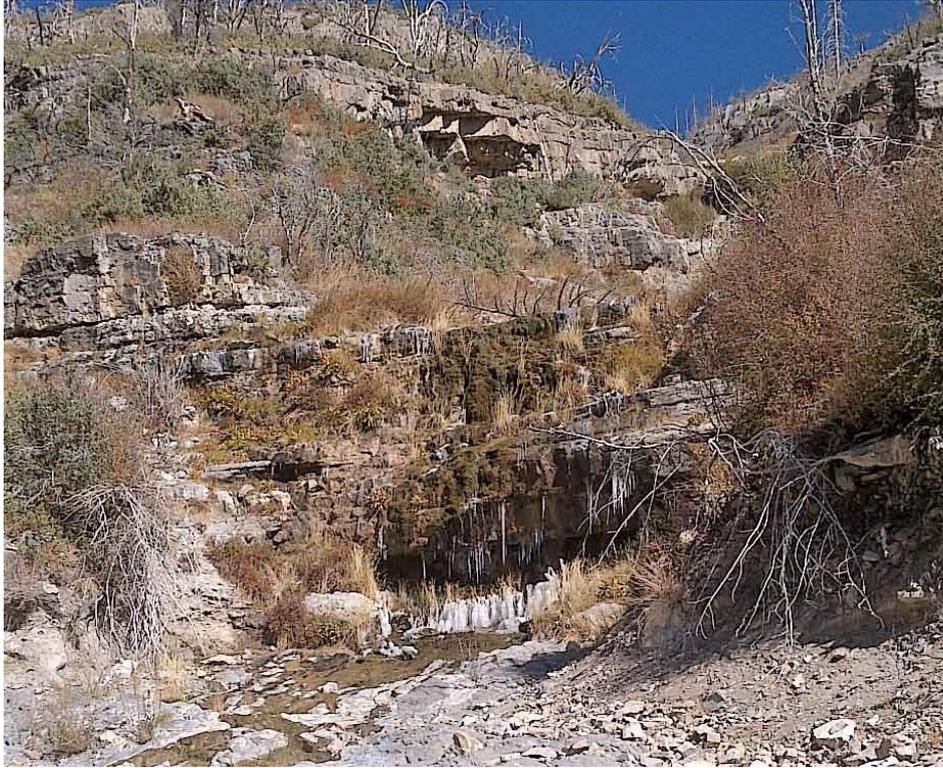
Fig 10.3 Ice Falls Spring Left: Icicles form where flow from the two Ice Falls Springs passes over a bedrock ledge.

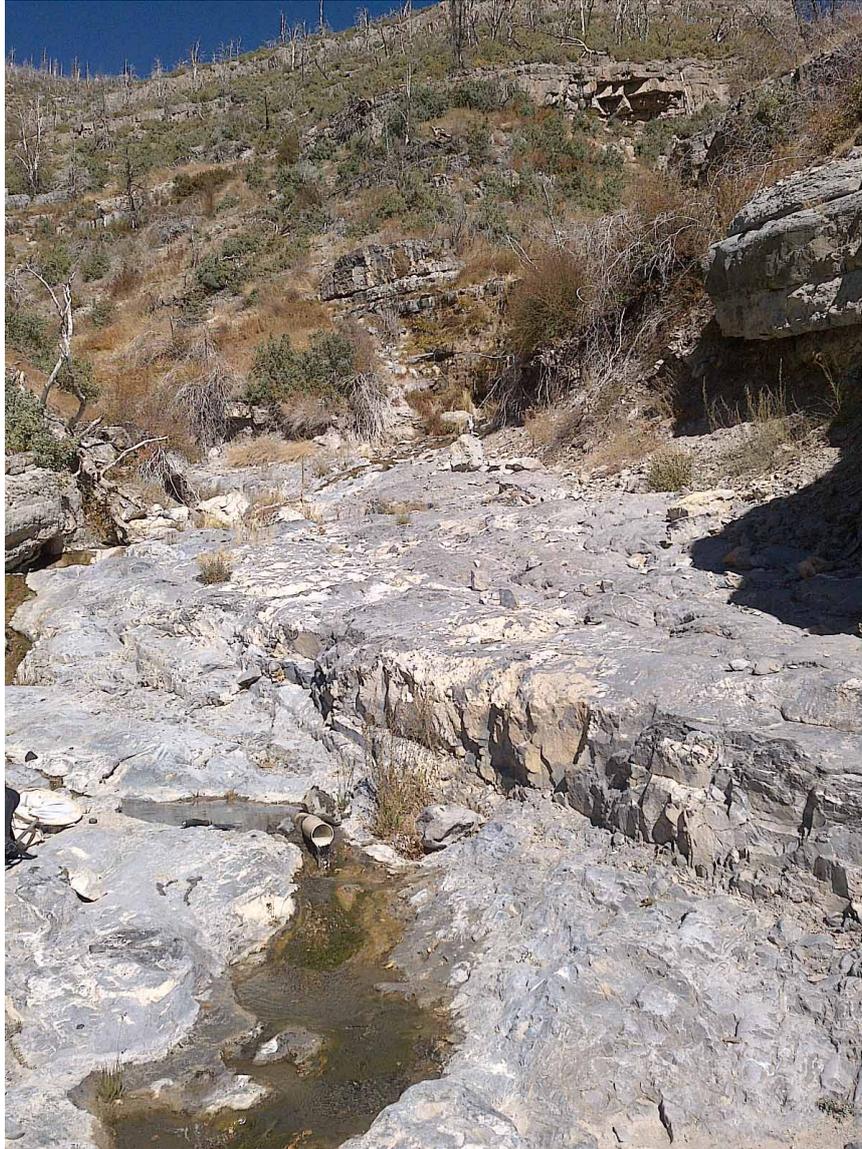
Fig 10.4 Ice Falls Spring Left: The flow measurement location, 30 meters downstream of the confluence of outflow from Ice Falls Spring Left and Ice Falls Spring Right. Approximately 95% of the flow passing through the pipe is from this spring.

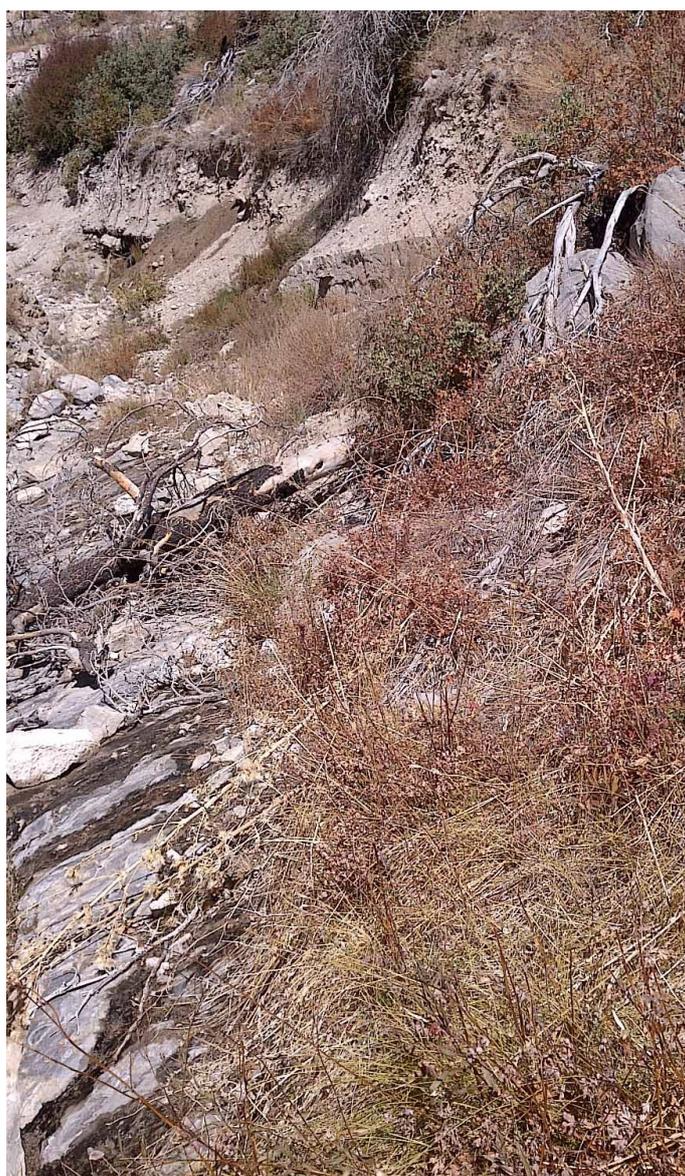
Fig 11.1 Ice Falls Spring Right: Seepage emerging from the dirt slope on the left side of this steep narrow canyon. The photographer is facing up-canyon.

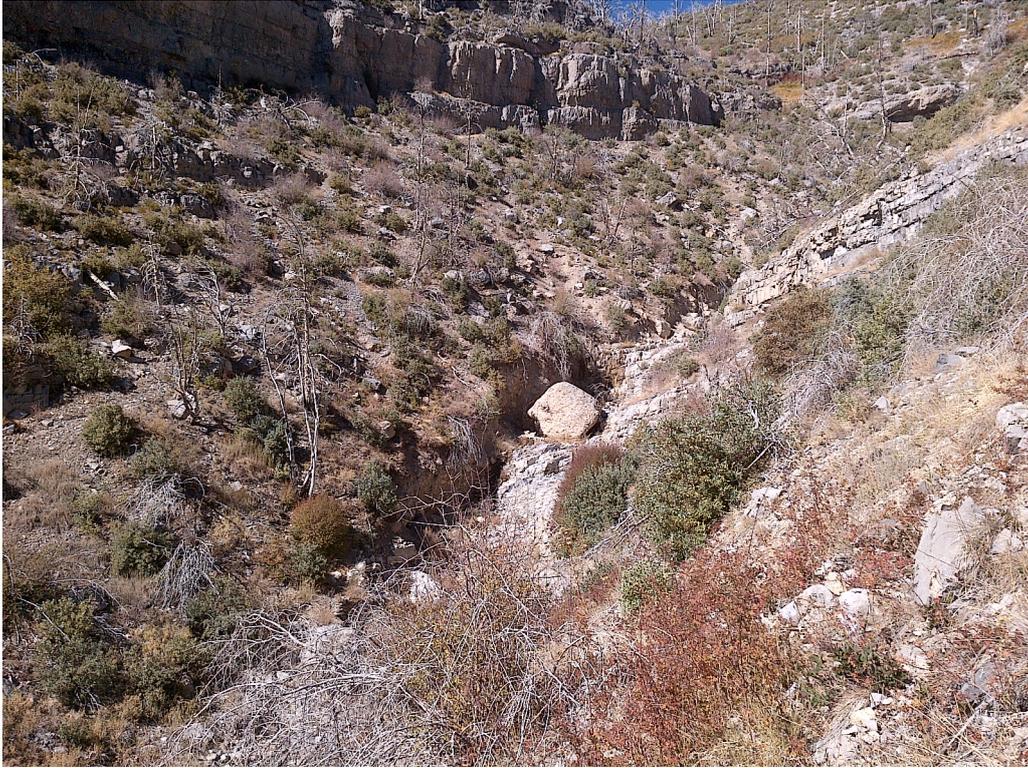
Fig 11.2 Ice Falls Spring Right: Seepage from this spring is just visible in the shadowed portion of the canyon bed, near the boulder at the center of this photo.

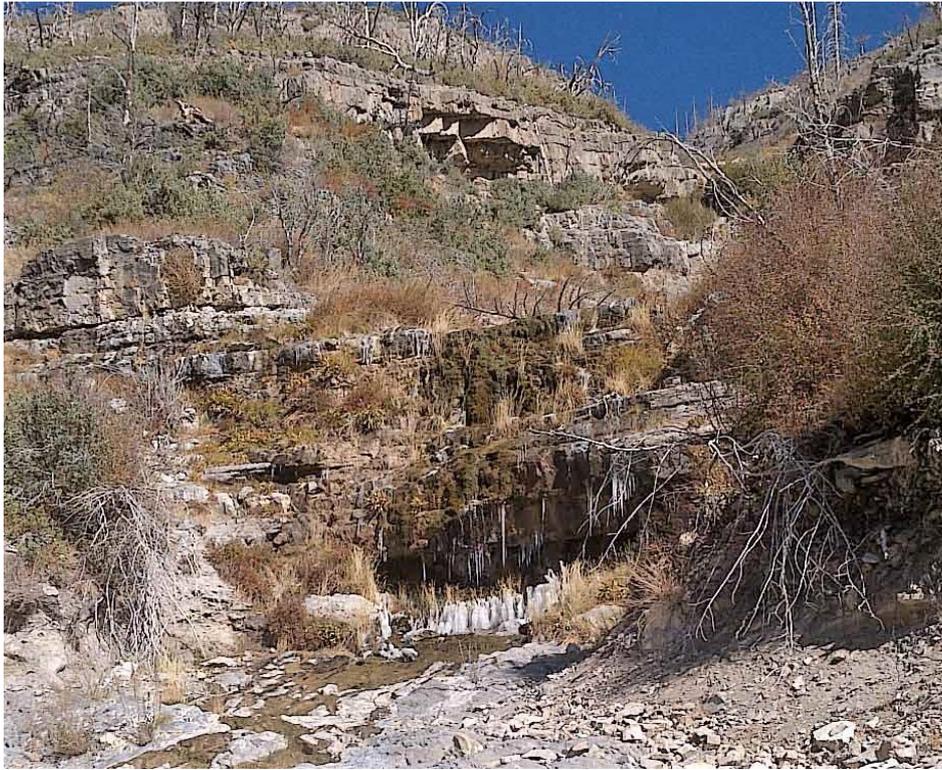
Fig 11.4 Ice Falls Spring Right: Icicles form where flow from the two Ice Falls Springs passes over a bedrock ledge.

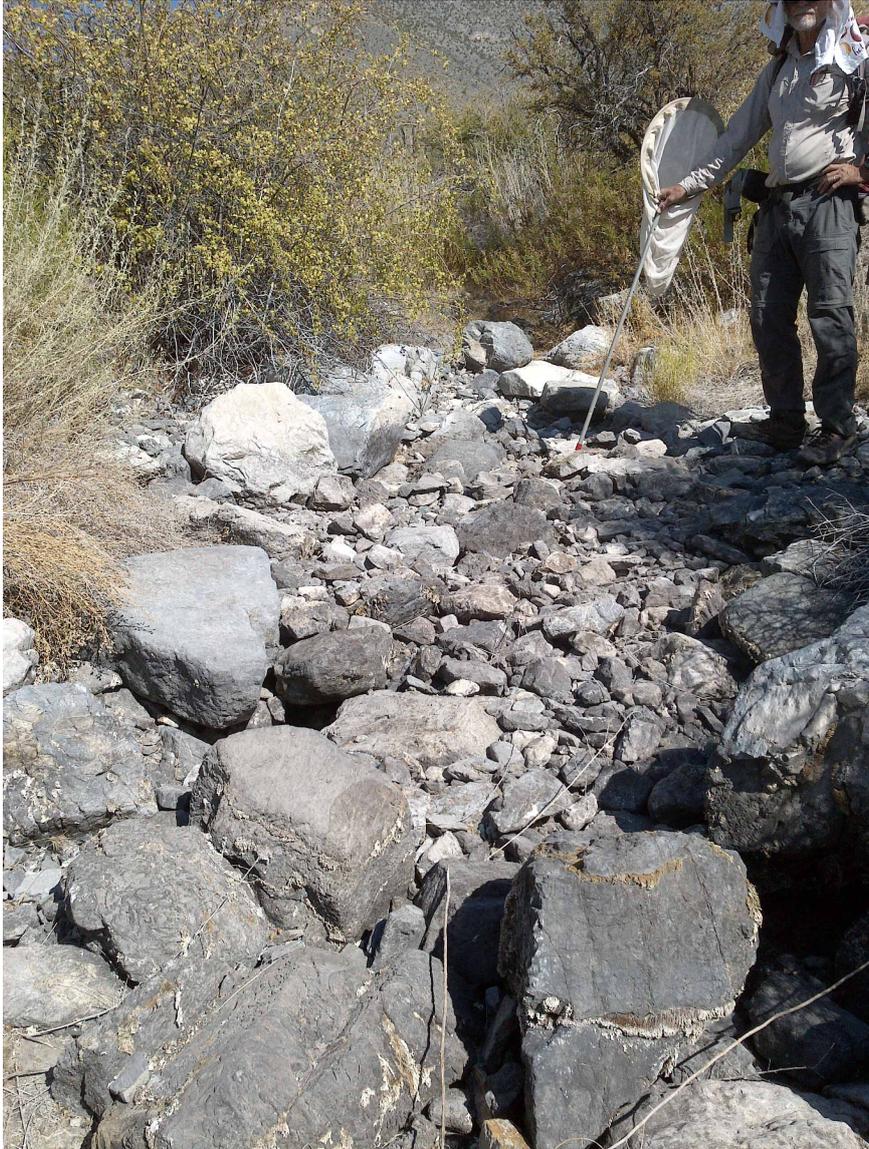
Survey Notes: The site was dry where it was mapped and for 200 or more meters in the channel upstream and downstream and in the nearby channels. Surveyors found evidence of past seepage 30 meters upstream of the mapped point in the form of magnesium precipitate. Surveyors recommend returning during a wetter season.

Fig 12.2 Intermittent Spring: The reported spring location in a dry drainage. Photo match 2011, facing upstream.

Management Recommendations: This naturally ephemeral spring does not warrant management attention, except determining the periodicity and range of discharge.

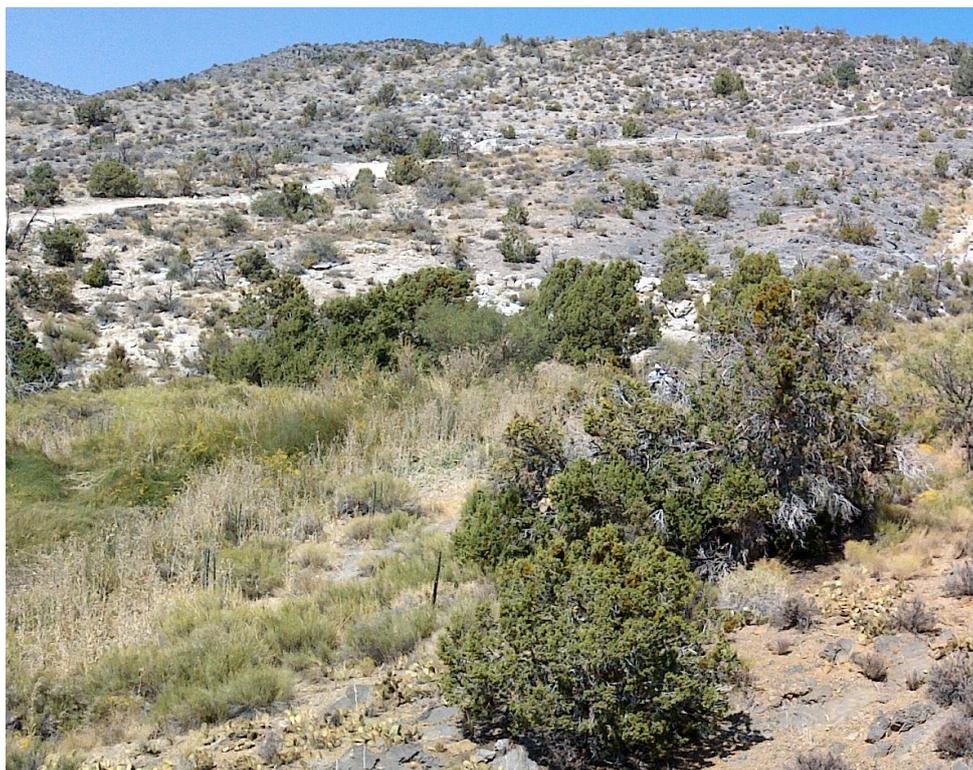
Fig 13.1 Kiup Spring: The springs ecosystem, on a travertine mound in the southern Spring Mountains. The field crew is clustered around the source (right of center). The white dirt road in the background leads north to Upper Kiup Spring.

Survey Notes: Water depth in the vertical culvert springbox was 26 cm. The site is recovering from a burn that occurred within the last decade. There is evidence of target shooting nearby, with many shell casings. There is significant elk trampling, scat, and beds. There are trails on both sides and throughout the site and surrounding area. Surveyors took a 45 minute lunch break and continued to observe wildlife during that time. There are old and newly developed pedestals. The springsnail population is only about 500 individuals at this time, due in part to elk trampling and the absence of firm substrate.

Management Recommendations: Get rid of the mesquite and remove the old iron fencing and barbed wire. Monitor the springsnail population size. Add more substrate to the springbrook to serve as springsnail habitat. Fence the source and meadow to reduce elk impacts, leaving water available at the downstream end.

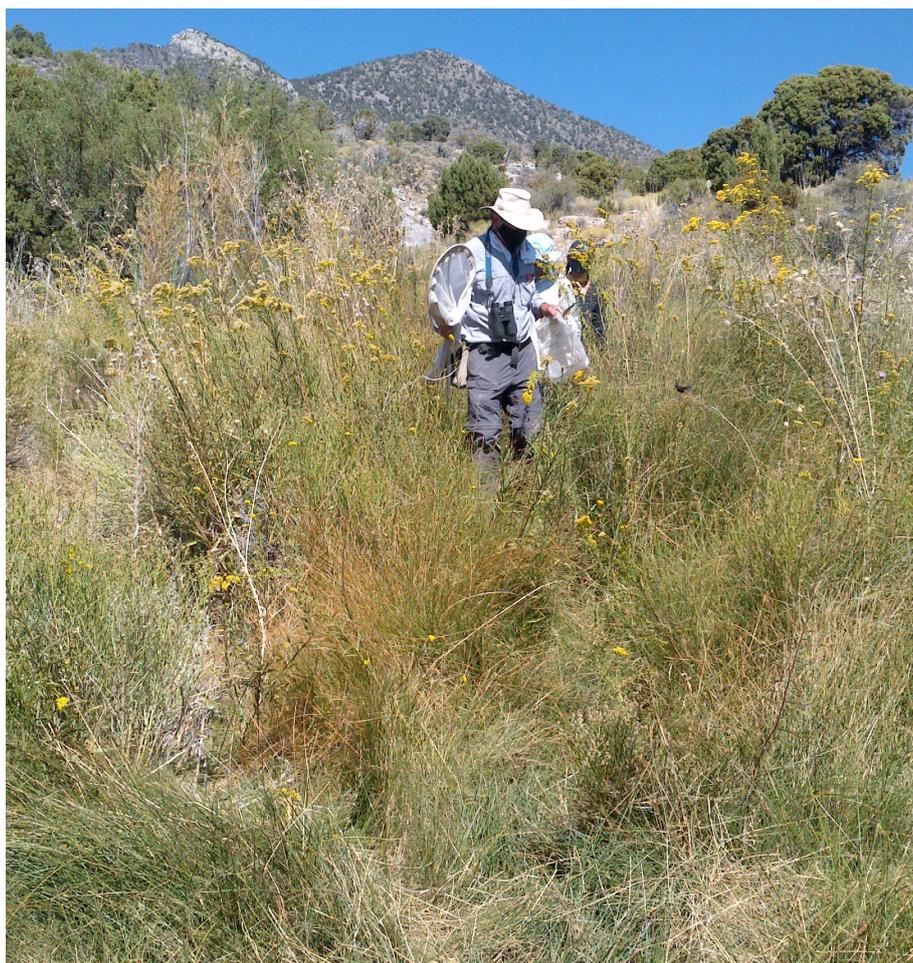
Fig 13.4 Kiup Spring: Crew wildlife biologist Larry Stevens prepares to catch a butterfly in the low gradient cienega. The spring source is behind the photographer, out of view.

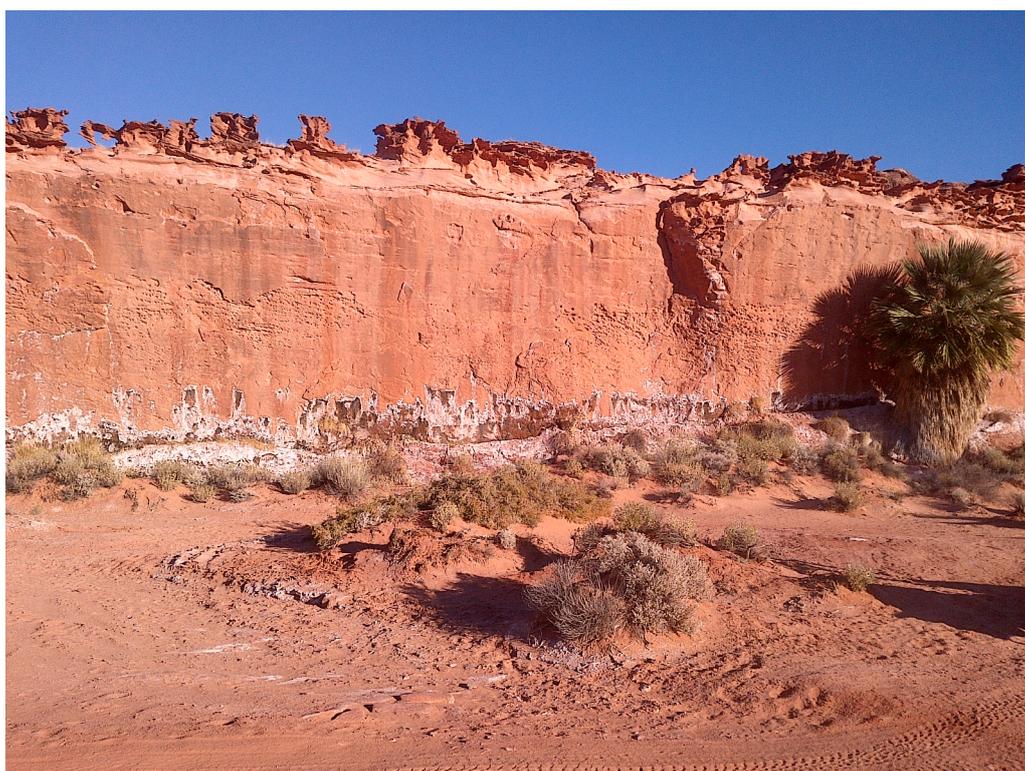
Fig 15.1 Little Finland Seep: The seep line, running along the base of this sandstone cliff. Note the abundant chemical precipitates deposited along the seep line; the water quality results show discharge from this spring to be exceptionally salty. The sandstone fins at the top of the cliff form part of the Little Finland hiking area.

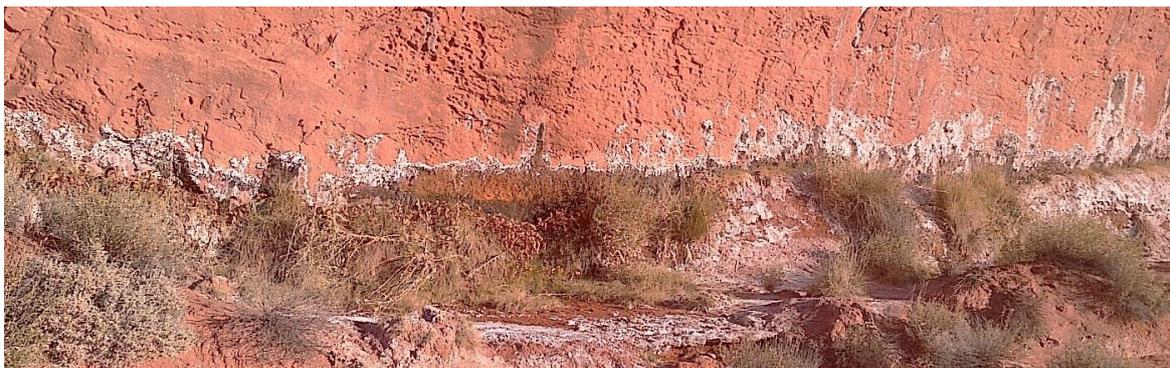
Fig 15.3 Little Finland Seep: This section of the seep line produces enough moisture to form a shallow pool in the sand at the base of the cliff (at bottom center of photo).

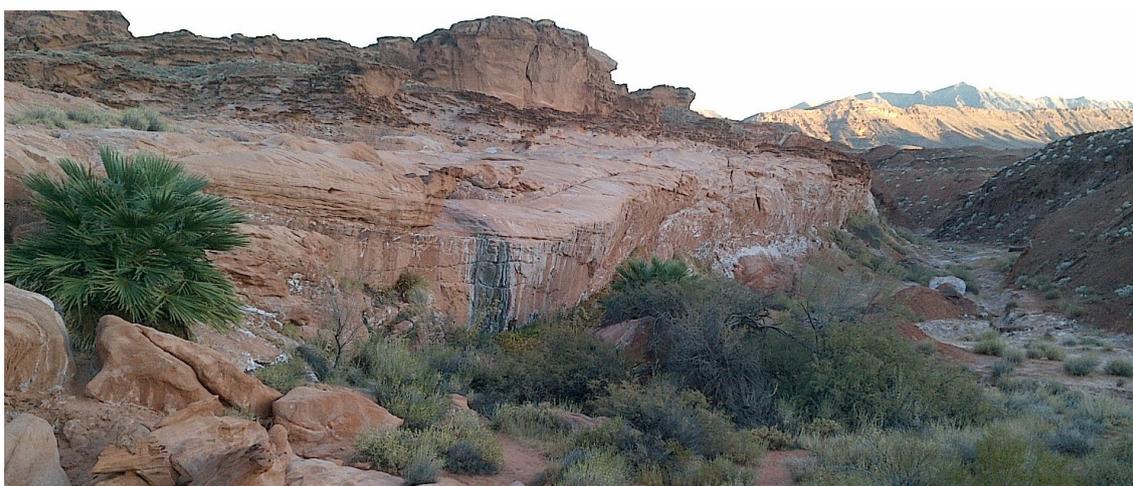
Fig 16.1 Little Finland Seep: The south half of the seep line, emerging from the cliff on the left and running parallel with a dry wash. A hiking trail (not visible) leads up the wash for about 500 meters before climbing up the cliff wall to access the Little Finland slickrock (left half of photo).

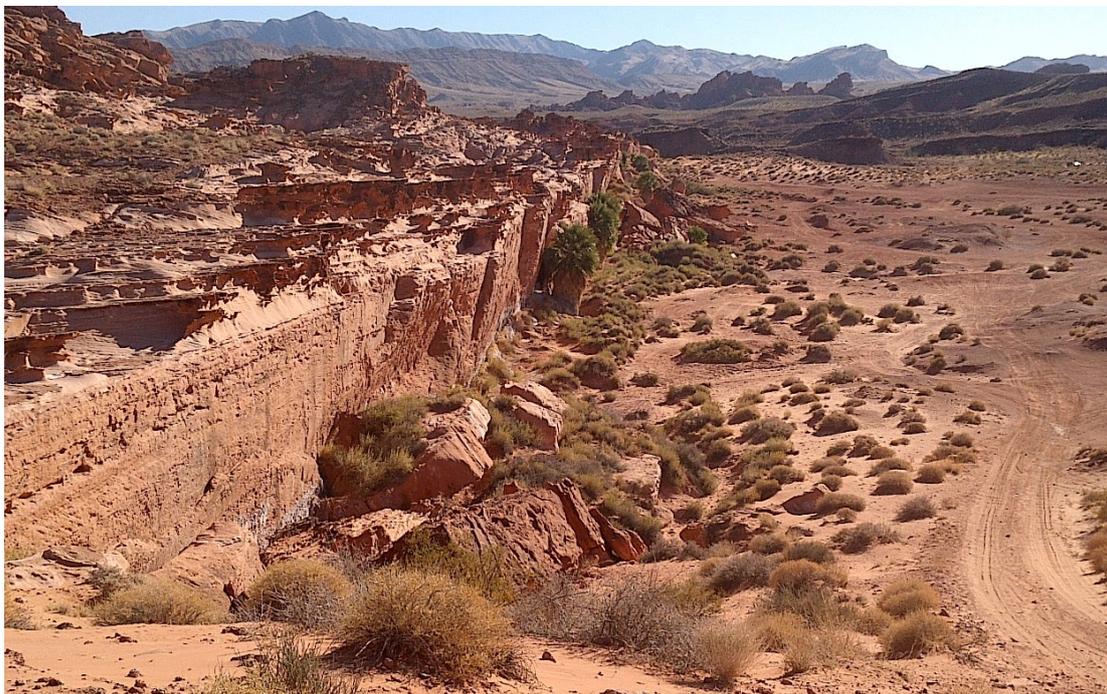
Fig 16.3 Little Finland Seep: The seep line runs along this sandstone cliff, near its base. Note the several palm trees, which are supported by this seep. Photo taken from a vantage north of the northernmost end of the seep line.

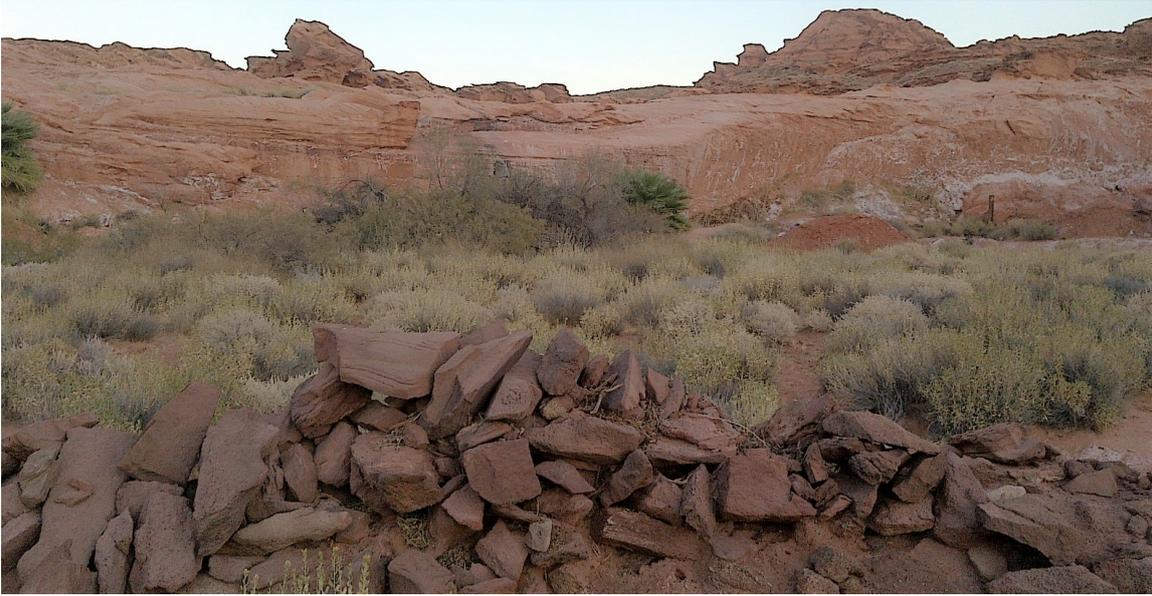
Fig 16.4 Little Finland Seep: A portion of the rock wall which forms a corral in front of the seep. Deposits of chemical precipitates associated with the seep are visible on the sandstone cliff. The Little Finland parking area is behind the photographer.

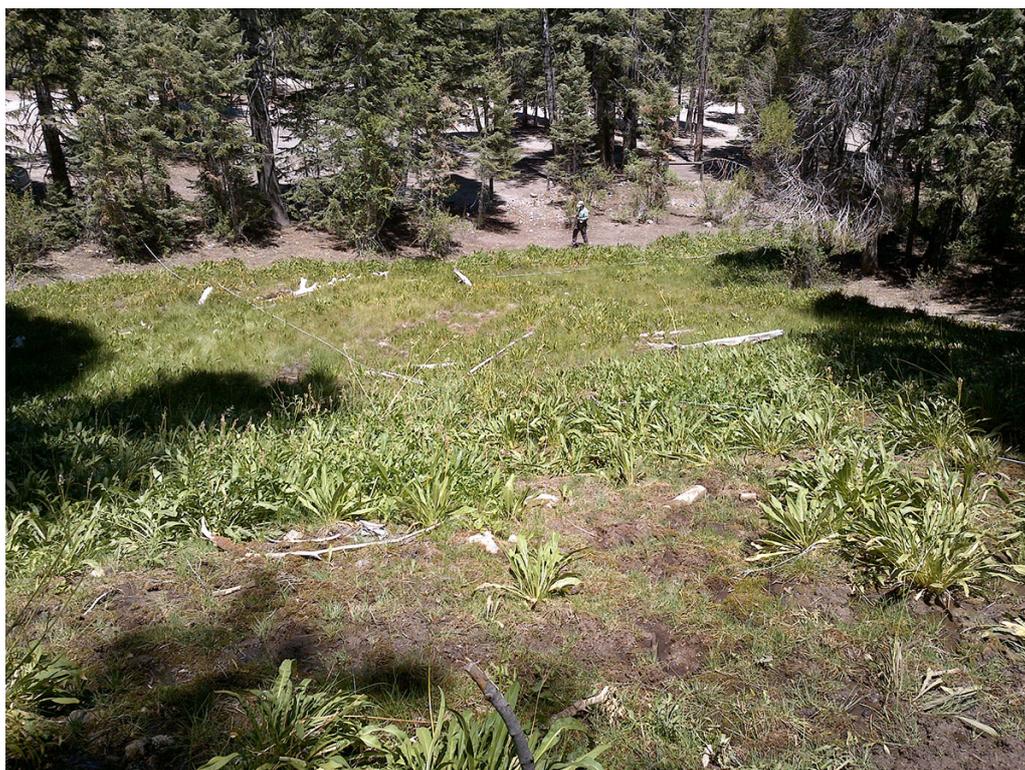
Fig 18.1 Macks Canyon Spring 1: The low gradient cienega and channel, as viewed from the excavated source.

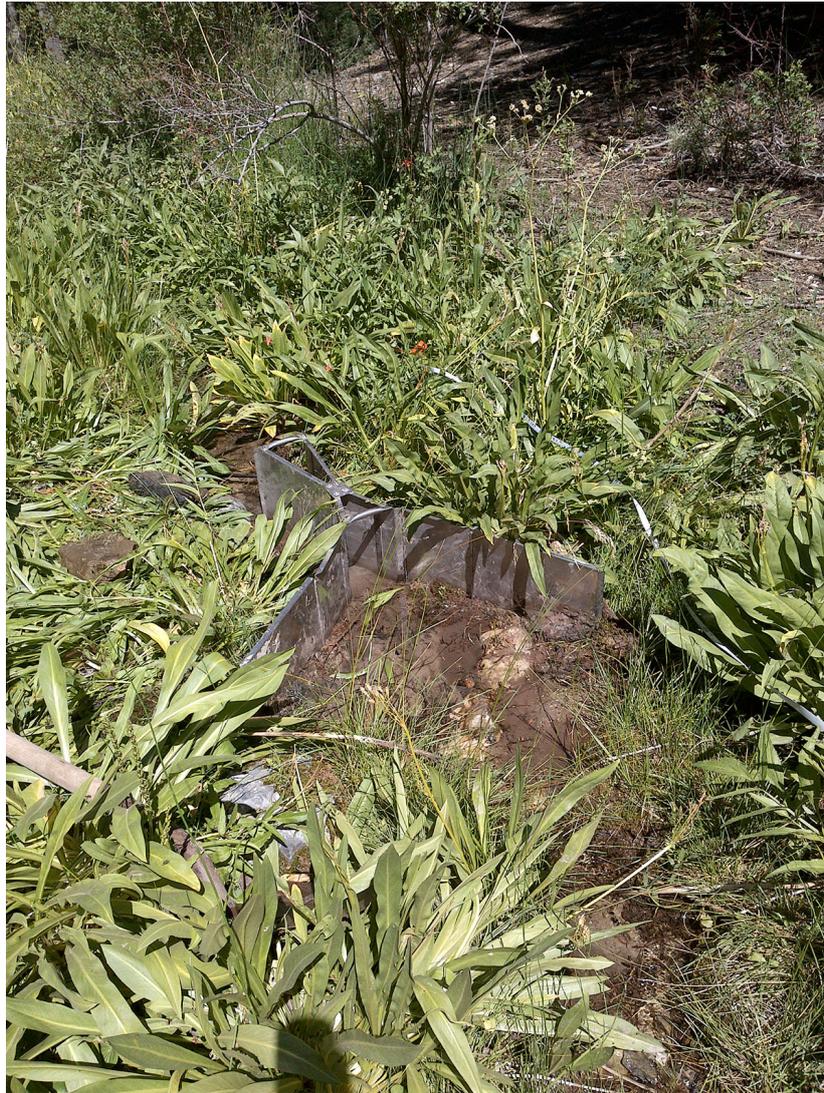
Fig 18.4 Macks Canyon Spring 1: Flow measurement location, in the channel 34 meters down from the uphill end of the low gradient cienega.

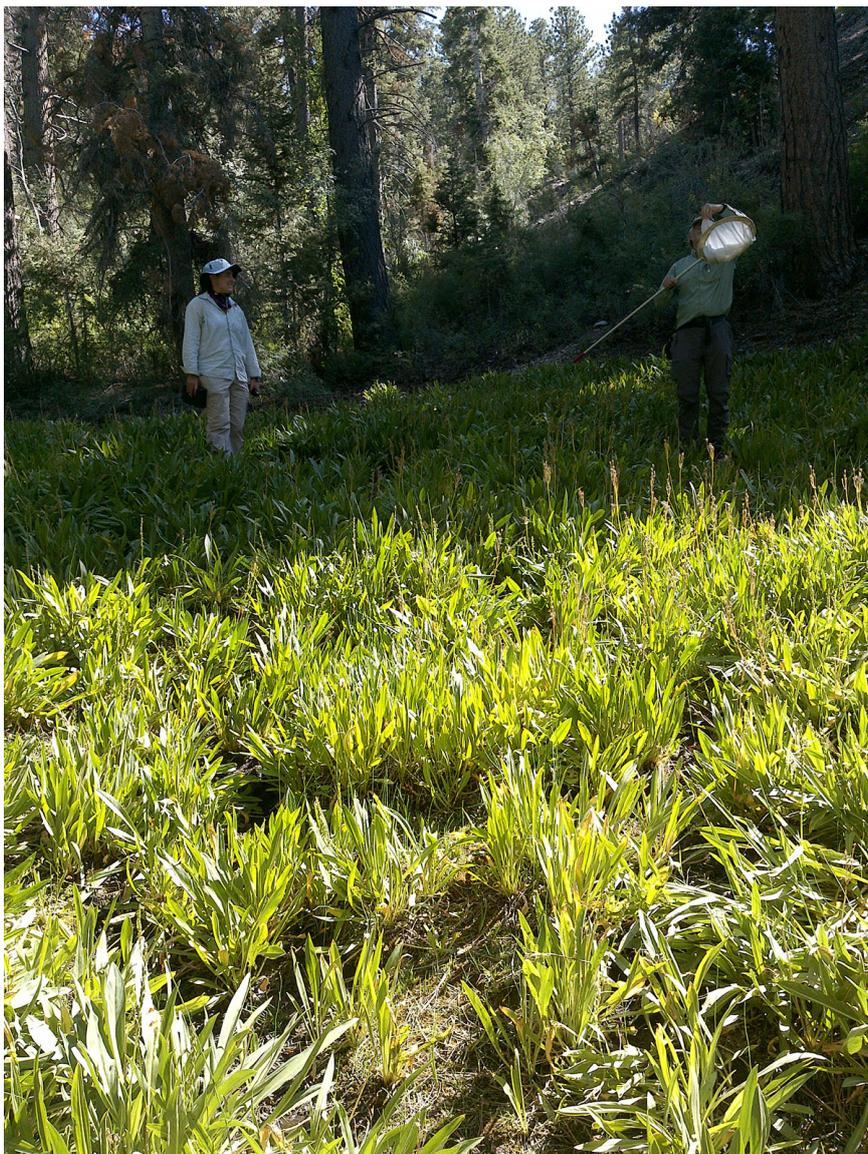
Fig 19.1 Macks Canyon Spring 2: Overview of the spring. The photographer is facing upslope.

Physical Description: Macks Canyon Spring 2 is a hillslope/anthropogenic spring. This spring emerges on a hill above a parking lot and camp area that is frequently visited. The surrounding area is heavily forested. The site has been excavated and piped. The flow emerges from a pipe embedded in a vegetated hillslope. The pipe flows into a small pool which has been dug out and retained with rocks. The hillslope is the broad mouth of a drainage upslope. The substrate is soil and small limestone colluvial gravels. The spring is 20 meters from a popular dirt road and campground, and a foot path runs through the spring.

Management Recommendations: Fence the helocrene to exclude horses, leaving water available downslope. Monitor the spring occasionally. The horse trail entering the helocrene, from the top in particular, is shedding gravel and small boulders onto the helocrene surface, changing grain size.

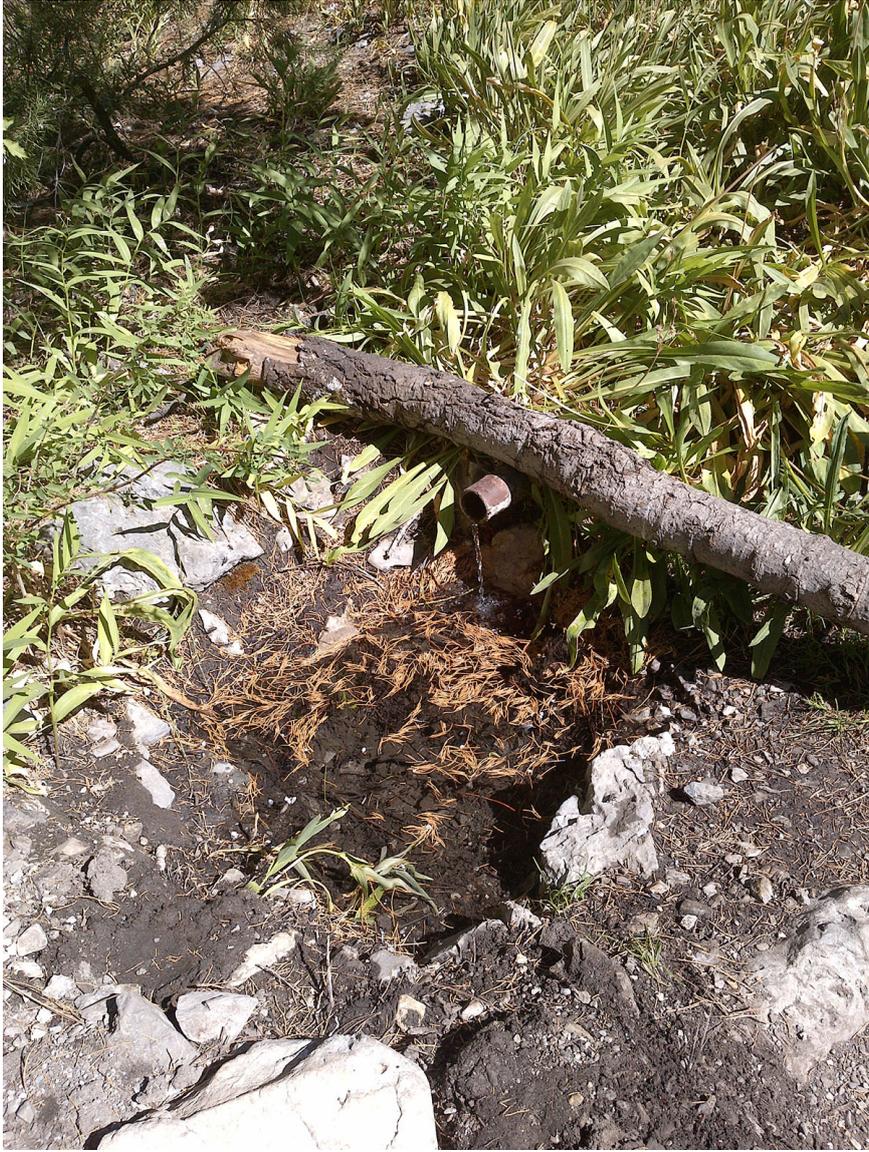
Fig 19.2 Macks Canyon Spring 2: The pipe outflow into the excavated pool, where surveyors measured flow.
