Clark County 2020 Survey Summary Reports
Springs Stewardship Institute
Volume 1 of 3

1. Buck Spring, 10/17/20
Survey Summary Report, Site ID 152983
Submitted 2/11/22 by Springs Stewardship Institute

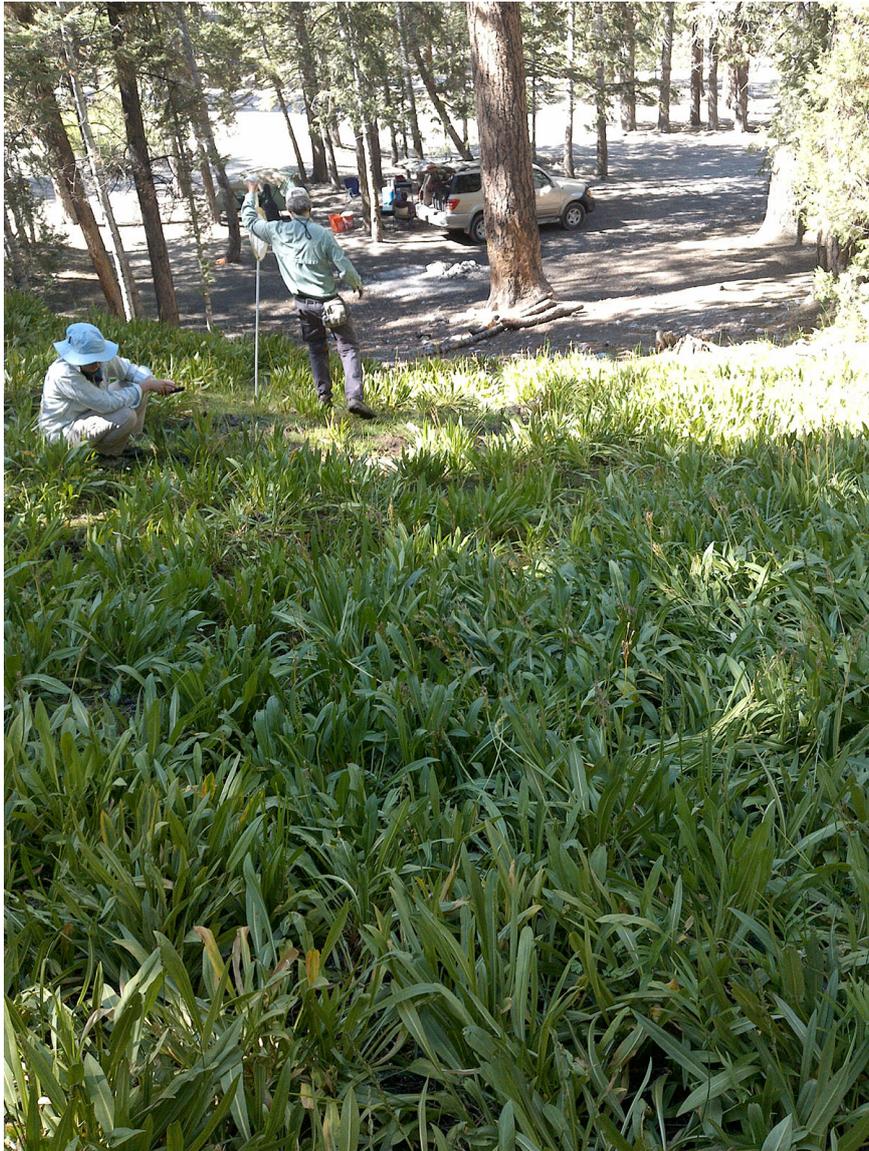
Fig 19.3 Macks Canyon Spring 2: The spring habitat and the adjacent parking and camping areas, viewed from above the source.
